Loss of performance involving DH-82A (Tiger Moth), VH-DDA

Luskintyre Airport, NSW, 15 December 2012

ATSB Transport Safety Report
Aviation Occurrence Investigation
AO-2012-169
Final – 23 April 2013

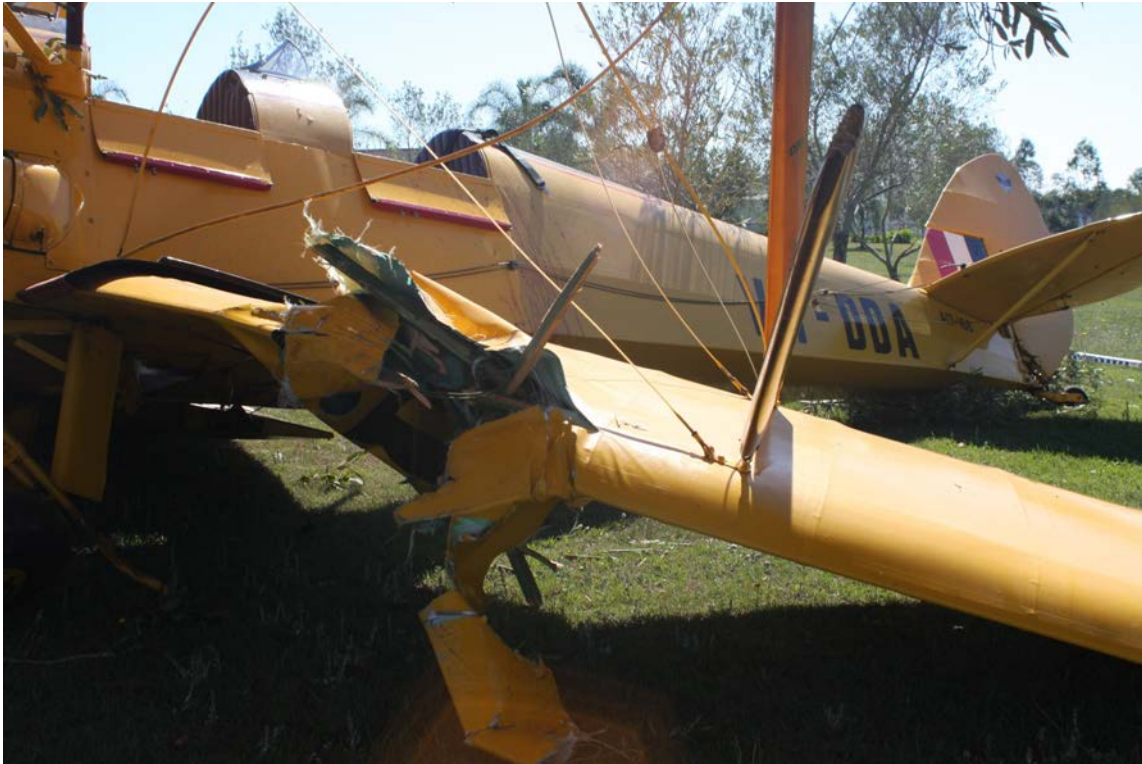
As there was insufficient distance remaining to land on the runway, and it had become evident that a forced landing was imminent, the instructing pilot input a slight left bank so that the left wing of DDA took the main force of the impact. The aircraft landed and struck a tree before coming to rest (Figure 1). Both pilots were able to undo their four-point harnesses and exit the aircraft without assistance, although the pilot flying received serious facial injuries.

A small fire caused by a fractured fuel line was quickly extinguished by ground crew and the aircraft sustained substantial damage.

Figure 1: Damage to left wing following impact with a tree
