Aircraft proximity event between an Alpha Aviation R2160, VH-NZT and a Diamond DA 40, VH-UNH

13 km NW of Bankstown Airport, NSW, 17 January 2013

ATSB Transport Safety Report
Aviation Occurrence Investigation
AO-2013-017
Final – 23 April 2013

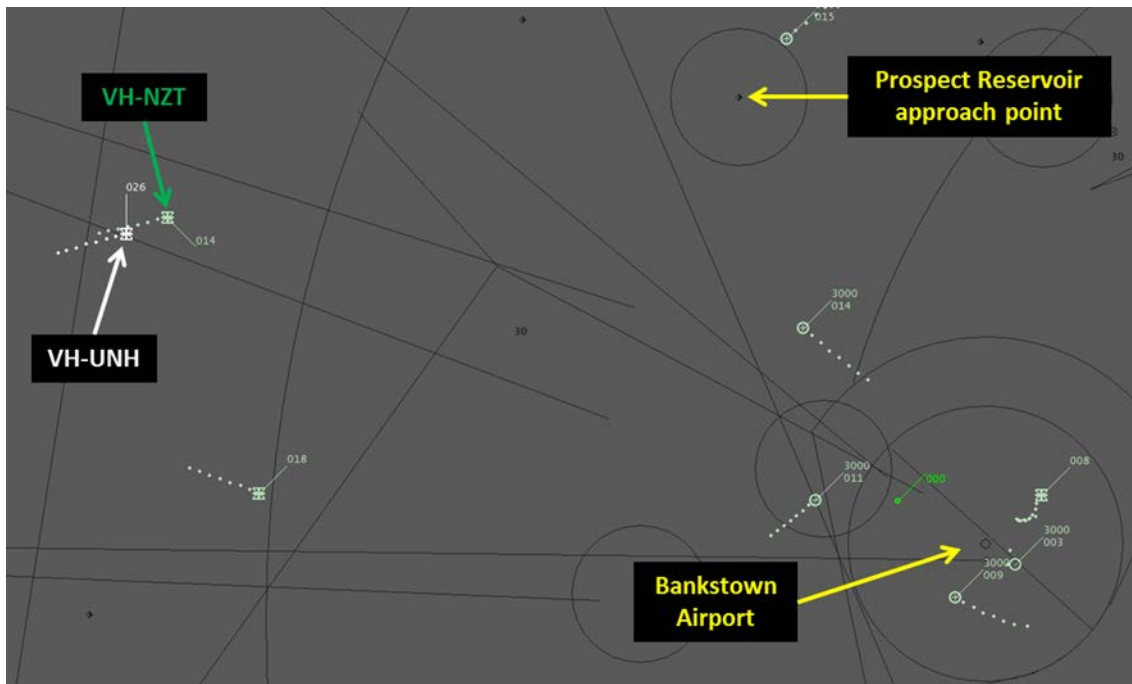
Figure 1: VH-NZT and VH-UNH tracking to Prospect Reservoir

Airservices Australia surveillance data showed UNH following NZT on a similar track (Figure 1).

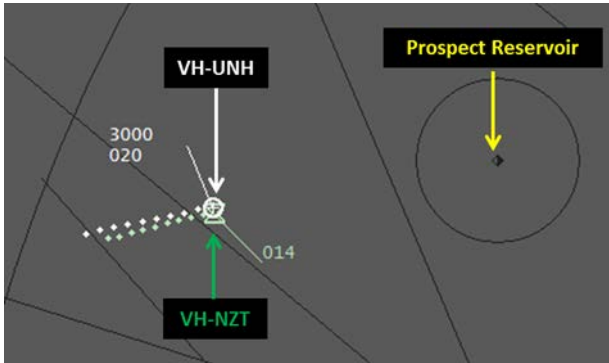
Figure 2: Aircraft positions at 1550:47

Both UNH and NZT continued tracking for Prospect and when at 4-5 NM, the instructor of NZT changed radio frequency to Bankstown Tower. Shortly after, at 3.5 NM (1550:47 Eastern Daylight-saving Time²), UNH was observed on the Airservices Australia surveillance data descending overhead NZT with 600 ft recorded vertical separation, which was actually 500 ft, accounting for

NZT’s transponder discrepancy (Figure 2). The pilot of NZT reported maintaining 1,500 ft while UNH continued to descend.

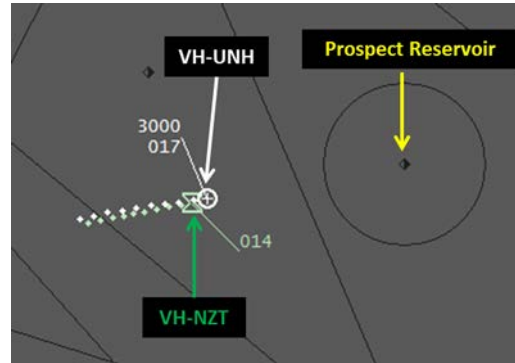
Figure 3: Aircraft positions at 1551:19

At 1551:19, the surveillance data showed that there was 0.2 NM lateral and 300 ft vertical separation (200 ft actual) between UNH and NZT (Figure 3). After that time, for undetermined reasons, the altitude readout for NZT on the Airservices Australia surveillance data was temporarily corrupted and not recorded.

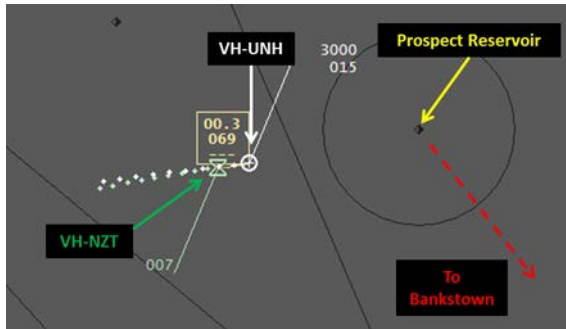
Figure 4: Aircraft positions at 1551:37

At 1551:37, when 2 NM from Prospect, the instructor of UNH changed to the Bankstown Tower frequency and heard a broadcast from NZT advising they were inbound from Prospect at 1,500 ft (Figure 4). At that time, UNH was also maintaining 1,500 ft. As the instructor and student were not aware of NZT, they immediately commenced looking for the aircraft.

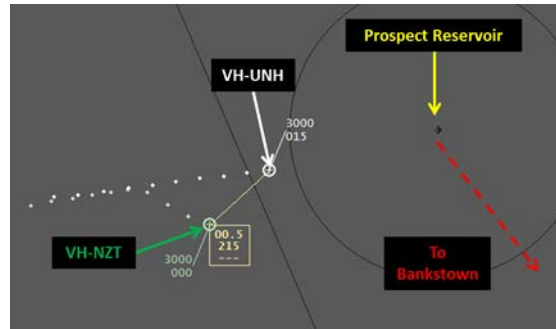
Figure 5: NZT turning inbound

NZT commenced the turn inbound to Bankstown (Figure 5). At the time of the incident, both NZT and UNH were operating in Class G airspace⁶.
