Collision on the ground involving a Cessna 172R, VH-IMS

Sunshine Coast Airport, Queensland, 2 August 2013

Final – 31 October 2013

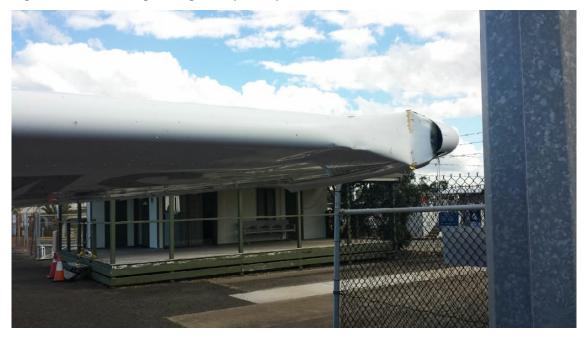
Other aircraft were operating in the area and the pilot wanted to ensure he remained clear of them. The pilot noted a fence and power pole on his left, and then focused on an aircraft taxiing in front of IMS. While the pilot was watching the other aircraft taxiing, he advised that IMS may have rolled forward unnoticed. When the pilot commenced a right turn, the aircraft was past the end of the fence and as he turned the aircraft, the left wing collided with a power pole.

Figure 1: Aircraft wing damage and power pole

There are many visual illusions that can lead to incidents in aviation. In this accident, the pilot was watching an aircraft taxiing away from him. He thought that his aircraft was stationary, and was unaware that it had rolled forwards because of the perception of movement relative to the other aircraft. The aviation medicine website, www.avmed.in/2011/04/spatial-disorientation-visual-illusions/, provides additional examples of visual illusions common in aviation.

The pilot reported that he had learnt a valuable lesson from the accident, in that the flight is not over until the aircraft has been shut down and secured. In particular, this incident highlights the need to keep a good look out during taxi as well as in flight.
