Hard landing involving a Grob G-115C2, VH-ZIV

Merredin (ALA), Western Australia, 11 October 2013

ATSB Transport Safety Report
Aviation Occurrence Investigation
AO-2013-178
Final – 27 March 2014

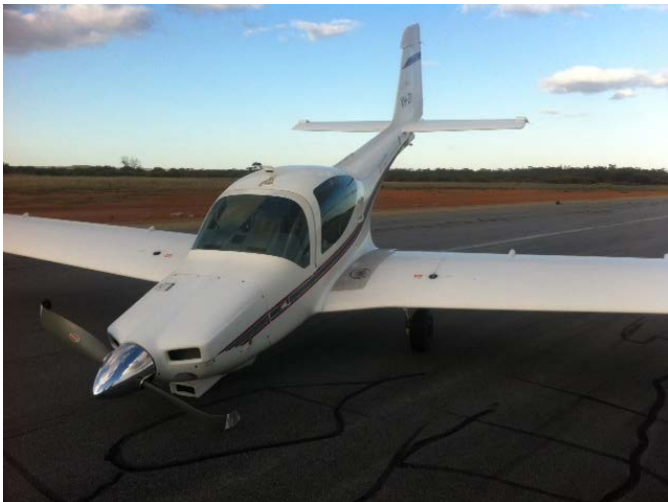
Figure 1: Accident site

The student located Merredin and joined the circuit for runway 28. When turning onto the base leg of the circuit, the student reported that the aircraft's airspeed was low so he adjusted the engine power and aircraft attitude. When on short final he determined that he was too high and initiated a go-around. The student commenced a second circuit to runway 28. When on short final, the student reported there was a crosswind with slight windshear, and the glare from the sun was making it increasingly difficult to see the runway. The student indicated that, at the height of the windsock, he reduced the engine power to idle and the aircraft sank quickly. At about 1700 Western Standard Time (WST),² the aircraft touched down heavily and bounced. The student reported that the sun glare made it very difficult to judge the height of the aircraft and he believed that the aircraft had not bounced very high. The aircraft touched down again on the nose landing gear, which subsequently collapsed. The aircraft slid along the runway and came to a stop. The student pilot was uninjured and the aircraft sustained substantial damage (Figure 1).
