# Turbulence event involving a Boeing 777, VH-VPE

472 km NW of Noumea La Tontouta International Airport, New Caledonia,  
23 September 2013

**ATSB Transport Safety Report**  
Aviation Occurrence Investigation  
AO-2013-181  
Final – 27 March 2014

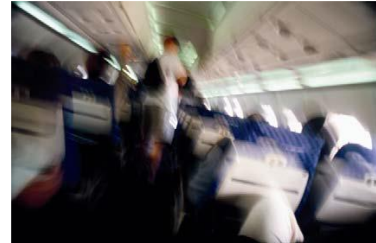
At the same time, the cabin crew had begun the meal service and the seat belt signs were turned off. Cabin crew members reported being thrown around the cabin by the turbulence with two crew hitting their heads on the aircraft cabin ceiling. Other injuries reported by the cabin crew included sore backs, a sore toe, a sore ankle and bumped heads. Food and catering equipment were spread over seats, passengers and the aisles with the rear section of the aircraft affected the most. All passengers were seated at the time with their seat belts on. One passenger reported a sore neck and another passenger reported a burn injury as a result of a spilt hot meal. There were no reported injuries to the four flight crew.
