Total power loss involving a Bell 206B, VH-NDL

179 km SE of Alice Springs Airport, Northern Territory, 12 November 2013

ATSB Transport Safety Report
Aviation Occurrence Investigation
AO-2013-208
Final – 14 July 2014

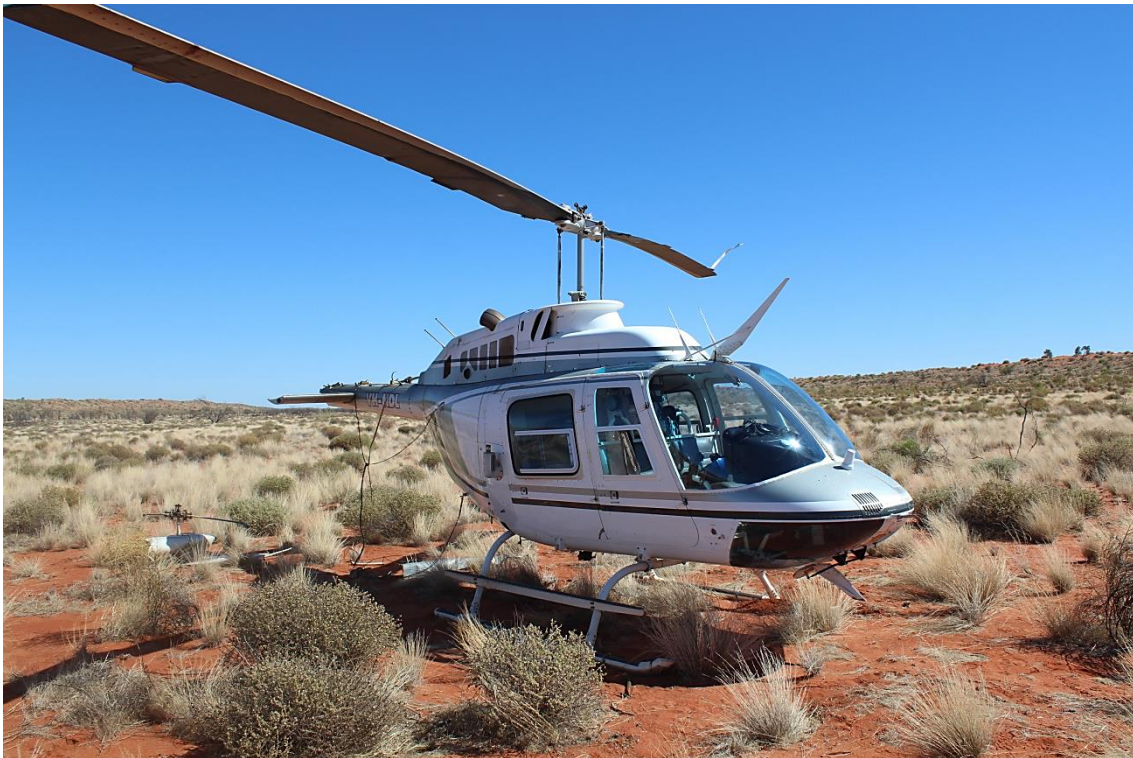
Figure 1: VH-NDL

On 12 November 2013, a Bell 206B helicopter, registered VH-NDL, departed a camp site located 51 NM SE of Alice Springs, Northern Territory, on a charter flight with a pilot and three passengers on board. The flight was conducted in visual meteorological conditions. About an hour into the flight and 2 NM from the landing area, the pilot commenced a slow descent from 2,000 feet above the ground (AGL). When lowering the collective, the pilot heard an intermittent grinding noise above the cockpit. The pilot checked the gauges, with nothing unusual noted. The noise continued to develop and the pilot elected to land. As the helicopter descended through 400 feet, a clunking noise was heard and power was lost to the main rotor. The pilot initiated an auto rotation and briefed the passengers for an emergency landing. During the touch down at about 0705, the main rotor blade severed the tail boom (Figure 1). The pilot secured the helicopter, waited for the main rotor to slow and assisted the passengers to exit. The helicopter sustained substantial damage; the occupants were not injured.

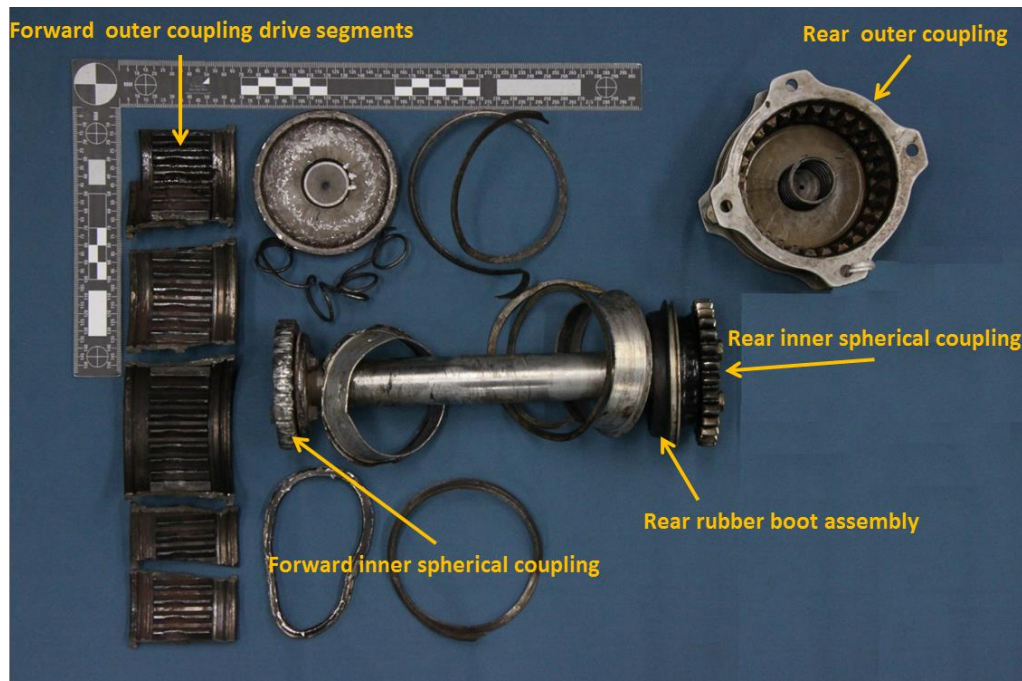
Figure 2: Main drive shaft VH-NDL

The operator determined that the engine-transmission main drive shaft¹ had failed due to the failure of the forward drive shaft boot. They reported that, during the week prior to the accident, the helicopter had operated short flights to landing areas with extended ground running, in high temperatures and with the helicopter loaded to near its maximum all up weight.

The following are the results of ATSB examination of the main drive shaft, which was supplied by the Civil Aviation Safety Authority (Figure 2).

The forward outer coupling had failed, in overload, into five segments. The surfaces of the segments had evidence of discolouration due to over-temperature and most of the surfaces had turned into red oxide (which forms in air at high temperatures, estimated to be over 500 °C). There was no detected grease that is needed for lubrication to reduce friction (heat) between the rotating parts. Without the grease, the gear teeth on the forward inner spherical coupling softened, deformed, fractured and became jammed, resulting in the forward outer coupling shattering into the five segments. The four Temp-Plate indicators (which indicate when there has been excess temperature) were not present on the forward outer coupling exterior. There were no detected remnants of the forward rubber boot that is part of the seal assembly for containment of the grease.

The rear outer coupling and rear inner spherical coupling were well lubricated and exhibited normal condition. All four Temp–Plate indicators were attached to the rear outer coupling exterior, with no apparent indication of an over-temperature. The rear rubber boot, which is part of the seal assembly for containment of the grease, was flexible and undamaged.

- Replace the main drive shaft assembly with a KAflex drive shaft system to all operator effected helicopters.
