Loss of separation assurance involving a Boeing 737, VH-XZA and a Fairchild SA227, VH-ANW

near Darwin Airport, Northern Territory, 2 June 2014

ATSB Transport Safety Report
Aviation Occurrence Investigation
AO-2014-102
Final – 3 September 2014

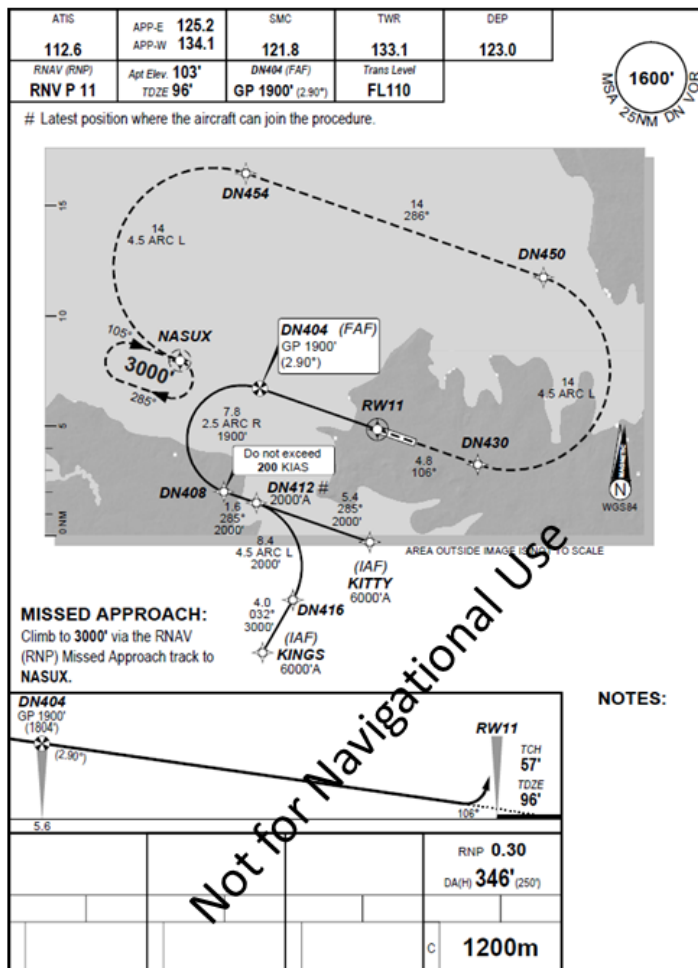
Figure 1: Darwin RNAV-P (RNP) RWY 11¹

On 2 June 2014, at about 1200 Central Standard Time (CST), the approach controller at Darwin Airport, Northern Territory, was processing the arrival of a Qantas Boeing 737 aircraft, registered VH-XZA (XZA), and an Airnorth Fairchild SA227, registered VH-ANW (ANW). When about 34 NM south-east of Darwin on a standard arrival route (STAR), XZA was cleared by the approach controller to descend to 3,000 ft and to conduct an Area Navigation ‘P’ (RNAV-P) approach to runway 11, via the ‘KITTY’ initial approach fix (IAF) (Figure 1).
