Engine failure involving Saab 340B, VH-RXE

141 km south of Perth, Western Australia on 21 December 2022

Aviation Occurrence Investigation (Short)

AO-2022-066

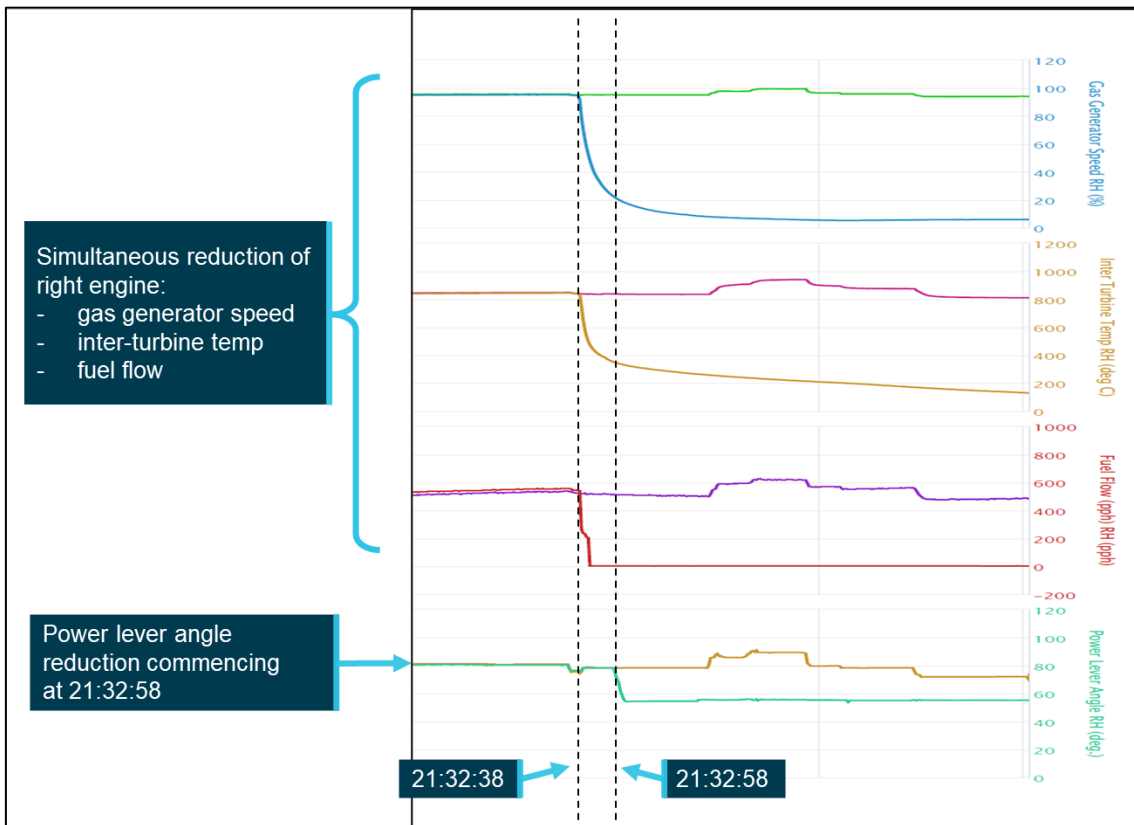
Figure 1: Recorded flight data for the occurrence showing selected parameters

- 21:32:38
 - gas generator speed began reducing from 92% to 5%
 - inter-turbine temperature began reducing from 820°C to 180°C
 - fuel flow reduced abruptly to 250 pounds per hour, stabilised with a gradual reduction for approximately 4 seconds, followed by another immediate reduction from 200 to 0 pounds per hour.
- 21:32:58
 - power lever angle started to reduce to 55°.

Flight data analysis also identified that the reduction in gas generator speed, inter-turbine temperature, and fuel flow preceded the power lever reduction by 20 seconds.

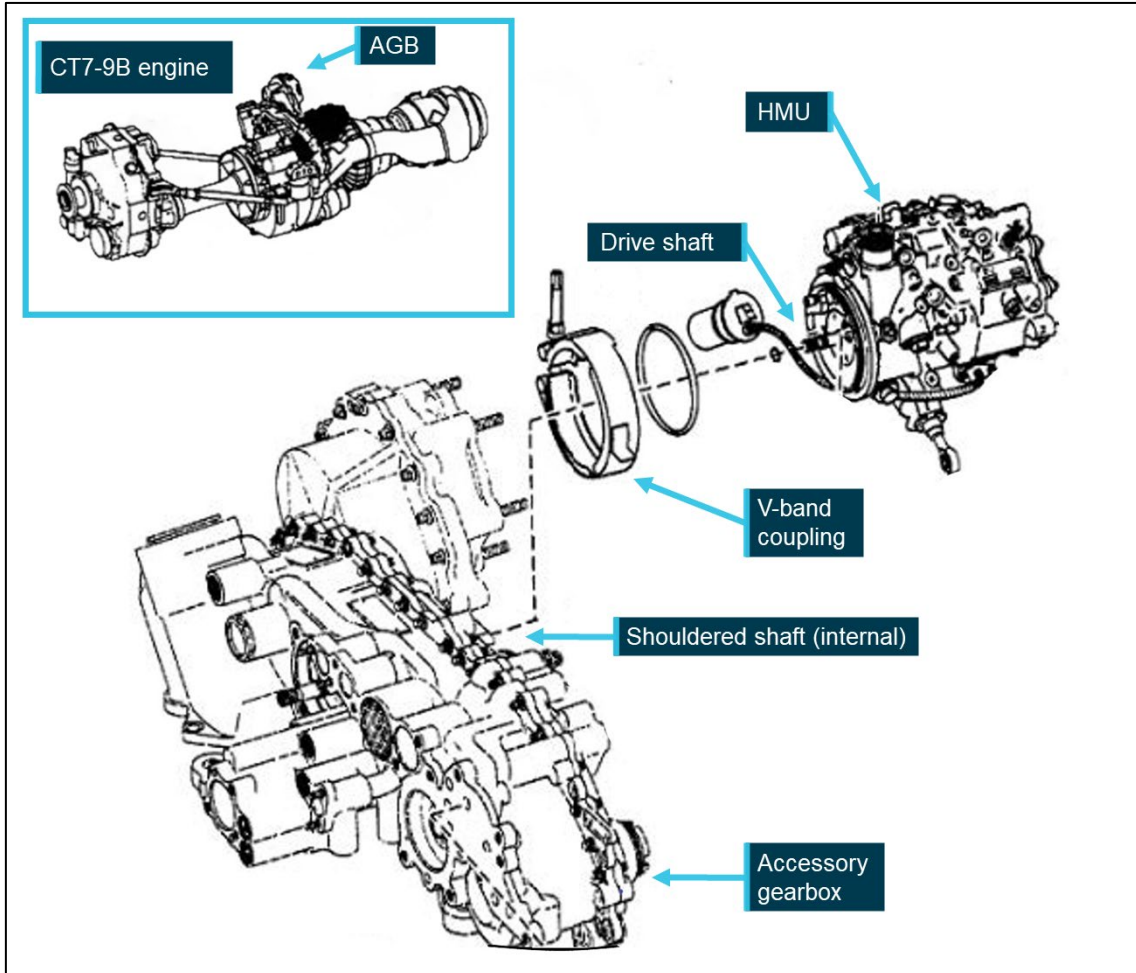
Figure 2: CT7-9B engine with accessory gearbox

The hydro-mechanical unit (HMU) provides high pressure metered fuel for combustion. It is attached to the engine AGB and contains a high-pressure fuel pump that is driven by the HMU drive shaft from an internal shouldered shaft within the AGB (Figure 2). This high-pressure fuel pump develops the pressure necessary to spray the fuel into the combustion chamber through the fuel nozzles. Failure of the high-pressure fuel pump will result in an immediate engine flameout.

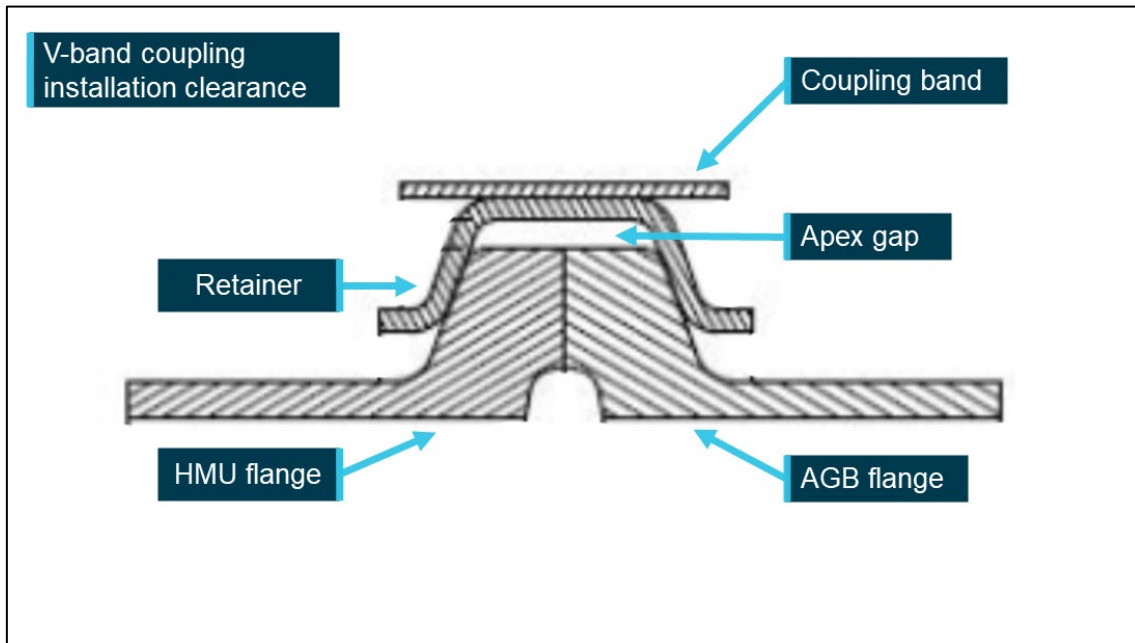
Figure 3: V-band coupling clearance after installation

The HMU is secured to the AGB by a V-band coupling (Figure 2). A V-band coupling consists of a series of V-shaped retainers that are welded to a band, these retainers fit over flanges on the HMU and the AGB. A single nut tightens the band which evenly distributes pressure around the entire circumference of the flanges holding them together. If the coupling is correctly aligned on the flanges, the inner diameter of the band maintains a clearance, known as the apex gap, to the AGB and HMU flanges with flange contact only on the sides of the V-band retainers (Figure 3).

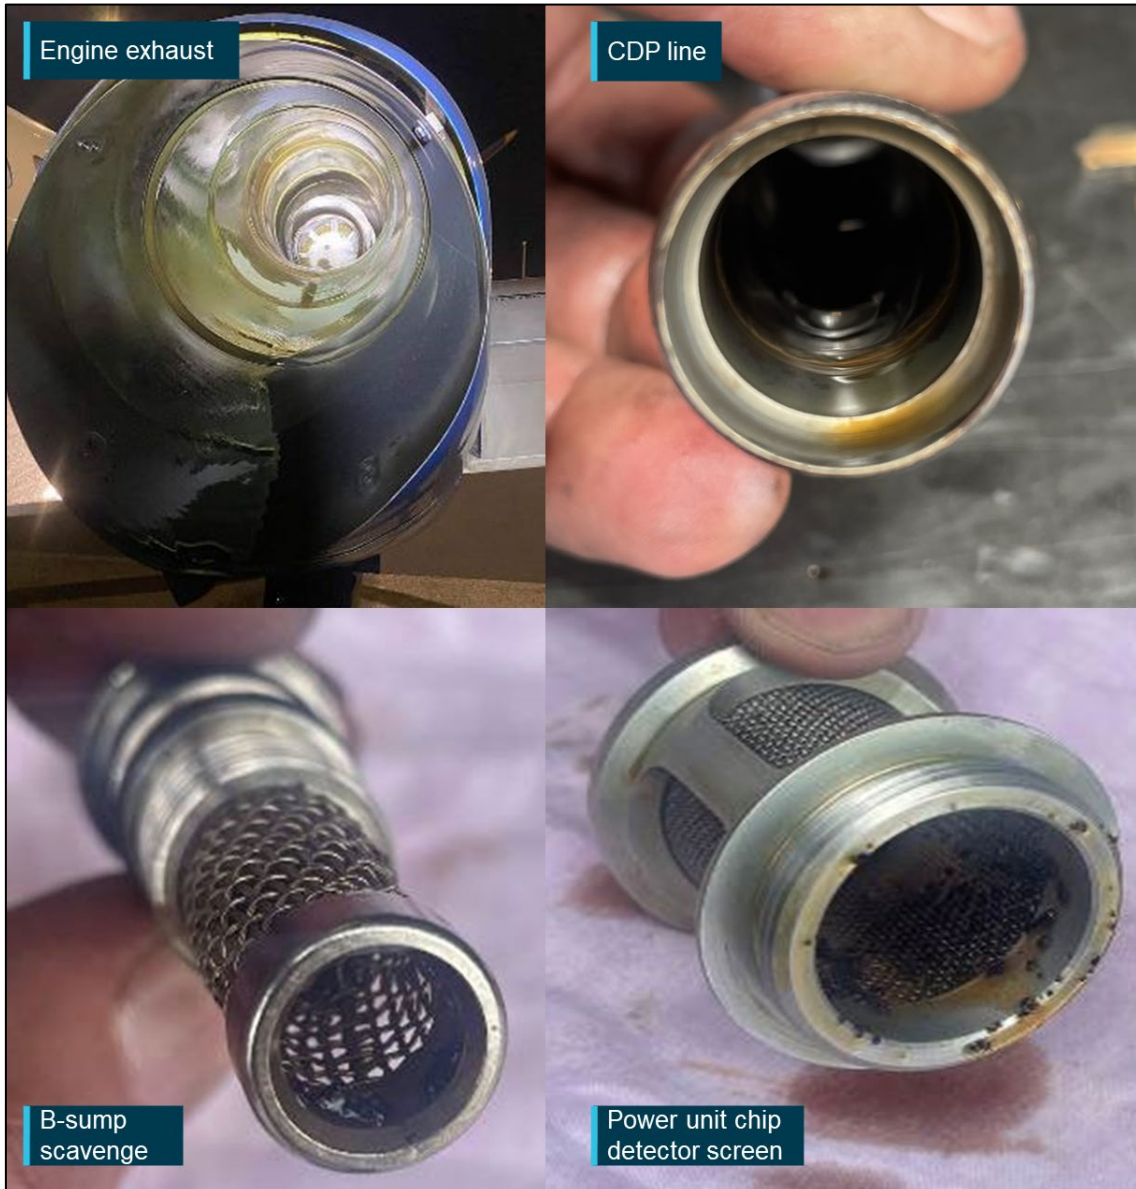
Figure 4: Post engine failure observations

During the initial post-occurrence engine troubleshooting, maintenance engineers identified oil in the exhaust and in the compressor discharge pressure (CDP) line. Debris was also identified on the engine power unit chip detector and the B-sump oil scavenge screen (Figure 4). Further troubleshooting by GE Aerospace later identified the debris material as non-ferrous oil coking³ and not related to the failure of the engine.

GE Aerospace commented that the presence of oil in the exhaust and the compressor discharge pressure line was a result of the engine oil scavenge system depressurising during the in-flight engine shutdown while the core engine continued to be rotated from the relative airflow, circulating oil.

Oil located in engine exhaust and CDP line. Debris located in B-sump scavenge and power unit chip detector screens
Source: Regional Express, annotated by the ATSB

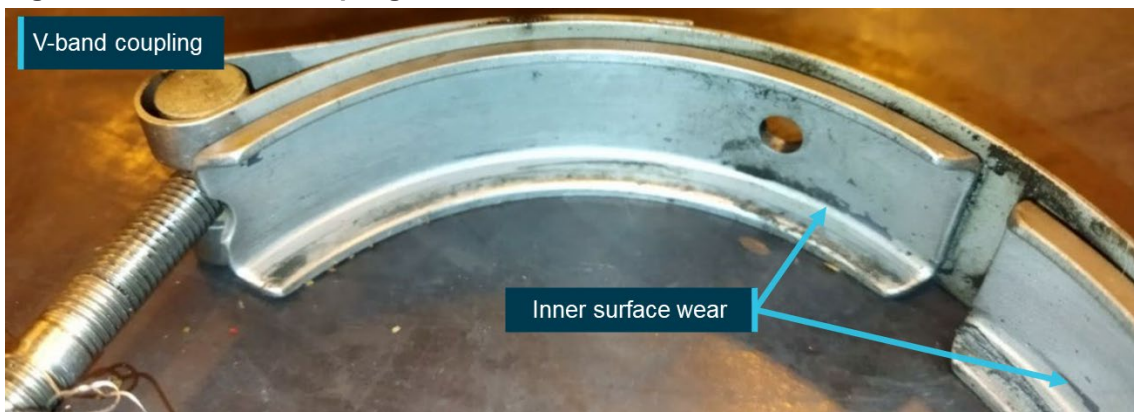
Figure 7: HMU V-band coupling wear location

The V-band coupling securing the HMU to AGB flanges together was observed to have wear on its inner surface from contact with the AGB flange. This wear was present in an area where, if the HMU and AGB flanges were correctly aligned and seated, the apex gap would be present. Interference wear in this area was evidence of a misalignment and non-seating of the HMU onto the AGB.

HMU V-band coupling with wear from the AGB flange located on inner surface clearance (apex gap) area
 Source: GE Aerospace, annotated by the ATSB

Wear marks from the AGB flange were observed on the inner surface of the V-band coupling. These wear marks were located on an area of the coupling that, when the flanges of the HMU and AGB are correctly aligned and the coupling is aligned correctly prior to and during torquing, an apex gap is maintained between the flanges and the inner surface of the V-band coupling. The presence of interference wear marks on the inner surface of the V-band coupling demonstrated that the flanges, or the V-band coupling, were misaligned during installation.

This misalignment of the HMU, taking into consideration that the HMU drive shaft was not bent, likely translated to an uneven loading of the splines of the HMU drive shaft and the AGB shouldered shaft receptacle during operation. This in turn probably caused wear, damage, and subsequent decoupling of the HMU drive shaft during operation.

GE Aerospace advised that it intended to share the learnings of this occurrence with its customers and maintenance facilities and to remind them of the correct installation and maintenance of the hydro-mechanical unit to prevent a reoccurrence and premature wear of the drive shaft and accessory gearbox internal shouldered shaft.

Regional Express reported a number of safety actions taken as a result of this occurrence. These include the dissemination of a technical notice to its engineers highlighting the importance of correct hydro-mechanical unit installation and the addition of V-band coupling installation to the list of critical control system maintenance items. The operator has also commenced a fleetwide inspection of its aircraft to confirm correct V-band coupling installation. As of 24 July 2024, 50% of the fleet had been inspected with no incorrect installations identified.
