Instrument failure and control issues involving Raytheon Aircraft Company C90A, VH-JEO

170 km north-east of Kalgoorlie-Boulder Airport, Western Australia on
25 January 2024

ATSB Transport Safety Report

AO-2024-003

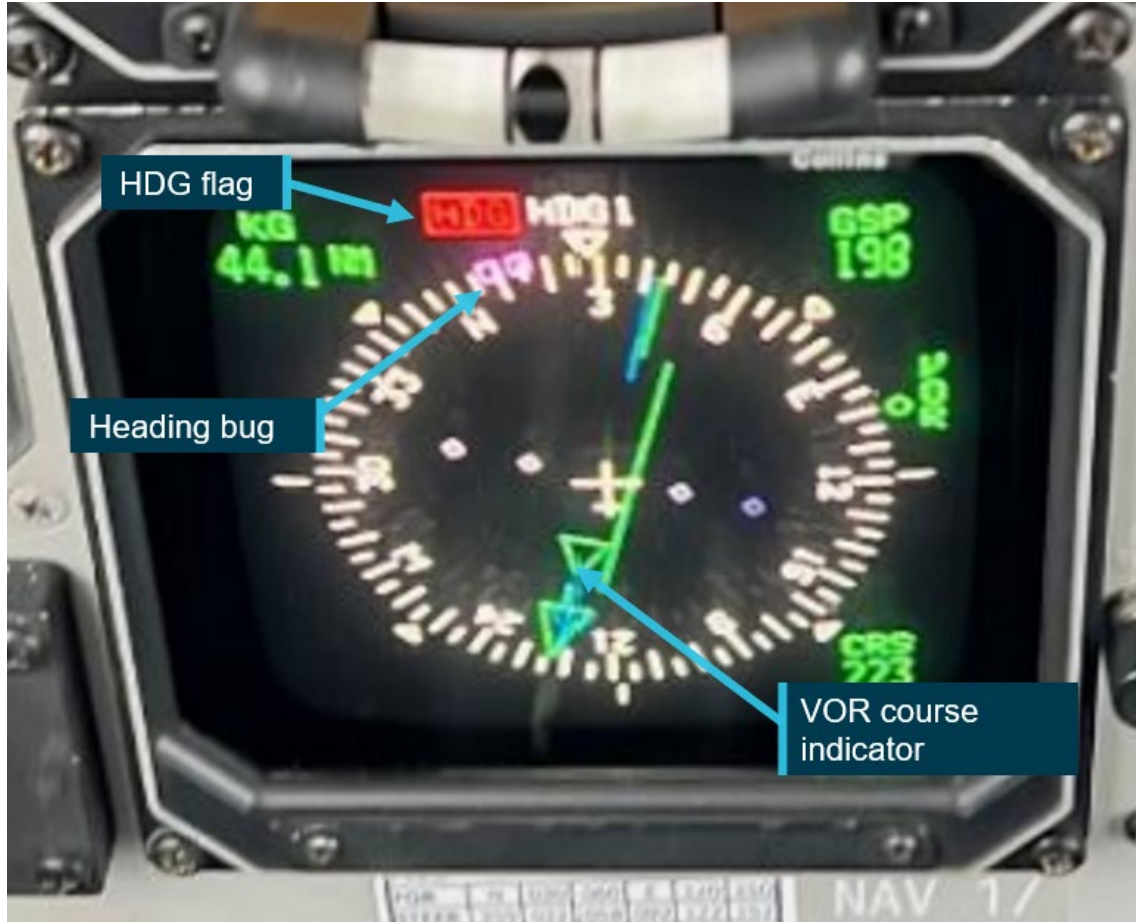
Figure 2: Horizontal situation indicator

Photo taken by the pilot during the flight showing the heading flag, the heading bug and the instrument indicating the aircraft heading was 027°.

The pilot then detected that the HDG (heading) red flag was displayed on the HSI, indicating that the magnetic input to the HSI had failed or was unreliable. At this time, the flight director (FD) indicator bars disappeared from the electronic attitude direction indicator (ADI), and a red FD flag was also displayed, indicating that the flight director was no longer reliable.

In-flight failure of the left remote gyroscope induced a slow, steady erroneous roll of the primary HSI display. As the autopilot was at the time operating in heading mode, the aircraft also began a constant turn to the right, attempting to follow the drifting heading bug.

In this instance, disengaging the autopilot and monitoring an alternate (secondary) compass system navigation aid (left RMI or right HSI) would have eliminated the uncommanded turn and enabled accurate instrument navigation.

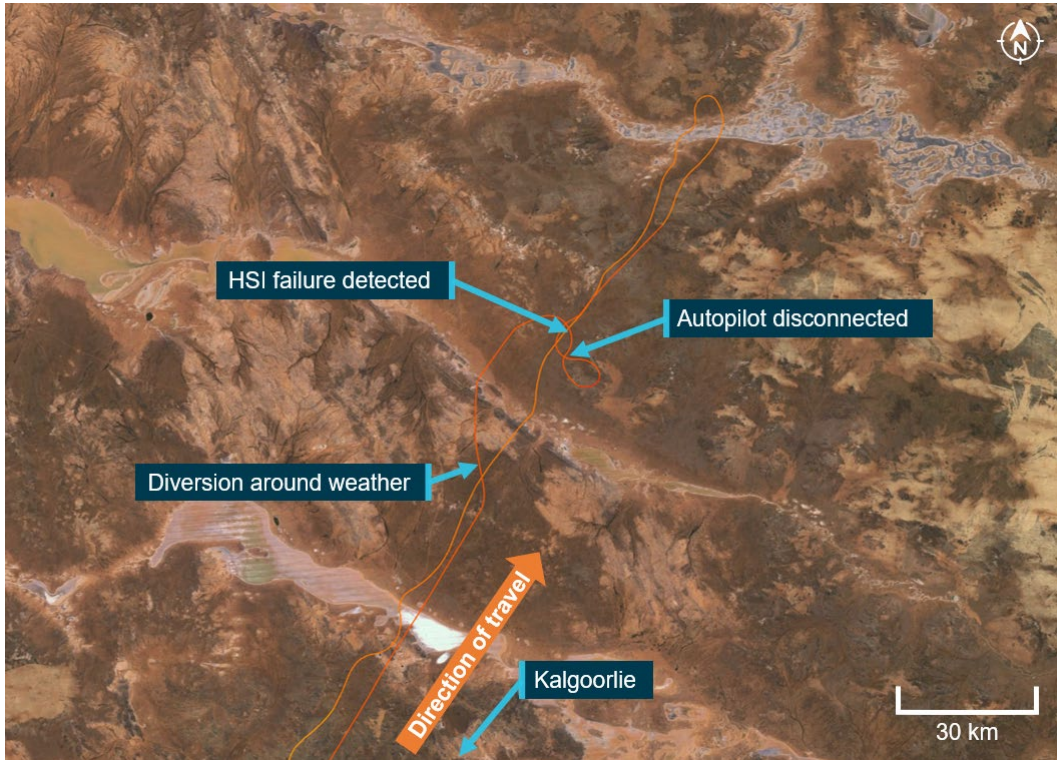
Figure 3: VH-JEO flight path

Still in IMC and now heading towards the storm and associated severe turbulence that the pilot had diverted to avoid, the pilot completely disconnected the autopilot, and manually manoeuvred the aircraft away from the storm and towards the planned track. During the turn, uncommanded altitude variations between -400 ft and +900 ft were recorded on ADS-B tracking services.

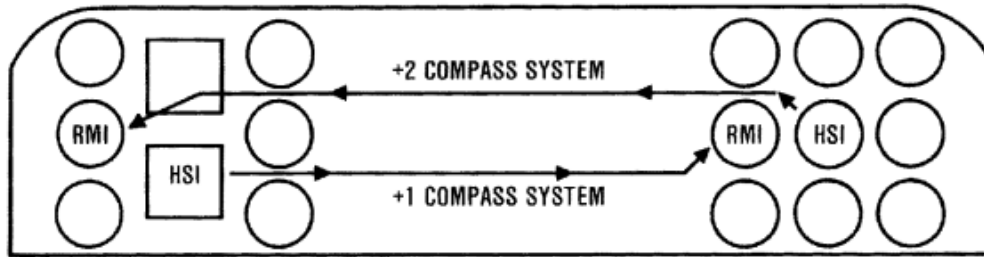
Figure 2: Compass systems on C90A

The C90A pilot operating handbook stated that, in the event of a heading failure on the HSI (indicated by a red HDG flag on the instrument), the pilot was to reference the instrument displaying compass no 2 data – either the opposite HSI or the same side RMI (Figure 4).
