Australian Transport Safety Bureau

Safety Advisory Notice

Number: AO-2024-013-SAN-01

DHC-1 Chipmunks may have incorrect rivets fitted

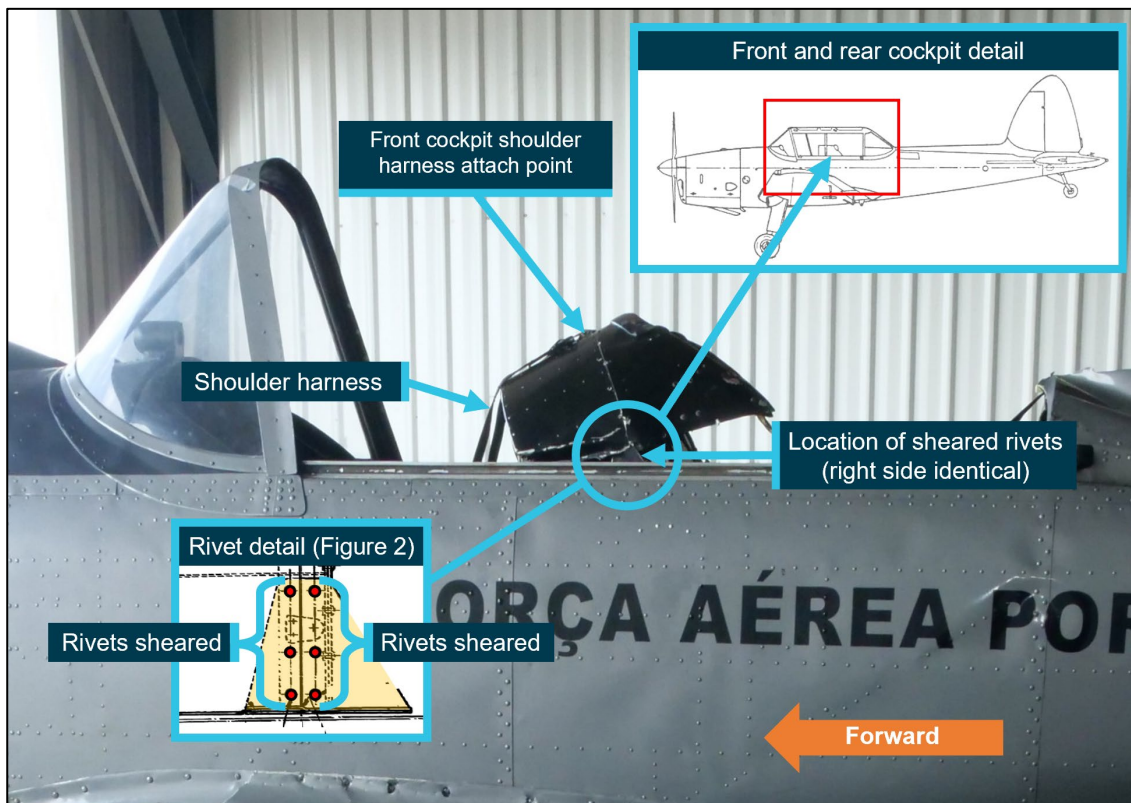
Figure 1: Location of sheared rivets

The ATSB found that on impact the upper structure between the front and rear cockpits, corresponding to the attach point for the front cockpit shoulder harness, was torn away from its mountings. Most noteworthy, all 12 rivets (6 per side) that attached the structure to the mountings had sheared (Figure 1).

- The rear row of countersunk rivets appeared to be pure or near-pure aluminium and therefore the incorrect specification. Testing indicated a significant reduction in strength (estimated to be about one-third of the specification strength).
- The forward row of round head rivets appeared to be an alloy consistent with L.86. The rivets were coated with a gold-coloured chromate conversion coating instead of violet anodising. ATSB testing indicated that the strength of the rivets met or exceeded literature values for L.86 alloy.

The presence of the non-conforming rivets significantly reduced the integrity of the structure retaining the front cockpit restraint, and thereby compromised the crashworthiness of the aircraft. This non-conforming modification may be present in other Chipmunk aircraft, in which case it would likely affect survivability in an accident.

AO-2024-013-SAN-01: The ATSB advises DHC-1 Chipmunk maintainers and owners to be aware that fitment of incorrect specification rivets where the upper structure between the front and rear cockpits attaches to the gussets on either side could significantly compromise the crashworthiness of the aircraft.

Those conducting work on aircraft must ensure modifications are carried out to the required specification, or during maintenance returned to that specification.

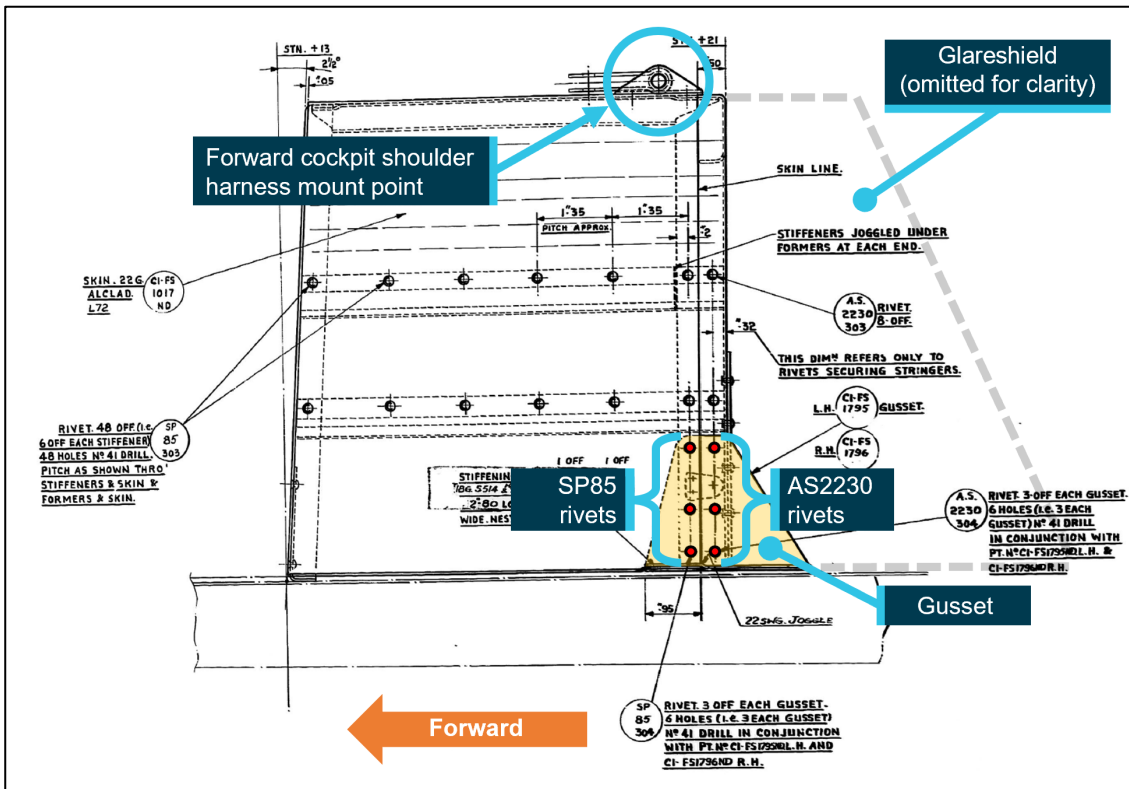
Figure 2: Rivet detail

The 2 mountings, called gussets, were installed as modification H.268. This modification was issued by Hawker Siddeley in 1966 to replace the original aluminium alloy gussets with high-tensile steel. The modification required the forward row of rivets attaching the structure to the gussets to be part number SP85 round head rivets, and the rear row to be part number AS2230 countersunk rivets (Figure 2).

Both part number SP85 and AS2230 rivets were required to be manufactured to British standard L.86, which was an aluminium alloy that included copper and magnesium (with international equivalences of Alloy Designation 2117, US specification AMS7222, and European specification ENAW-AICu2.5Mg). The standard also specified that the rivets were to be anodised (a surface treatment) and coloured violet.
