# Flight below minimum altitude involving Boeing 737-800, PK-LDK

19 km south of Canberra Airport, Australian Capital Territory on 14 June 2024

**ATSB Transport Safety Report**  
Aviation Occurrence Investigation  
AO-2024-035  
Preliminary – 4 September 2024

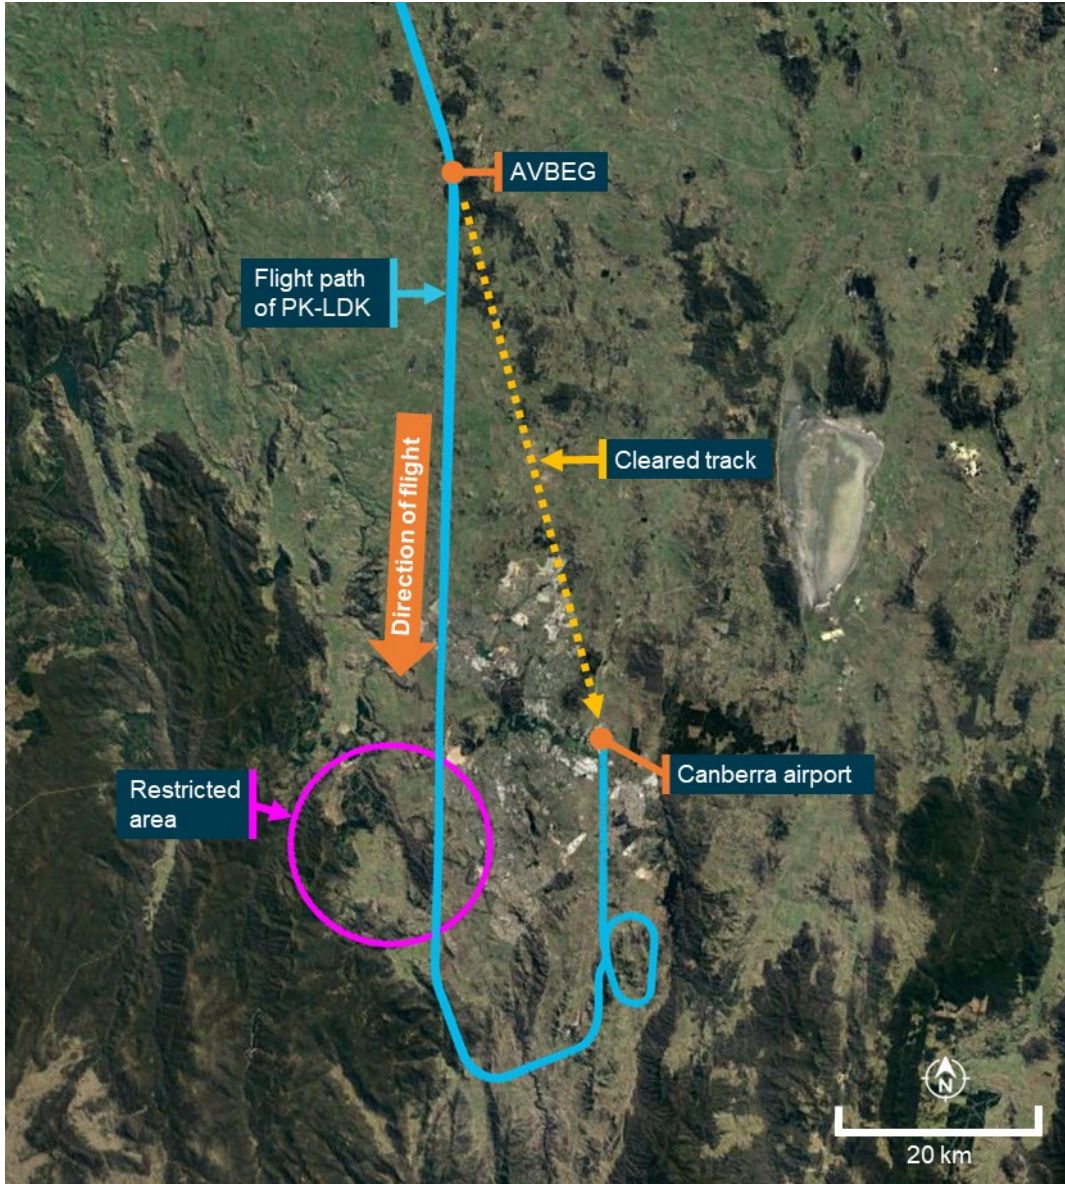
Figure 1: Overview of the descent

At 0541 local time, as the aircraft approached AVBEG, ATC cleared the crew to leave controlled airspace descending. The aircraft crossed AVBEG while descending below FL205 and commenced tracking via the AVBEG 5A STAR. The Melbourne Centre air traffic controller identified that the Batik flight was deviating from the cleared track (direct to Canberra) and noted that the aircraft was descending toward a restricted area (Figure 1).

The crew levelled the aircraft at 10,000 ft AMSL with the autopilot engaged and the aircraft passed over the restricted airspace. As was required by ATC procedures, the controller waited until the aircraft was observed to be more than 2.5 NM past the restricted area before instructing the crew to continue the descent to leave controlled airspace. The crew responded by advising that they would descend and continue tracking via the STAR. At about this time, the crew noted that the aircraft was about 1,300 ft above the desired descent profile for the arrival.

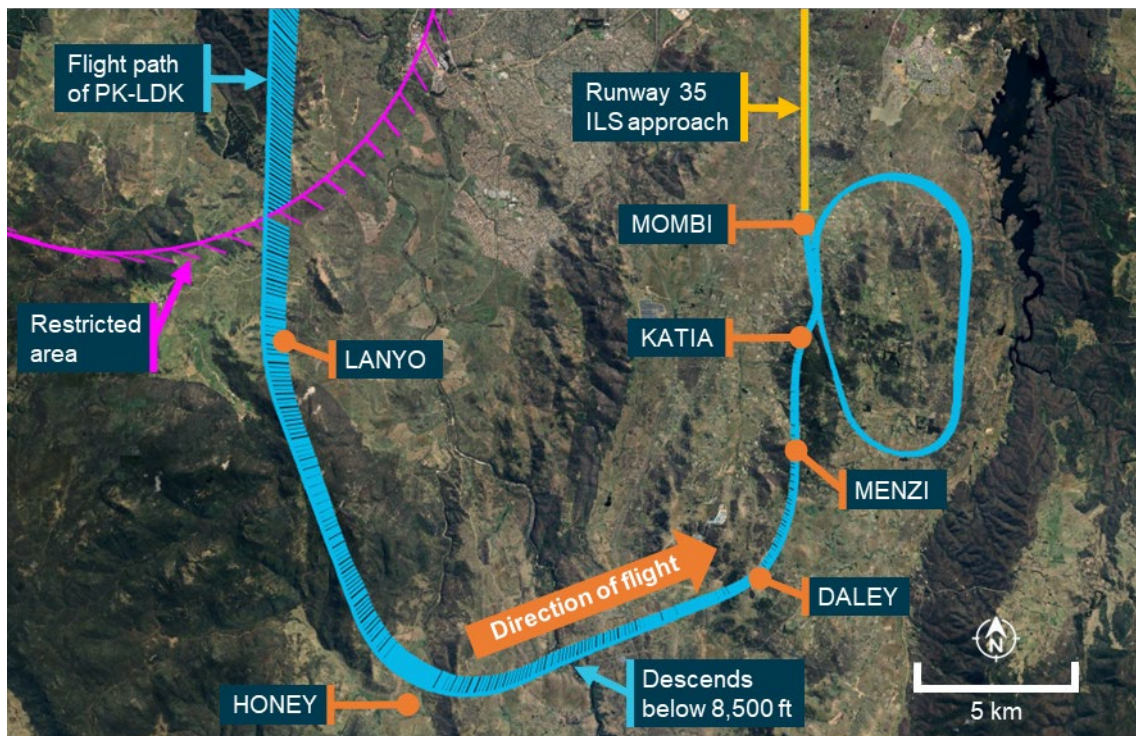
**Figure 2: Overview of arrival**

At 0553:10, the aircraft passed the arrival waypoint MENZI (Figure 2) while descending below 6,720 ft AMSL and soon after made another request to hold at MOMBI. The controller provided traffic information for the hold and requested that the crew make a right-hand orbit to remain clear of the restricted airspace, now to the west of the aircraft.

As the aircraft approached MOMBI, the captain entered 5,400 ft AMSL (the approach’s minimum safe altitude before intercepting the ILS glideslope) into the autopilot mode control panel (MCP) and at 0554:15, the aircraft descended below the minimum holding altitude of 5,600 ft AMSL (see the section titled *Instrument landing system approach*) before levelling at 5,400 ft AMSL.

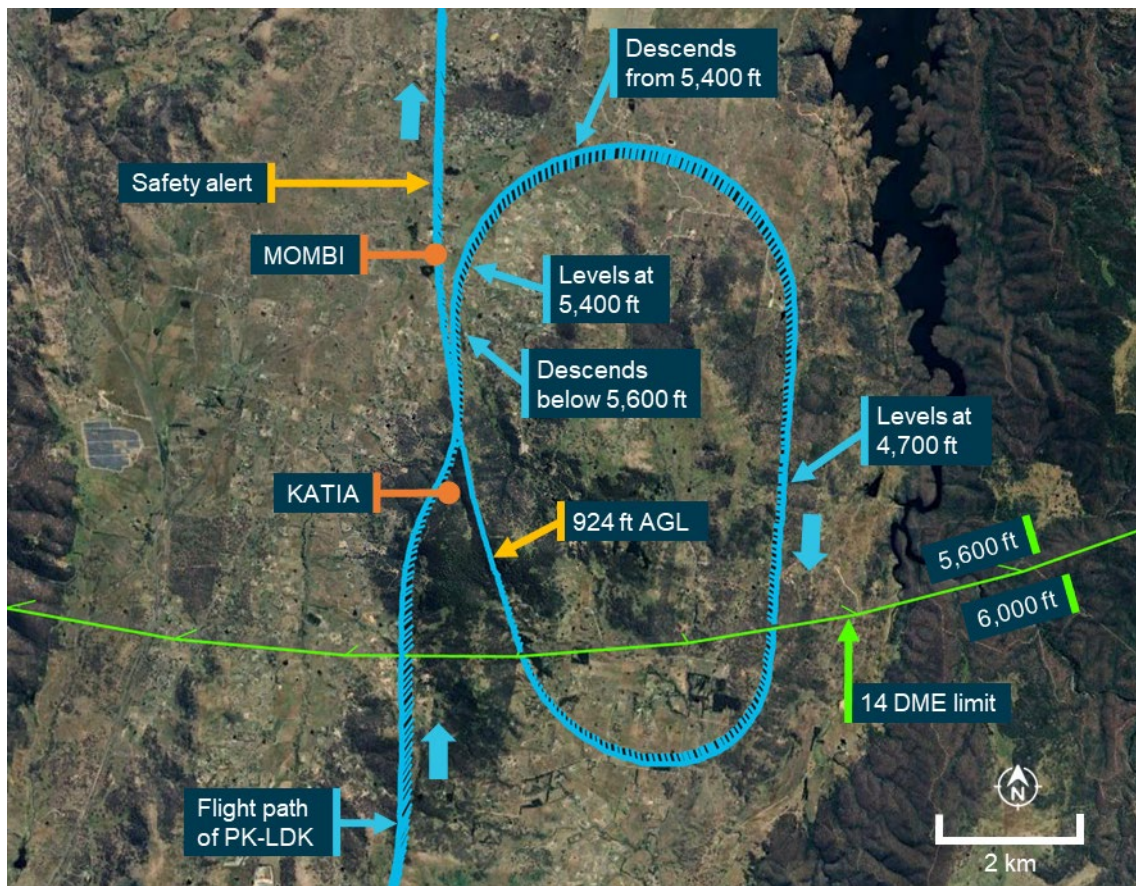
**Figure 3: Overview of MOMBI hold**

The aircraft continued turning toward MOMBI (Figure 3) and as it crossed over the eastern slopes of Mount Campbell at 0557:46, the recorded radio height reduced to a minimum of 924 ft above ground level. At 0558:21, the aircraft rejoined the ILS approach.

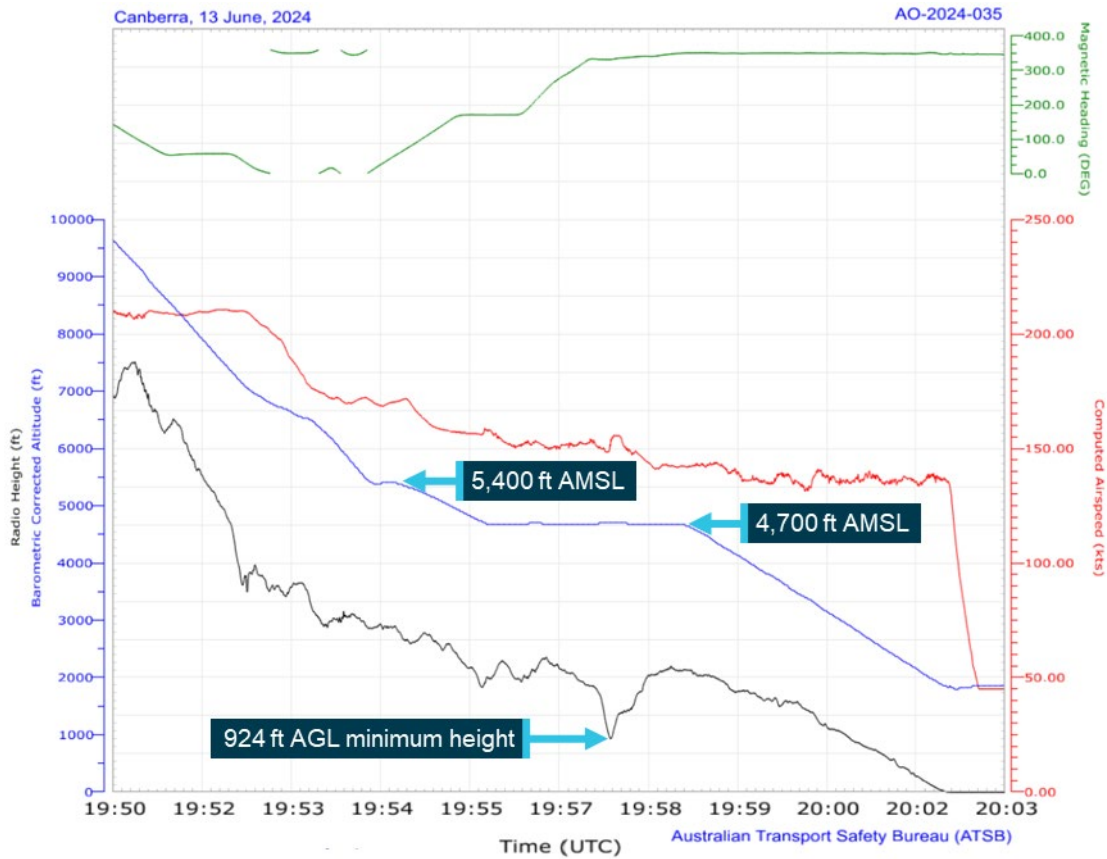
Figure 8: Recorded quick access data

At 0555:44, the aircraft turned to and maintained a heading of 170° and 15 seconds later levelled at 4,700 ft AMSL (Figure 8). At 0556:25, the aircraft proceeded beyond 14 DME from Canberra DME before commencing the right turn toward MOMBI 4 seconds later. During this turn, the lowest recorded radio height was 924 ft above ground level (AGL). No ground proximity alerts were recorded.

The aircraft passed KATIA at 0557:53 at an altitude of 4,700 ft AMSL while tracking back toward MOMBI and rejoined the approach about 12 NM from the Canberra DME at 0558:19.
