**Australian Transport Safety Bureau**

# Mid-air collision involving Robinson R22 Beta II, VH-HQH, and Robinson R22 Beta II, VH-HYQ

51 km south-south-east of Curtin Airport, Western Australia, on 25 July 2024

# Preliminary report

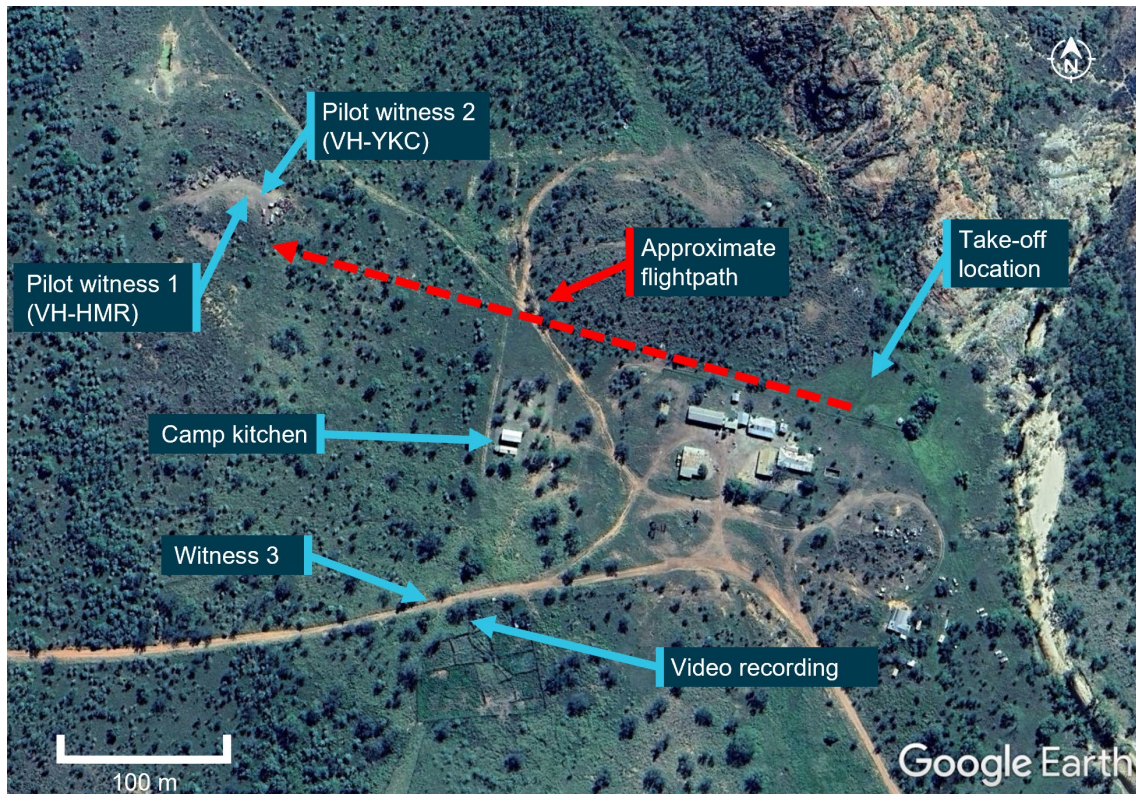
**Figure 1: Witness locations**

At 0603, HQH and HYQ departed the overnight parking area and flew west, to where the other 2 helicopters would join them (Figure 1). A witness (witness 3) located near the stockyards about 200 m to the south of the homestead watched the 2 helicopters accelerate away, climbing above the buildings and depart with HQH in front and HYQ following slightly lower and behind off to one side.

The accident site was located about 300 m west-north-west of the historic Mt Anderson homestead (Figure 1). Power to the homestead buildings was produced via generator. There were some low power lines immediately above, and close to, the roof line but there were no power lines situated on the flight path. The local vegetation was dry, low open woodland. There was no evidence of any wildlife or tree strike in the vicinity of the start of the debris trail.

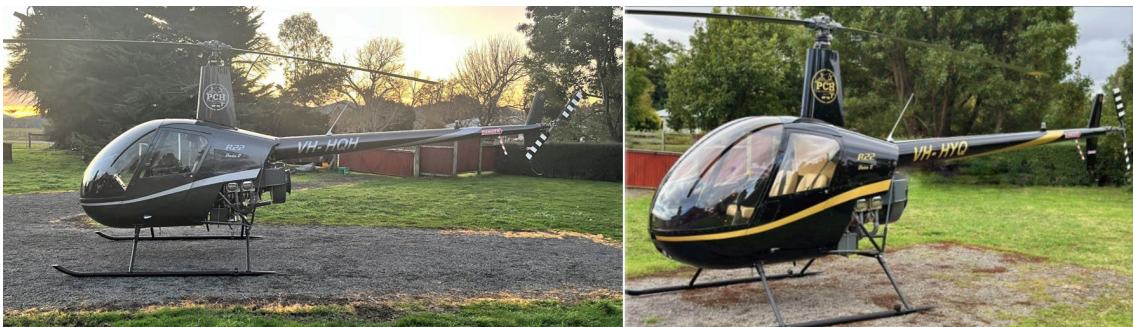
**Figure 2: VH-HQH (left) and VH-HYQ (right)**

VH-HQH, serial number 3936, was manufactured in the US in 2005 and first registered in Australia in September 2005 (Figure 2). The helicopter had undergone a periodic inspection along with a 2,200 hr / 12-year inspection/overhaul that was completed on 8 July 2024 at 6,087 hours total time-in-service. The current maintenance release was not located, however, the operator reported the helicopter had accrued about 60 hours since the rebuild.

VH-HYQ (HYQ), serial number 3835, was manufactured in the US in 2005 and first registered in Australia in May 2005 (Figure 2). A 2,200 hr / 12-year inspection/overhaul was completed in April 2023. The most recent periodic inspection, at 4,946 hours, was conducted on 19 July 2024. The current maintenance release was not located, however, the operator reported the helicopter had accrued about 40 hours since the last periodic inspection.

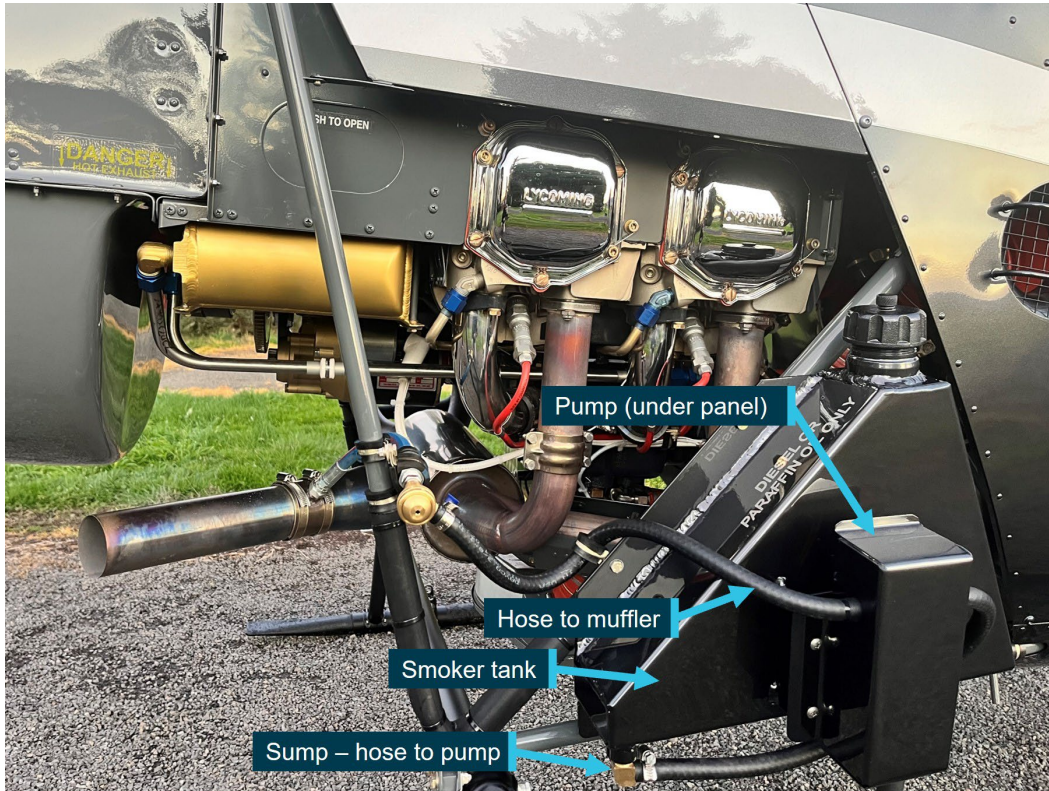
**Figure 3: VH-HQH smoker unit installation**

HQH was fitted with a smoker unit to aid in aerial mustering operations (Figure 3).<sup>1</sup> It consisted of a small tank (about 5 L capacity), that was filled with either diesel or paraffin oil and mounted on the right-side lower frame. A small integrated electrical pump activated by a trigger on the pilot's controls would transfer the diesel from the tank into the exhaust outlet where it was vaporised by the exhaust heat creating a veil of smoke that was blown downward by the main rotor downwash.

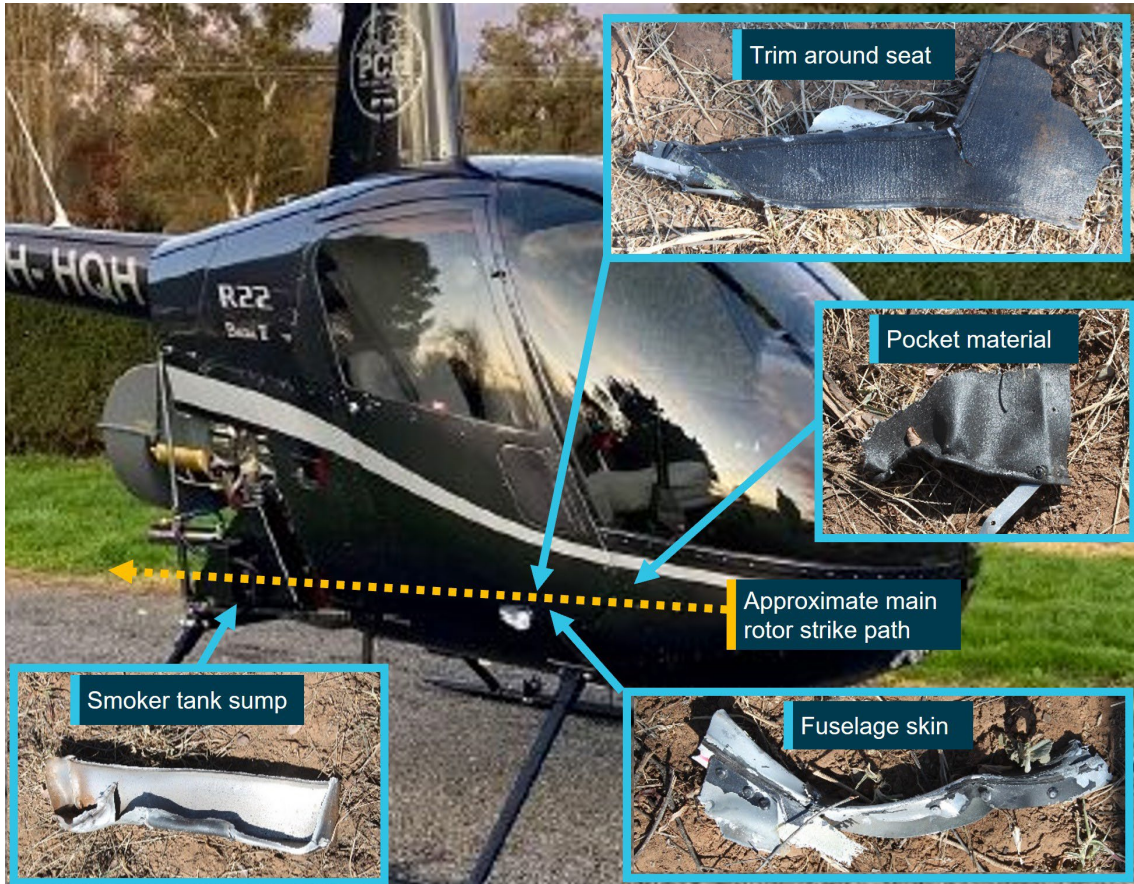
The first items in the debris field, about 300 m west-north-west of the take-off location, were consistent with a rotor blade strike to the right side of HQH (Figure 4), and consisted of:

- smoker unit pump cover panel
- smoker tank sump (separated horizontally from most of the upper portion of the tank)
- smoker unit lower (horizontal) mount
- fuselage skin from just forward of right position light
- right seat 'pocket' material section (located on forward panel of the pilot seat structure)
- trim from around the forward and right edges of pilot seat.

**Figure 4: VH-HQH (pre-accident) showing approximate location of rotor strike location and locations of first items in debris field**
