Breakaway and grounding of *CSC Friendship*

Port of Brisbane, Queensland on 27 February 2022

ATSB Transport Safety Report

MO-2022-003

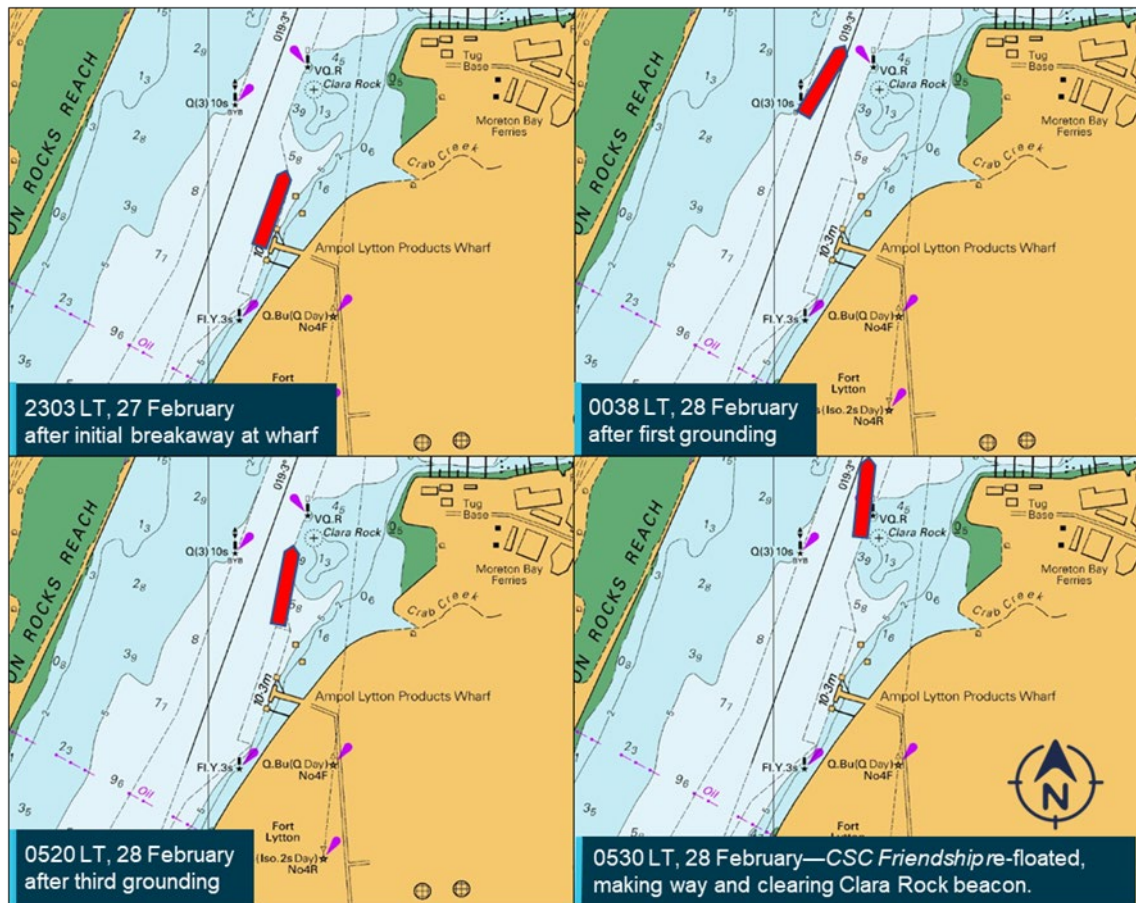
Figure 3: *CSC Friendship's* position (red) at key times

At 0500, while it was still dark, the pilot estimated the ebb current flow had decreased to roughly 3 or 4 knots and requested the tugs to make fast to the ship to attempt another move. The port anchor remained a concern for the pilot and, after discussion with the master (who was consulting the ship's managers ashore), the pilot agreed to the request to retrieve the anchor without compromising the re-floating attempt. Ten minutes later, the pilot instructed both tugs aft to lift off using full power and move out to starboard to bring the ship's stern towards the channel.

The stern of the ship immediately started to move into the channel and the pilot instructed the master to heave in the anchor. The attempt to weigh anchor caused the bow of the ship to swing sharply to starboard and the stern to swing back to port. This resulted in the ship grounding again along its port quarter.
