In-flight break-up involving Cessna 210N, VH-TFT

237 km east-north-east of Katherine, Northern Territory on 24 December 2022

ATSB Transport Safety Report

AO-2022-067

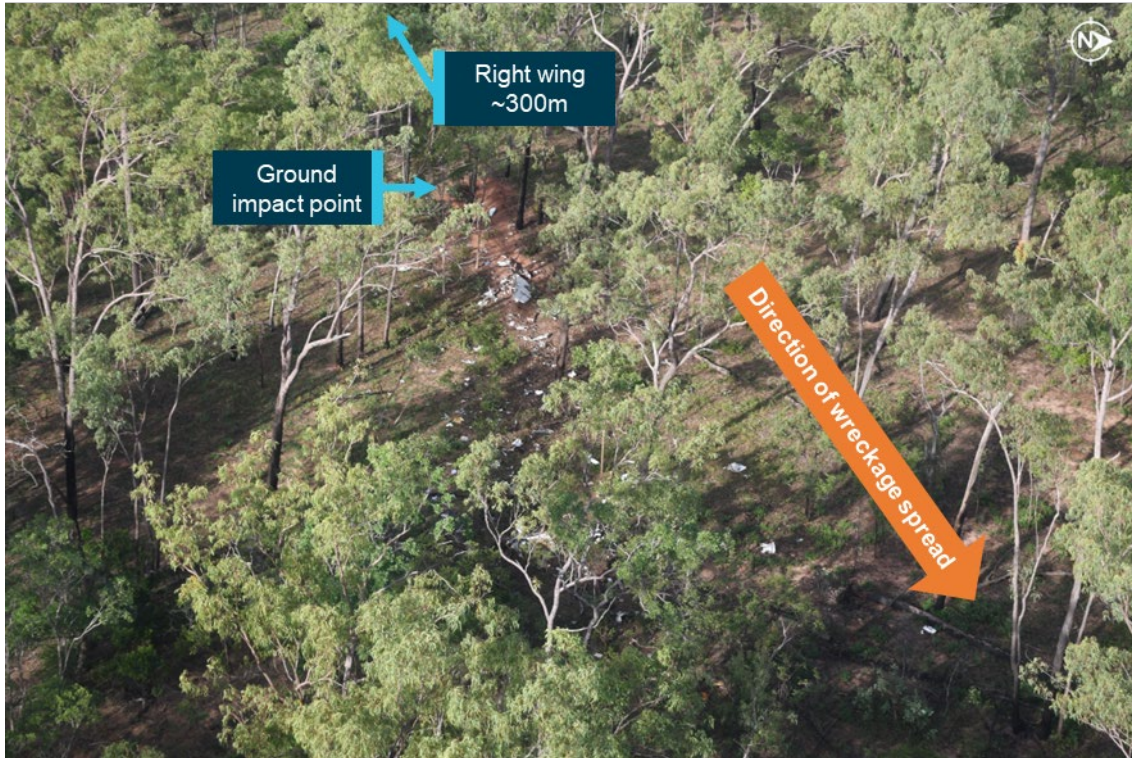
Figure 8: Aerial view of the accident site showing the spread of wreckage

Severed tree branches and ground scars were consistent with the aircraft having a trajectory of approximately 35° down from horizontal immediately before colliding with terrain. Almost complete fragmentation of the aircraft structure had occurred on impact leading to aircraft components spreading over about 80 m from the primary ground contact point. The propellor, engine, left wing, carry-through structure, empennage, nose gear and cabin components were all identified in the wreckage trail.

The orientation of the wreckage trail was in a north-east direction, which was about 180° to the intended flight track to Katherine Tindal. The tail and empennage section had broken into several pieces and was partially reassembled to ensure that all the extremities and flight control mass balance weights were identified. Excluding the right wing and wing tip, all key components of the airframe were identified in the wreckage trail with no pre-impact defects identified. The left wing remained attached to the intact wing carry-through structure. The landing gear was assessed to be retracted at impact and the flaps were assessed to be in the retracted position.

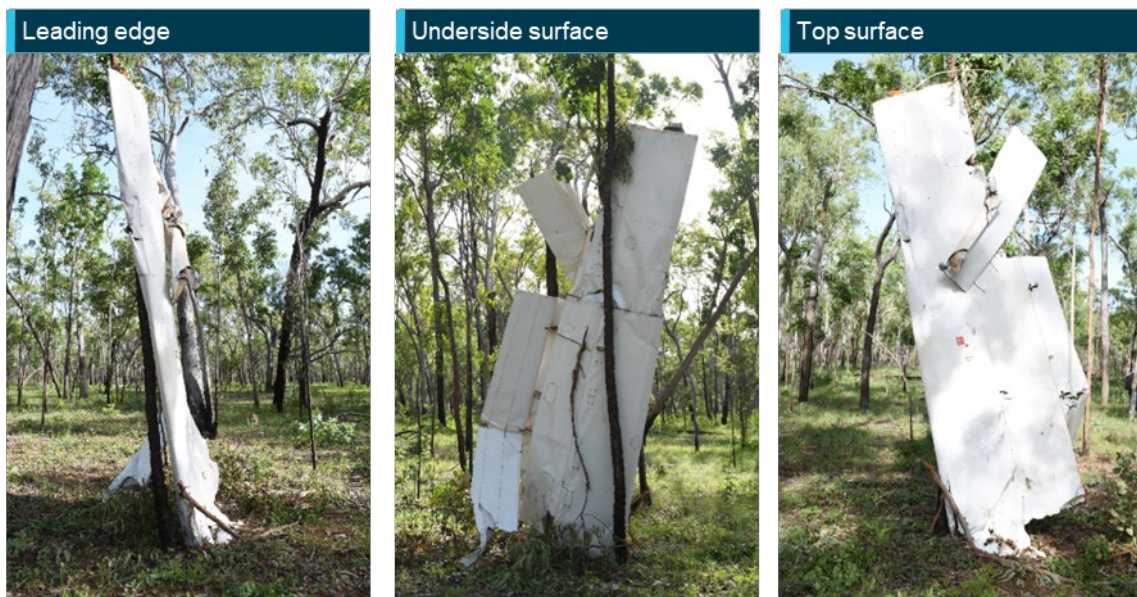
Figure 9: The right wing as it was found approximately 300 m from the main wreckage

Onsite examination of the right main wing spar identified that it had fractured diagonally, about 30–60 cm from the fuselage attachment points (Figure 9–Figure 11).

The right wing showed extensive permanent deformation and tearing of the internal structure with associated compression rippling to the upper skin. The damage was indicative of substantial upward bending forces applied to the wing prior to its failure and separation from the aircraft. The wing structure at the point of failure contained a permanent deflection of about 30° in the upward

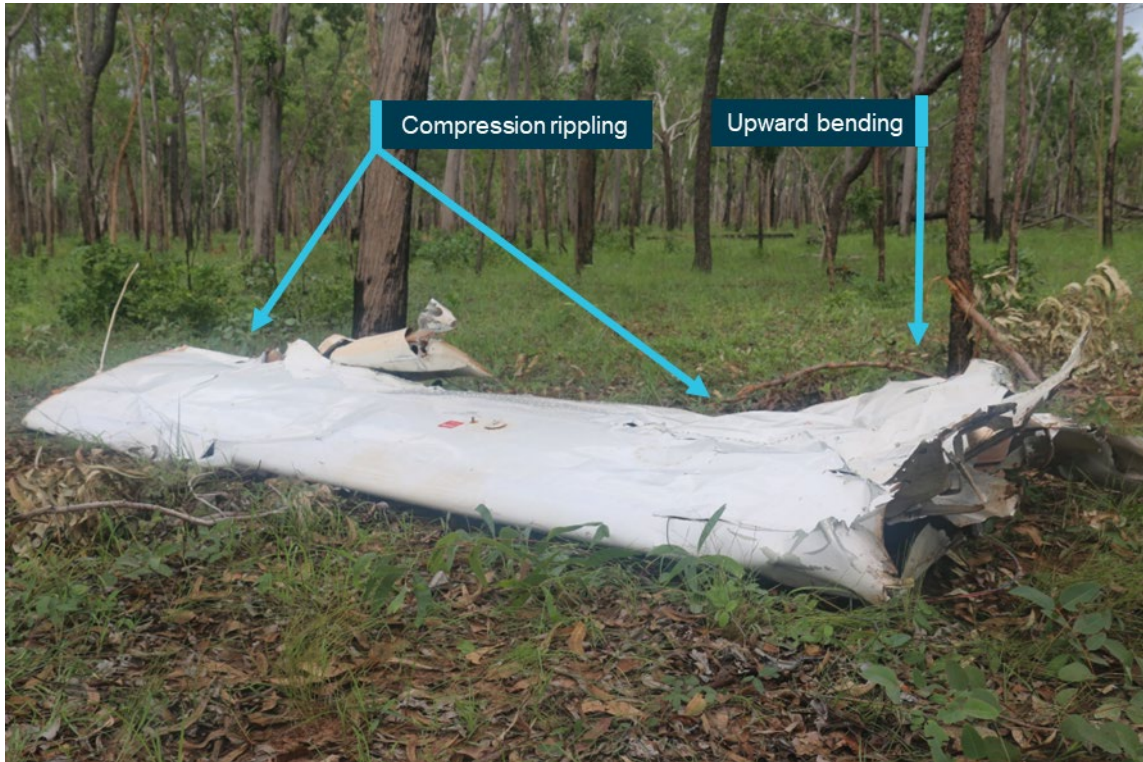
Figure 10: The right wing showed compression rippling of the upper skin surface and permanent deformation from exposure to upward bending

The wing was permanently deformed by about 30° in the upward direction at the point of failure.
Source: ATSB

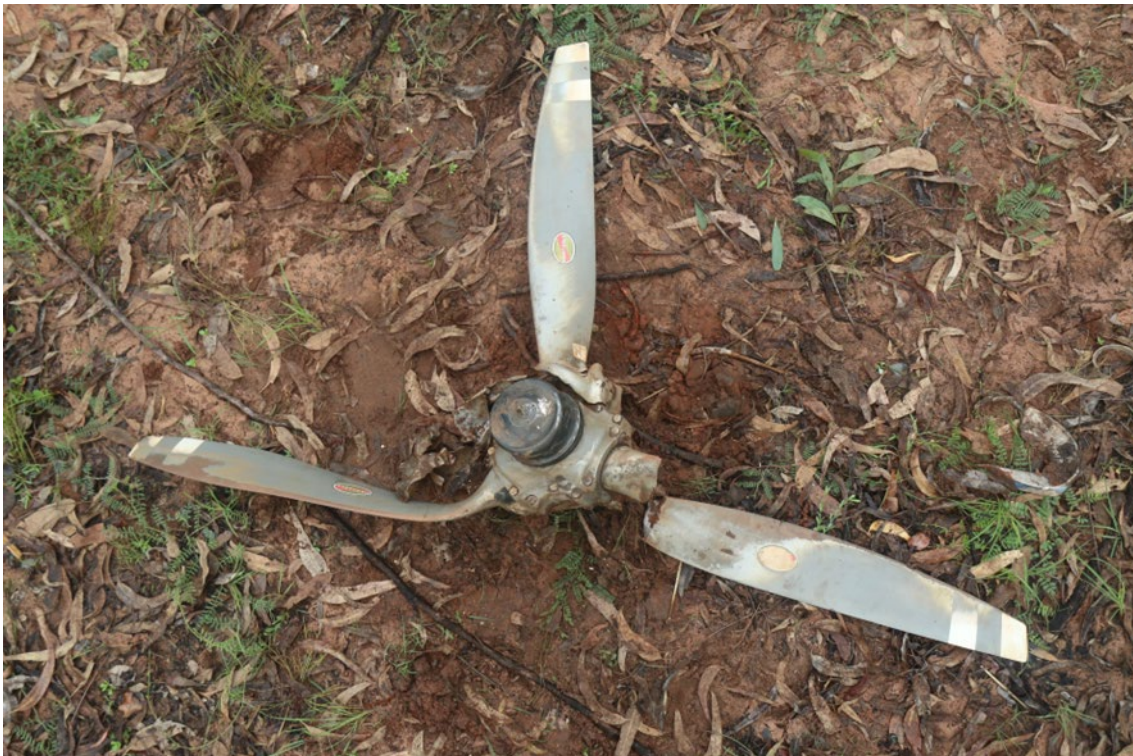
Figure 12: Propeller assembly after removal from the ground impact site

The propeller hub had separated from the engine crankshaft due to overstress fracture under predominantly bending loads. One propeller blade had fractured from the hub at its base. All blades had sustained forward bending and rotational abrasion damage from passing through sand/soil. One of the blades displayed chord-wise twisting and compound bending. The damage signatures produced on collision with the terrain were consistent with an operating engine (Figure 12).

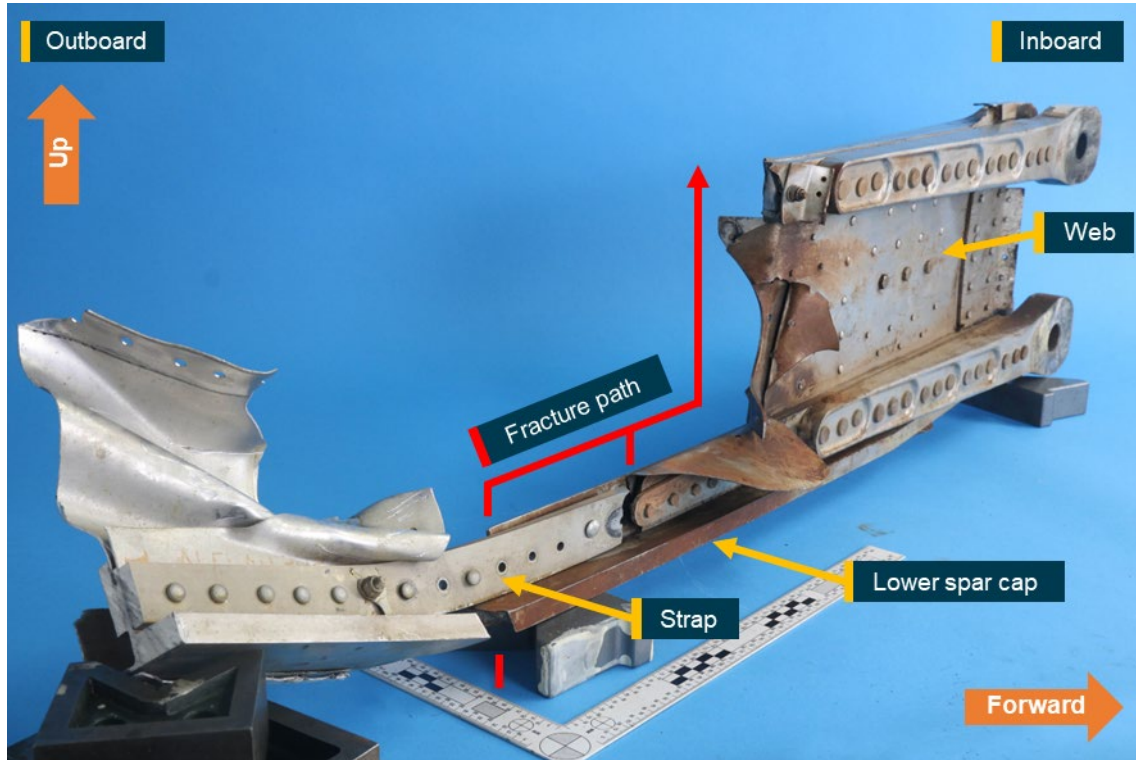
Figure 13: Fractured right wing main spar as received at the ATSB’s technical facilities

A red-brown product was adhered to much of the spar fracture surfaces and was likely a mixture of soil and impacted vegetation. Detailed examination of the main spar fragments identified features typical of ductile overstress. There was deformation and angular tearing throughout the spar cap, shear web and strap structure.

Overstress fracture in ductile materials (including the alloys comprising the wing component) occurs when the structure is loaded beyond its ultimate limit. Several rivets that had secured the straps to the spar cap had sheared during the break-up. The examination did not identify any evidence of pre-existing damage such as fatigue cracking, corrosion or other defects (Figure 13 and Figure 14).

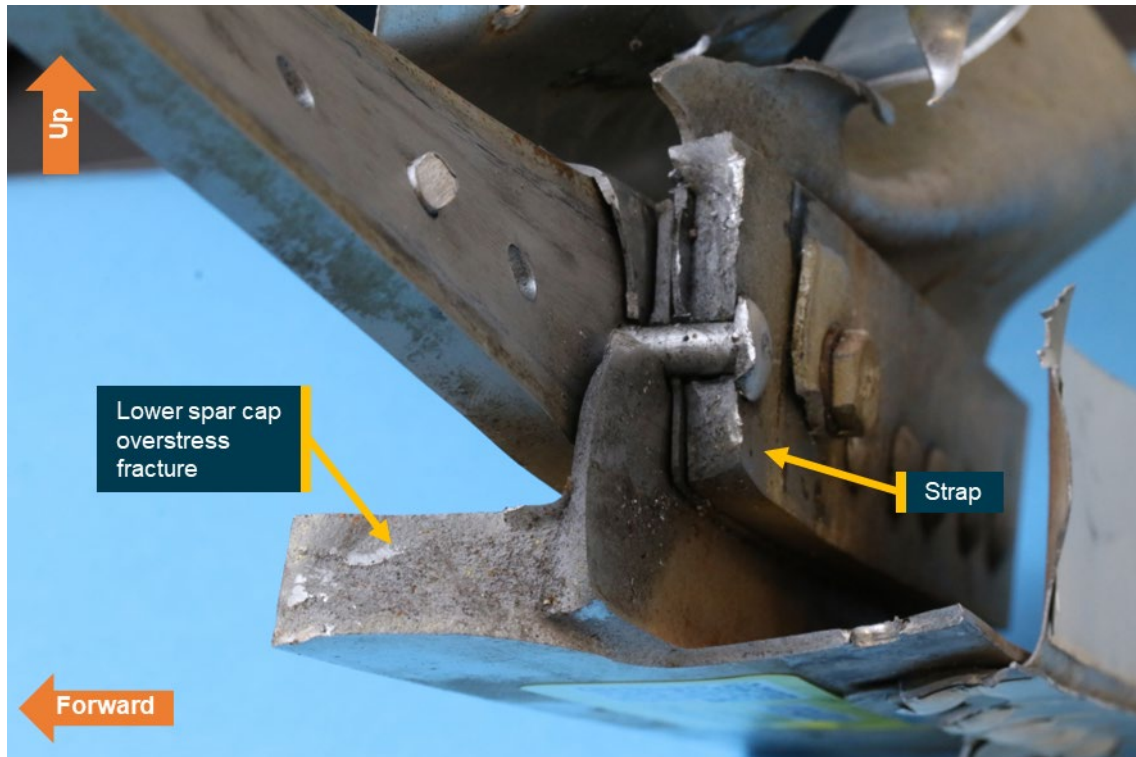
Figure 14: Close-up of the lower spar cap outboard fracture surfaces

Only ductile overstress features and associated deformation was present through the spar structure fracture surfaces.
Source: ATSB
