# Loss of control and collision with water involving Bell Helicopter Company 204B, VH-EQW

Tarome, Queensland, on 20 September 2023

Aviation Occurrence Investigation (Short)

AO-2023-044

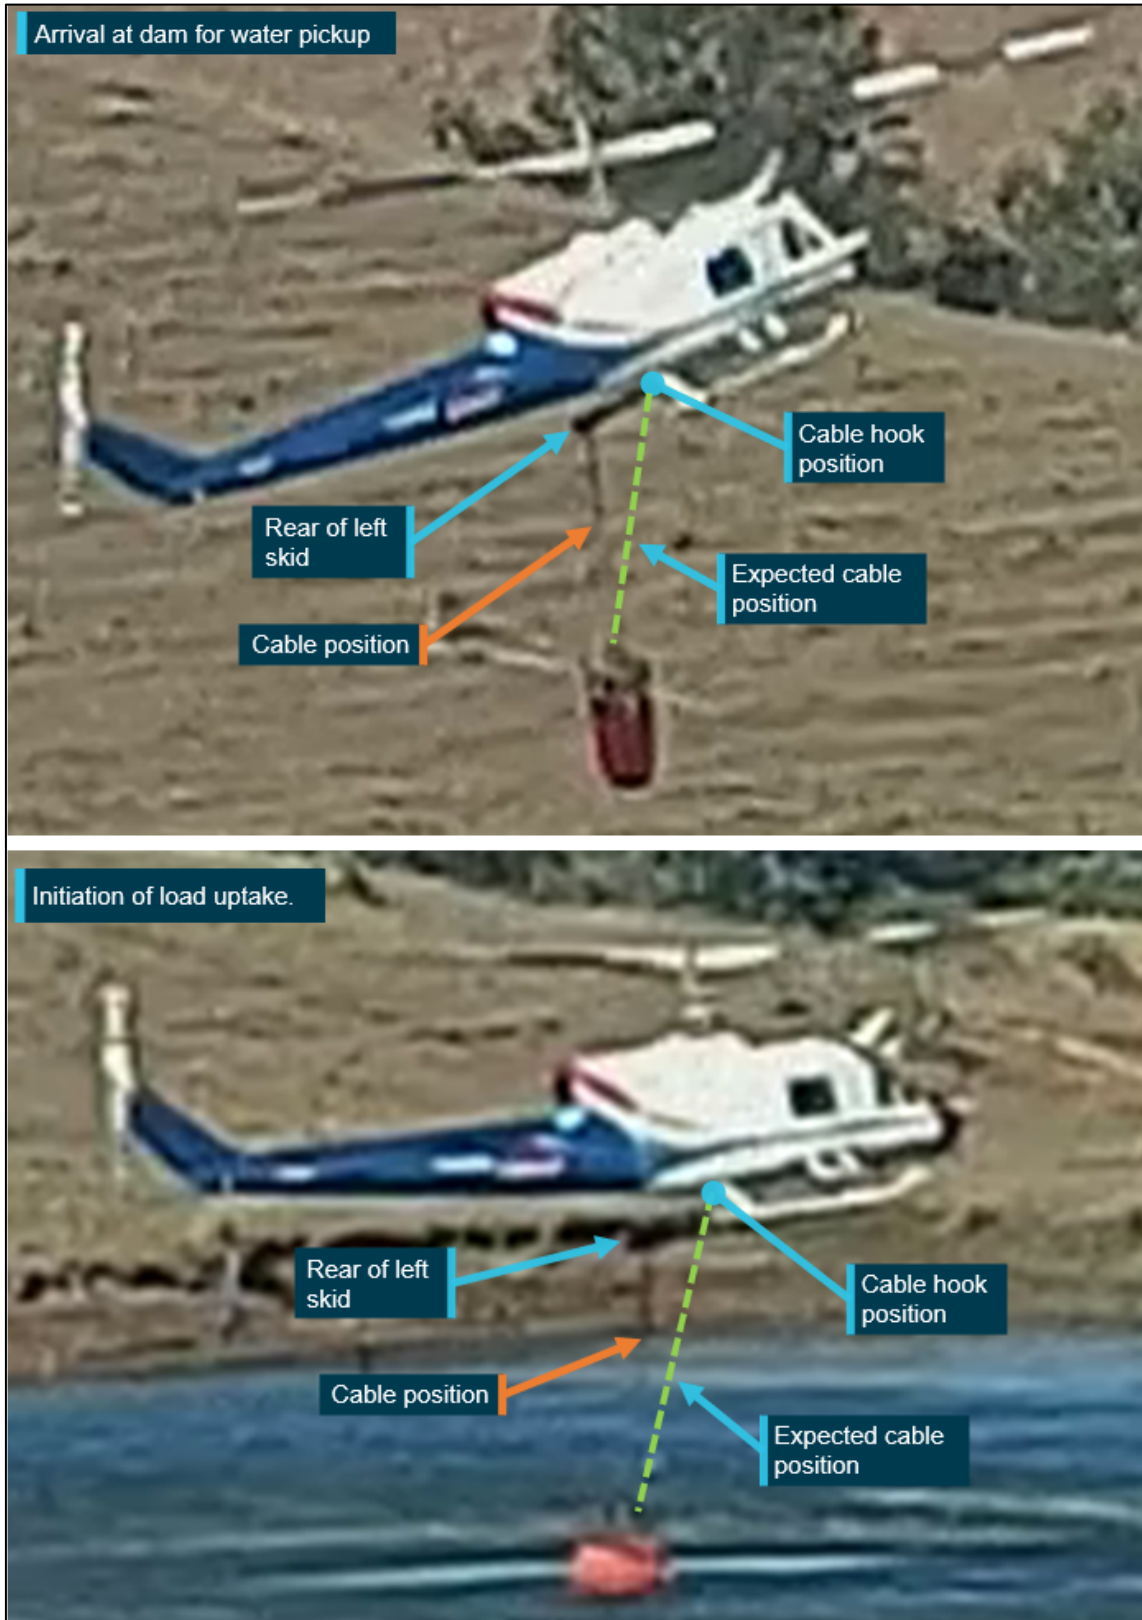
**Figure 3: Sequence of water pickup from dam showing bucket cable position from approach (top) to lifting off (lower)**

Recorded video taken by witness 1 just prior to the accident showed the helicopter on approach to the dam. It captured the water bucket suspension cable caught over the rear of the left skid when on the approach (from the start of the video – Figure 3 top) until the helicopter was initiating lift-off with the external load of water (Figure 3 lower). The video ended as the helicopter started to take the weight of the bucket, which contained a large quantity of water. The helicopter was recorded

starting to pitch up and roll left before the video stopped. There was no discernible change in sounds emanating from the helicopter for the duration of the video.

Video evidence showed the Bambi Bucket suspension cables were caught over the left rear skid when the helicopter was on approach to the dam and remained attached to the skid during the water uplift. This evidence was consistent with:

The video ruled out the capture of the cables over the skid during the water collection phase. However, the ATSB was unable to identify if the cables had become captured due to pre-flight bucket and cable positioning, take-off manoeuvring or during the transit flight to the dam.

Just before the video ceased, it showed the initiation of the full water bucket uplift followed by the helicopter pitching up and rolling left slightly. The ATSB weight and balance calculations concluded that any bucket weight above 300 kg (full is 1,300 kg) acting over the left rear skid, would be sufficient to move the centre of gravity outside of the helicopter’s balance limit. Therefore, it was almost certain that as the load of water was lifted, the helicopter’s centre of gravity moved aft and left as a result of the suspension cables being caught over the skid. The tethered weight created an asymmetric lifting point, which resulted in a rapid loss of control and subsequent collision with water.

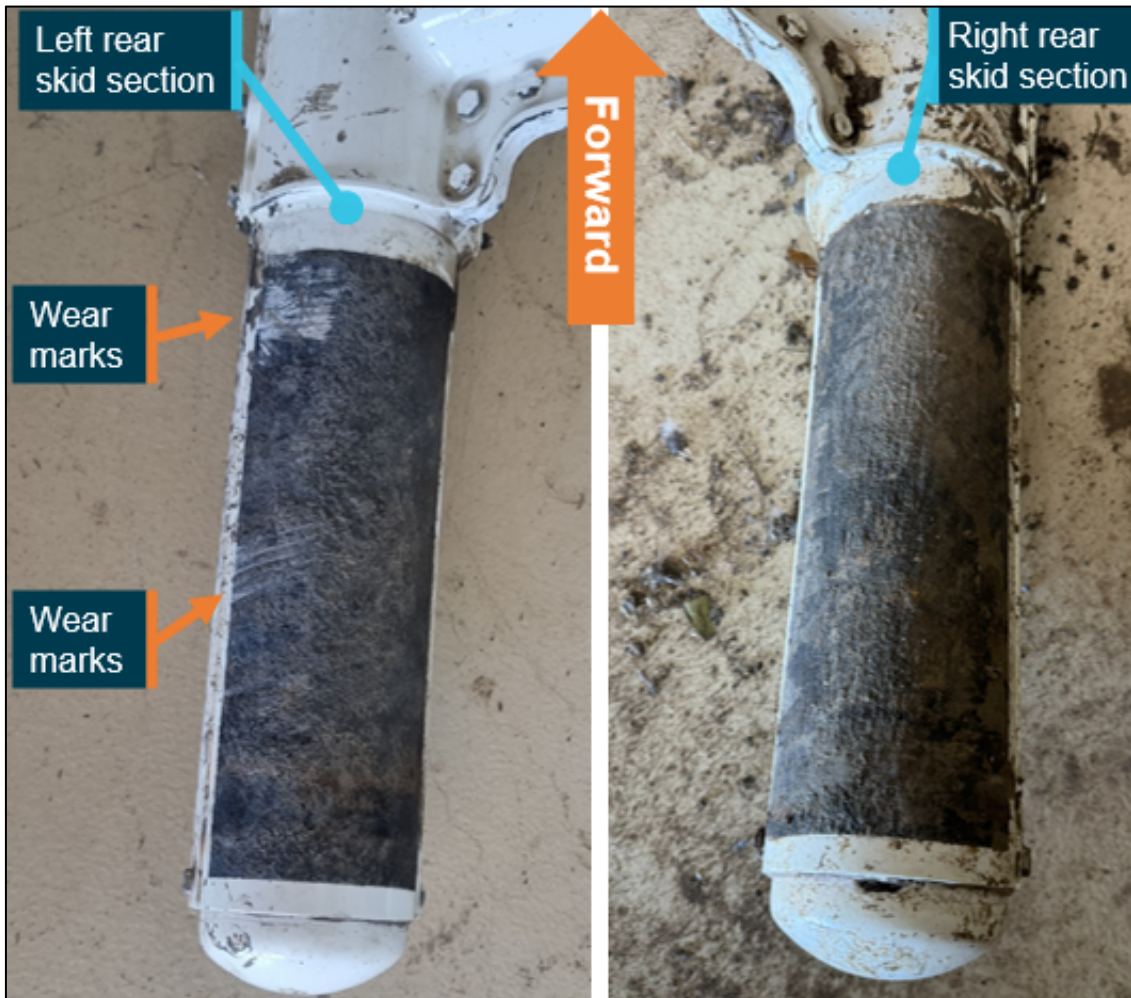
Figure 7: Rear of left and right skid sections with the left skid showing wear marks

The left and right skid had their bear paw pads removed to facilitate the transport of the wreckage to the storage facility. The right skid did not have any notable damage. The left skid had several striation type wear marks at the rear of the skid (Figure 7).

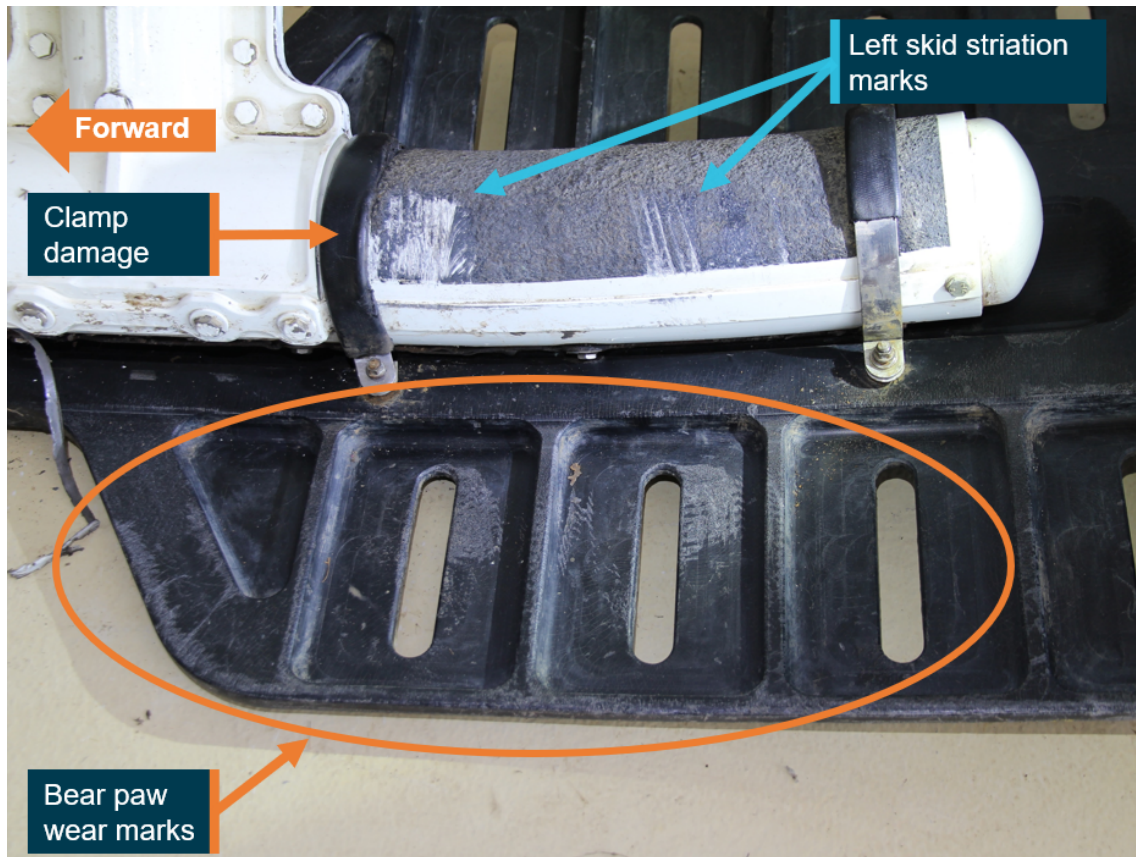
**Figure 8: Left rear skid showing corresponding skid and bear paw damage**

The left bear paw was refitted to the left skid to facilitate inspection as an assembly. It was noted that the bear paw had permanent deformation damage that indicated that it had rotated counterclockwise (viewed from the rear) until it had come into contact with the rear skid support. There was also damage to one of the attachment clamps, which had been forced forward at its upmost point. That clamp was directly in front of the forward set of wear marks on the rear of the skid. There was further abrasion damage that indicated the left bear paw had flexed downward under significant load on its outboard side (Figure 9).

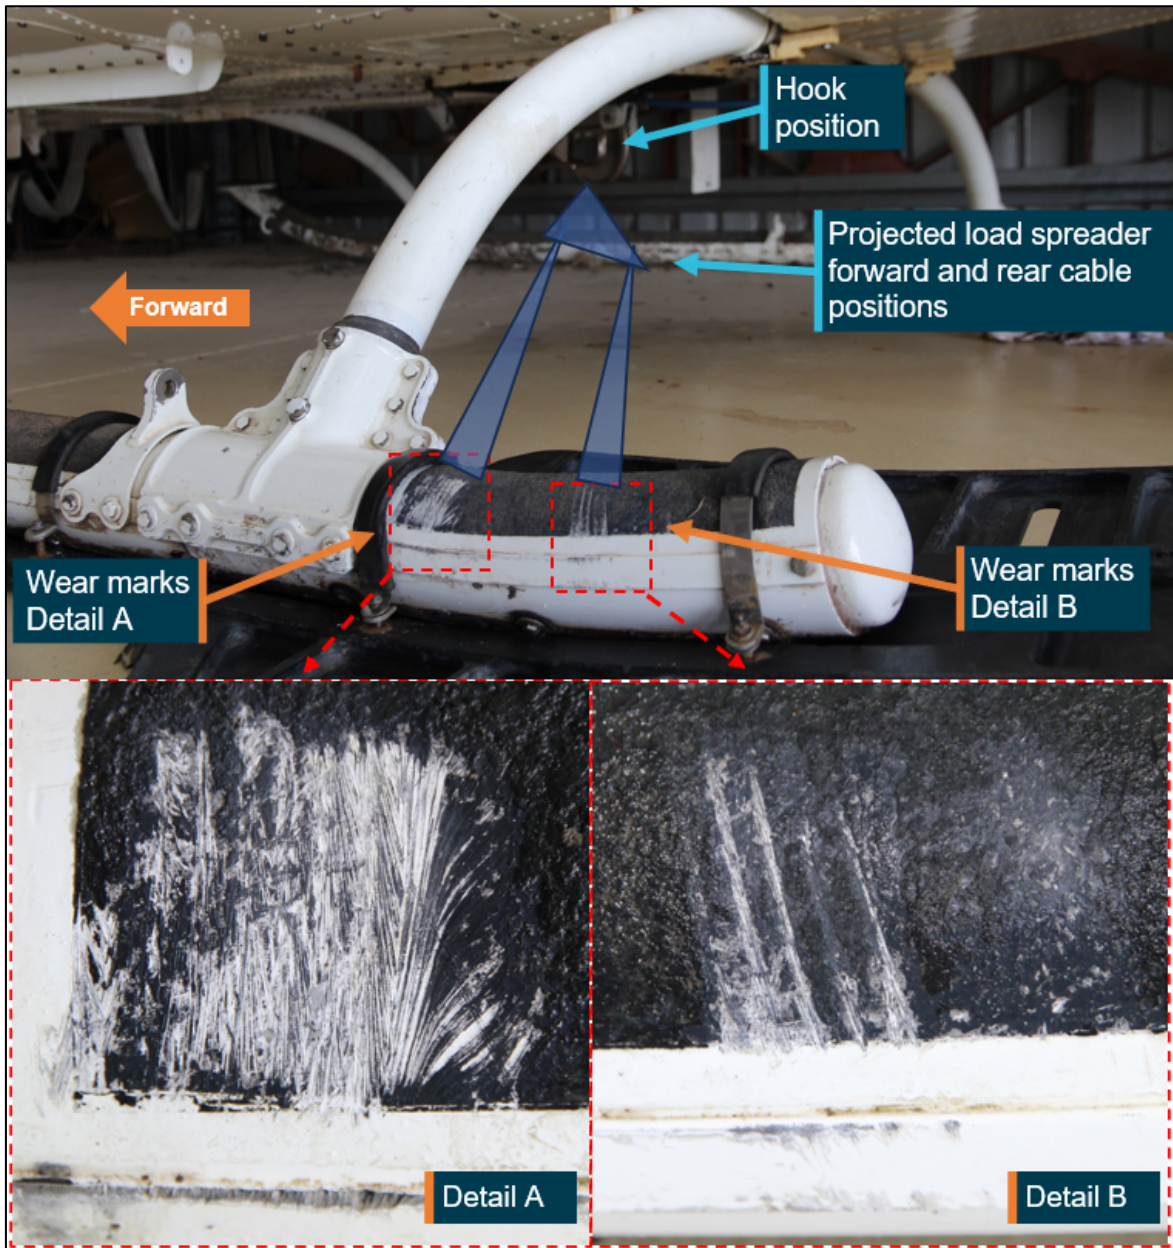
**Figure 9: Outboard of left rear skid showing hook position and likely position of spreader with forward and rear cables aligned with wear damage**

The ATSB conducted testing with string lines and a spreader bar configured in a similar manner to the water bucket suspension cables. It was identified that, if both sets of cables were caught over the left skid, the position of the forward and rear cable positions was consistent with the locations of the striation type wear damage found on the left skid.

Figure 9 shows the left rear skid, viewed from an outboard direction, showing projected alignment with the hook, cable spreader and multiple bucket suspension cables. Detail A and B show close-up wear patterns consistent with numerous stainless-steel cable wear striations that aligned with the direction of the external cargo hook attachment point.

- The ATSB’s wreckage examination, which identified that the left rear skid and bear paw showed multiple areas of damage including striation marks indicative of contact with the bucket suspension cables.
- Testing of the striation marks alignment with the fore and aft cable positions when attached to the external cargo hook with the triangular load spreader.
