VFR into IMC, loss of control and collision with terrain involving SOCATA-Groupe Aerospatiale TB-20, VH-JTY

65 km west of Mackay Airport, Queensland, on 28 October 2023

ATSB Transport Safety Report

AO-2023-052

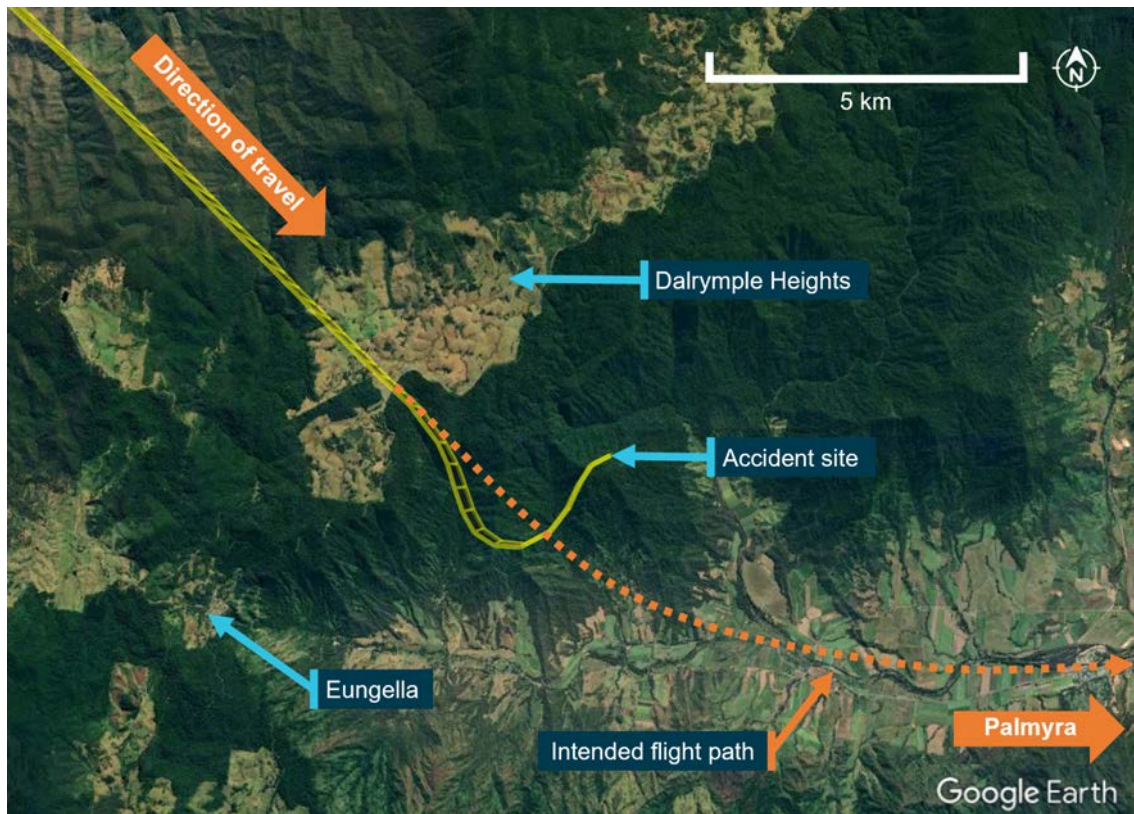
Figure 1: VH-JTY fight path

OzRunways³ data showed the aircraft was flown to 5,500 ft above mean sea level (AMSL) where it maintained a steady track without any significant deviations during the cruise phase of flight.

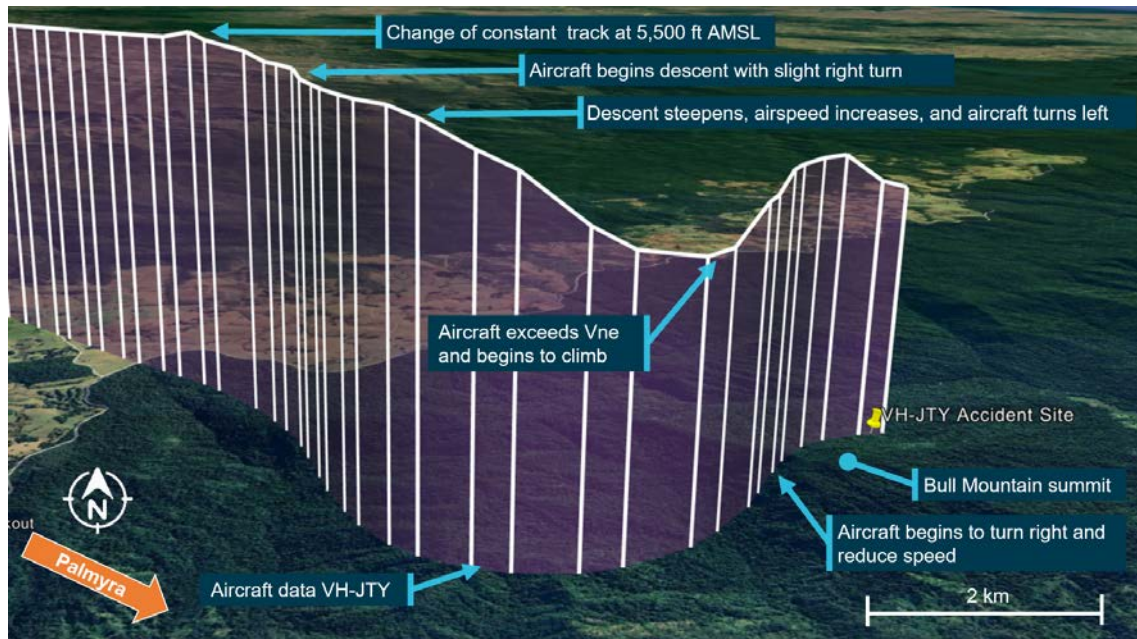
Figure 2: VH-JTY descent

At 08:34, there was a change to the previously stable flight path. The aircraft initially climbed about 100 ft and entered a slight right turn before turning left towards Bull Mountain in a shallow descent. As the turn continued, the aircraft's descent rate increased, descending about 1,600 ft in 13 seconds (average descent rate of 7,400 ft/min) (Figure 2).

During this descent, the aircraft accelerated to about 218 kt, 29 kt above the aircraft's published V_{NE}^4 (velocity never exceed) of 189 kt (Figure 3).

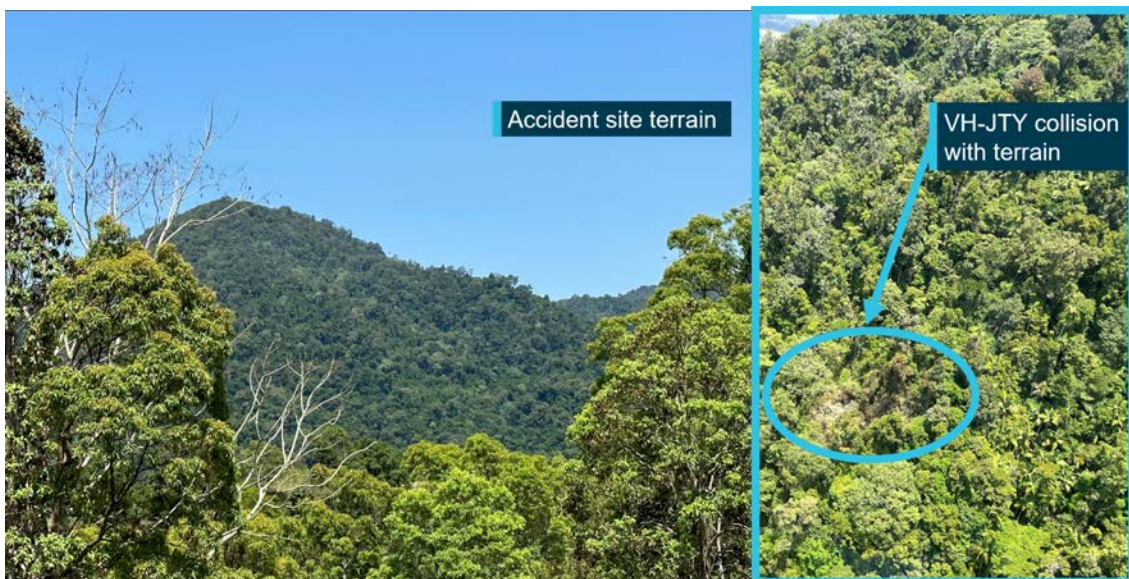
Figure 5: Accident site terrain

The ATSB's review of the accident site photographs, and evidence provided by QPS, showed that the aircraft impacted the terrain at a steep angle while tracking 036° (close to north-east). The aircraft was destroyed by the impact and consumed by a post-impact fuel-fed fire. Several components were buried by shifting soil after the accident.

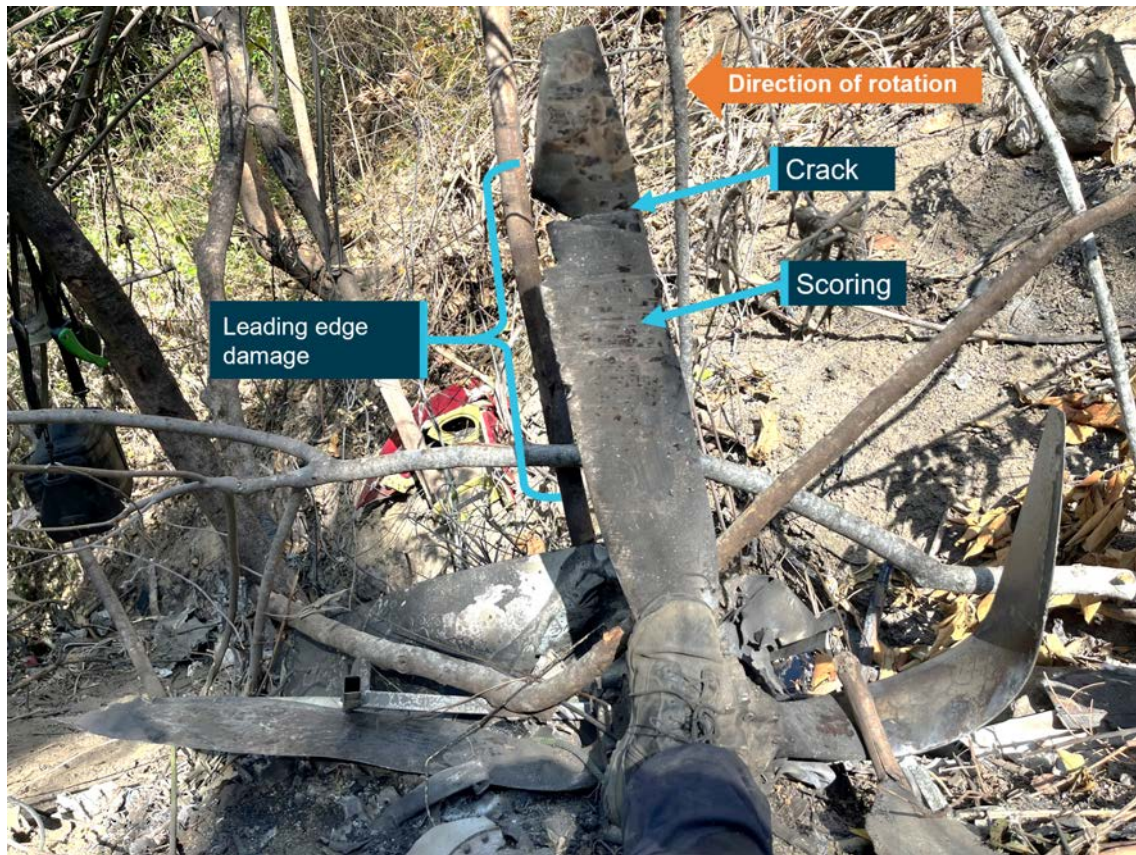
Figure 6: Propeller damage

- Impact marks on engine and propeller components indicated that the propeller was turning with power applied when it impacted terrain, indicating the engine was almost certainly operational at that time (Figure 6).
- The extremities of the aircraft, the wing tips and stabilator were found at the accident site indicating that the aircraft was complete at the time of collision.

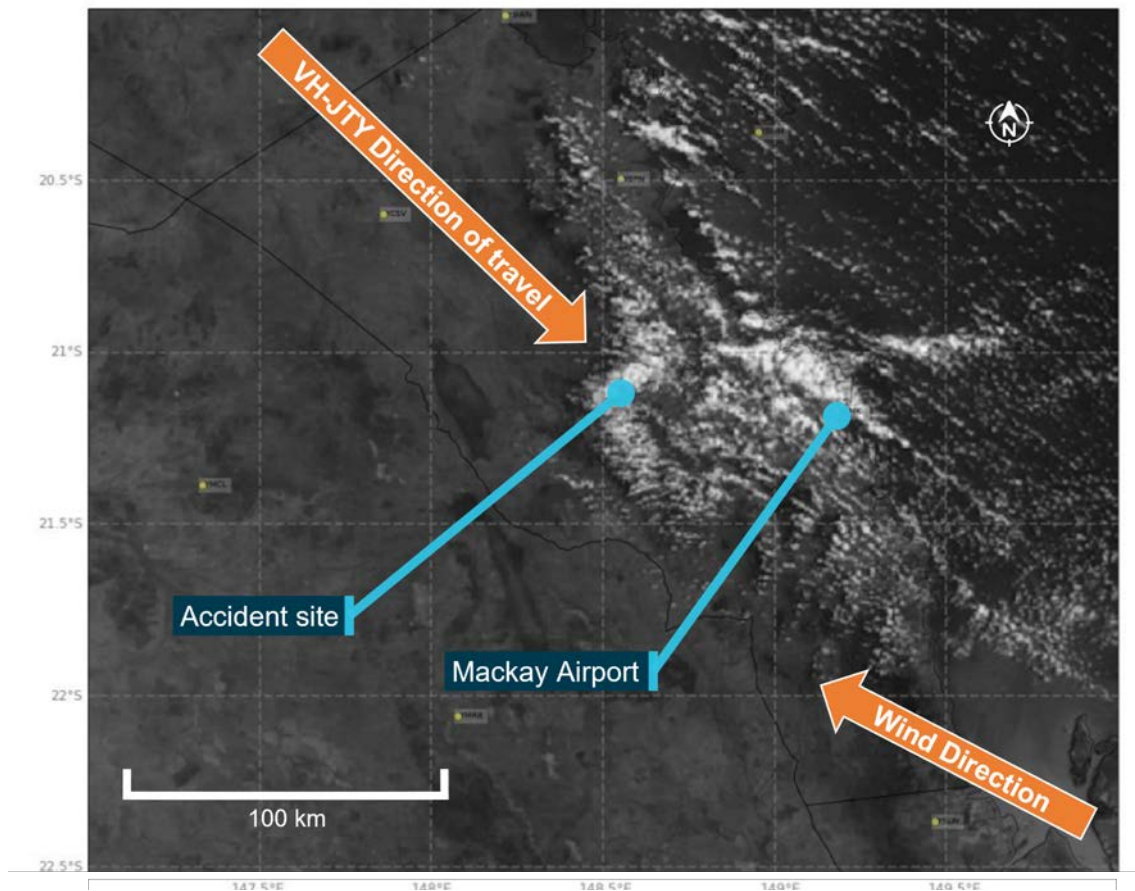
Figure 10: Satellite image showing cloud formation on 28 October at 0830 local time
 Himawari-8/9 RGB (eVIS: Enhanced Visible): 2023-10-27 22:30 UTC

- Cloud extended from the coast to the ranges and was clear west of ranges.
- South easterly winds persisted which often bring cloud between 2,000 – 3,000 ft, being lower earlier in the day and climbing as the day warms up.
- Over the accident site, cloud was overcast to broken.
- Cloud extended 25 NM south of accident site.
- Eungella Dam was visible to the west on satellite images.
- Closer to the coast cloud was scattered to broken.

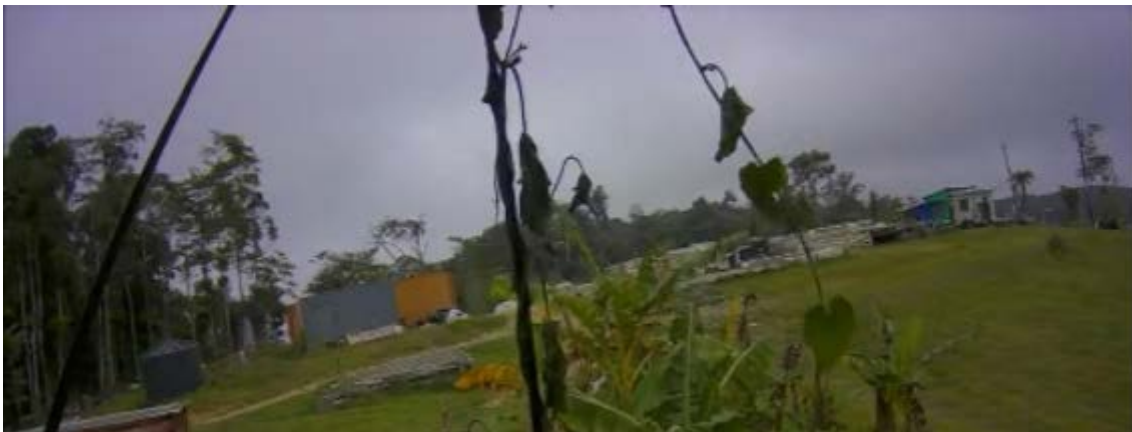
Figure 12: Closed circuit footage from Dalrymple Heights

Additionally, a large bushfire around 70 km to the south-east had filled the Pioneer Valley with smoke which was yet to dissipate. The pilot of the rescue helicopter advised that during the search for VH-JTY at around 1000, the cloud base was scattered at 3,000 ft with poor visibility in smoke haze.
