Fumes event involving Cessna 404, VH-LAD

Near Moranbah, Queensland on 11 April 2024

ATSB Transport Safety Report

AO-2024-029

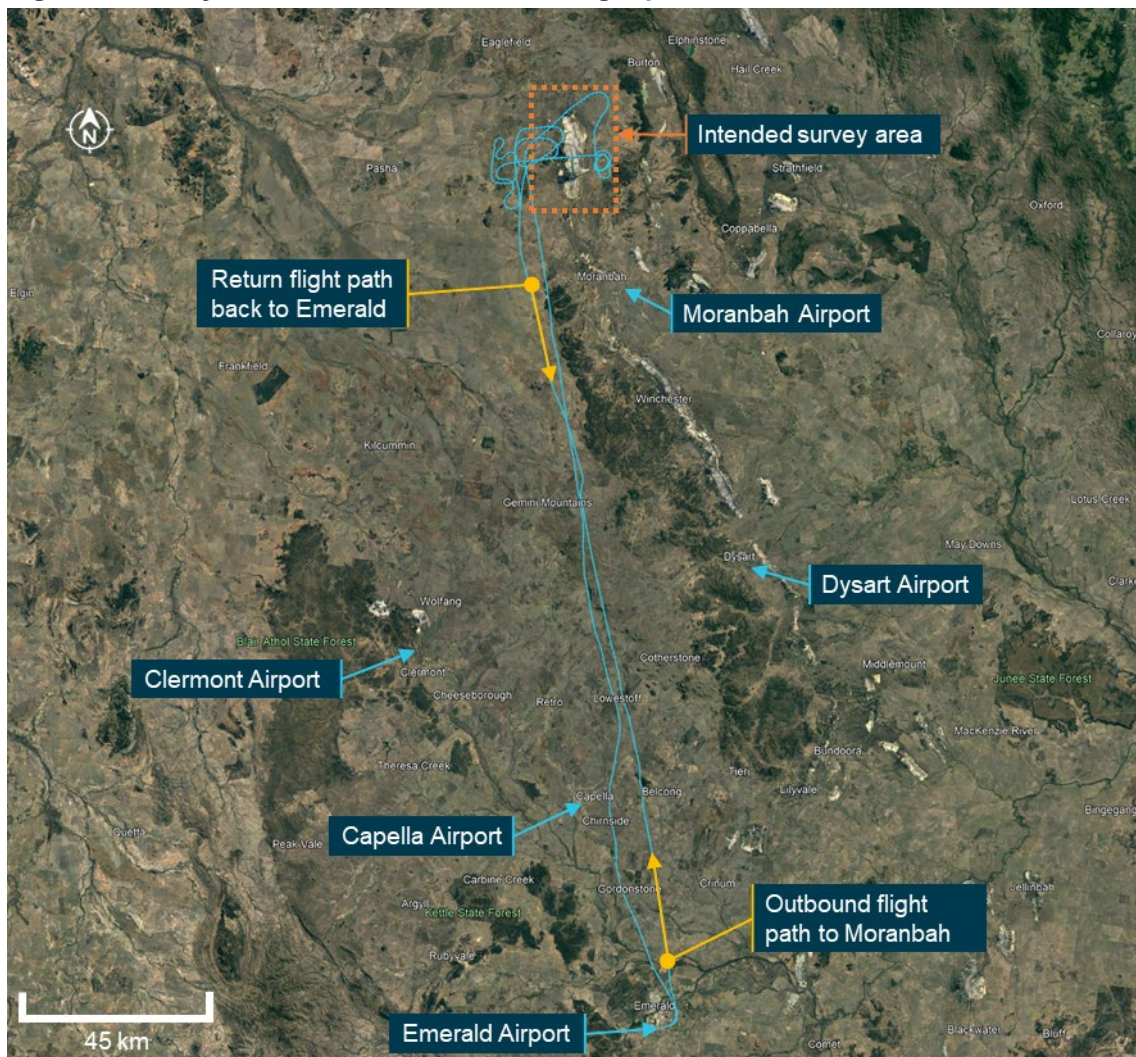
Figure 1: Survey area location and recorded flight path between Emerald and Moranbah

On 11 April 2024, a Cessna 404 Titan was being operated by Aero Logistics on an aerial survey flight north of Emerald, Queensland. The flight was being operated under visual flight rules,¹ with one pilot and 2 task specialists operating the survey equipment. At 1317 local time, the aircraft departed Emerald Airport to the north-east before turning towards Moranbah and climbing to an altitude of 5,000 ft (Figure 1).
