Australian Government
Australian Transport Safety Bureau

Collision between a passenger train and a motor vehicle

near West Dapto Road level crossing, Kembla Grange, New South Wales on
20 October 2021

ATSB Transport Safety Report
Rail Occurrence Investigation (Defined)
RO-2021-012
Final – 25 October 2024

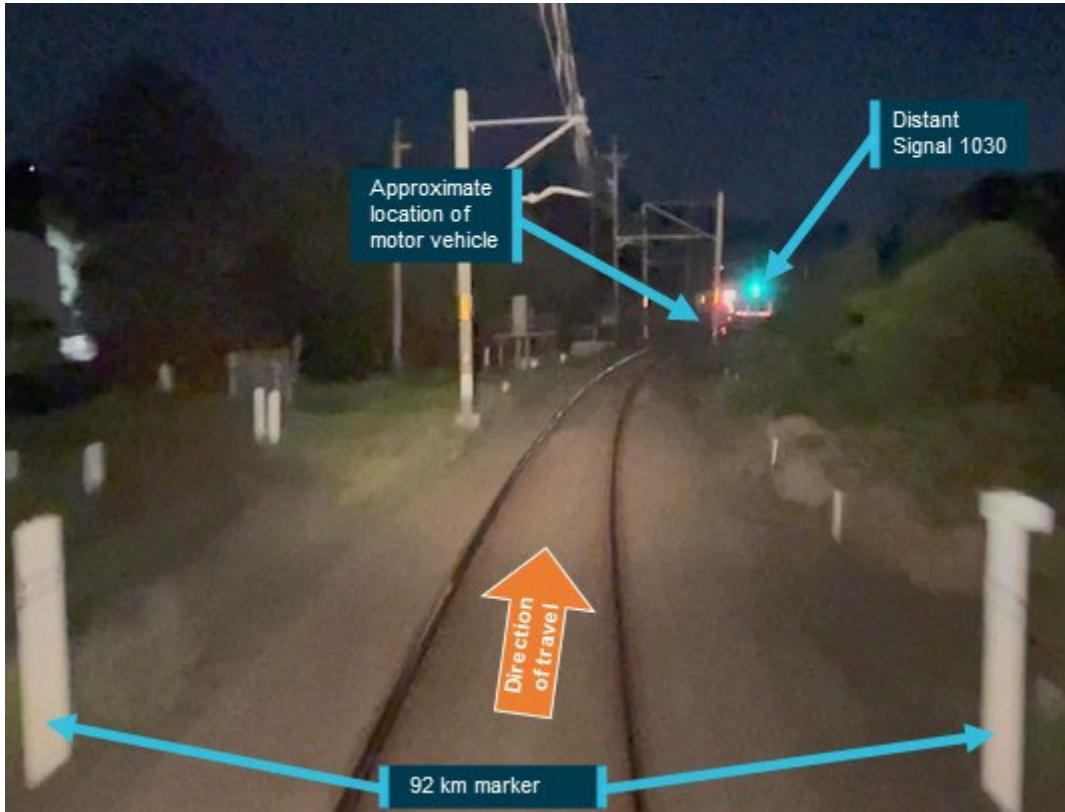
Figure 1: Approach to level crossing

At 0409:06, the train passed the track circuit that activated the West Dapto Road Level Crossing warning bells and lights (92.672 km). 26 seconds later, at 0409:32, the driver made an initial brake application (91.944 km). It was estimated the train was approximately 200 m from the motor vehicle at this time. Three seconds later the driver applied full braking (91.860 km) and within the second after, applied emergency braking.

*Front of train footage taken from a subsequent train journey at the same time of day. The location of the motor vehicle was 268 m beyond the 92 km posts. At this time the motor vehicle was likely in relative darkness.
Source: Sydney Trains*

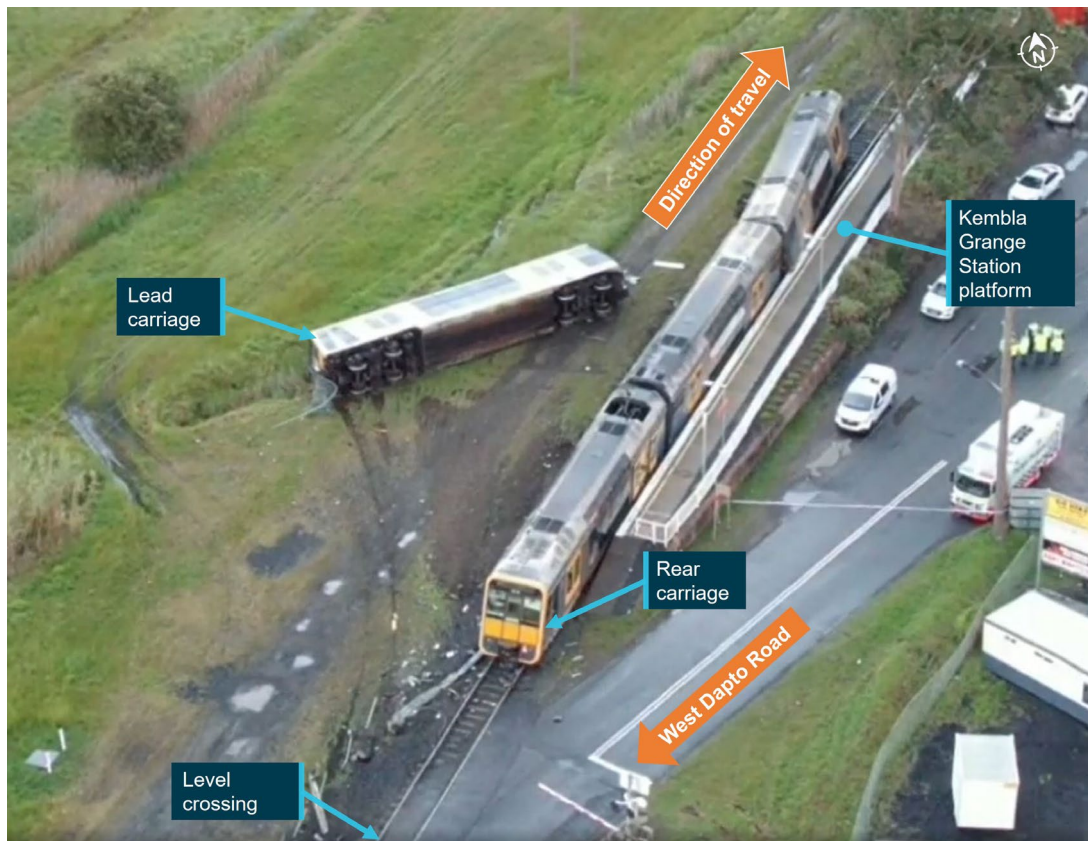
Figure 2: C012 after the collision and derailment

The first carriage tipped onto its right side and jack-knifed so that the rear of the carriage separated from the second carriage, and then slid a further 25 m off to the side of the rail track. The remaining 3 carriages stayed upright with the second carriage derailing and the third and fourth carriages remaining on track and alongside Kembla Grange Station platform (Figure 2).

C012 alongside Kembla Grange Station after collision and subsequent derailment
Source: Sydney Trains, annotated by ATSB

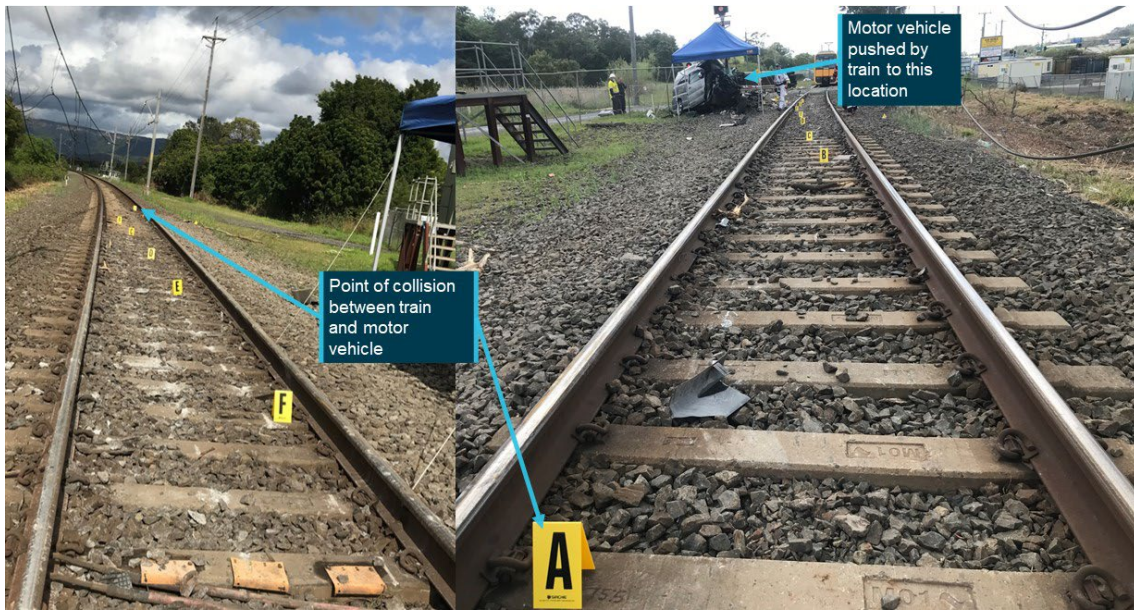
Figure 3: Point of collision and abandoned motor vehicle

Police forensics marked the location of the motor vehicle at 91.732 km, 68 metres from the West Dapto Road Level Crossing (see Marker A in Figure 3).

*The motor vehicle was abandoned on the rail line at yellow marker A and pushed by the train to the location in the picture.
Source: OTSI*

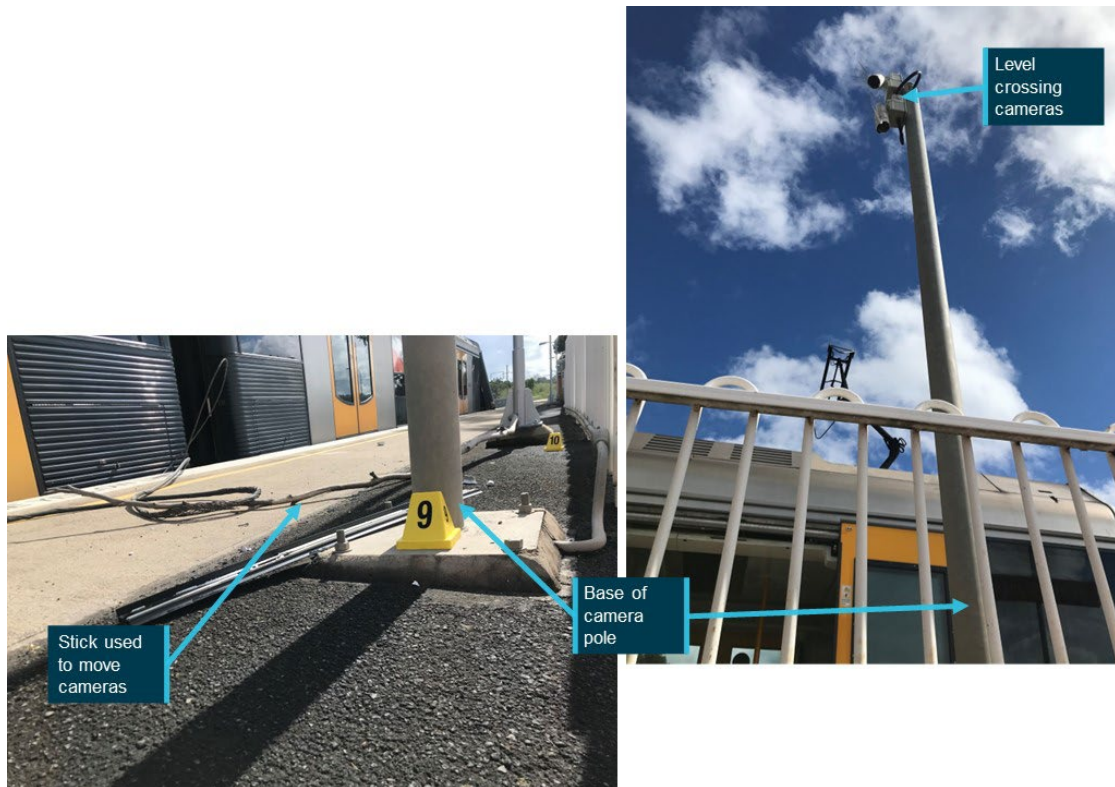
Figure 4: Level crossing cameras at Kembla Grange Station

At 0313 and again at 0326 on 20 October 2021, a Sydney Trains CCTV recorded the individual moving cameras to face away from the West Dapto Road level crossing (Figure 4).

*CCTV cameras facing the ground and away from the level crossing, moved by the convicted felon as captured on CCTV.
Source: OTSI*

The contract required tamper alarms to be installed on all cameras. However, the cameras were prone to vibration caused by passing freight trains and other anomalies resulting in high false alarm rate. Security Control Centre staff could not manage the excessive number of tamper alarms being generated causing installation to be stalled.

Following this incident, Sydney Trains Security group worked with the contractor to find out what was stopping the implementation of the tamper alarm functionality. An issue raised was poor detection on outdoor cameras due to lighting conditions. At the time of authoring this report, other solutions were still under consideration such as electro-mechanical tamper alarms and/or more bespoke high-end video analytics were being trialled on cameras used to monitor level crossings.

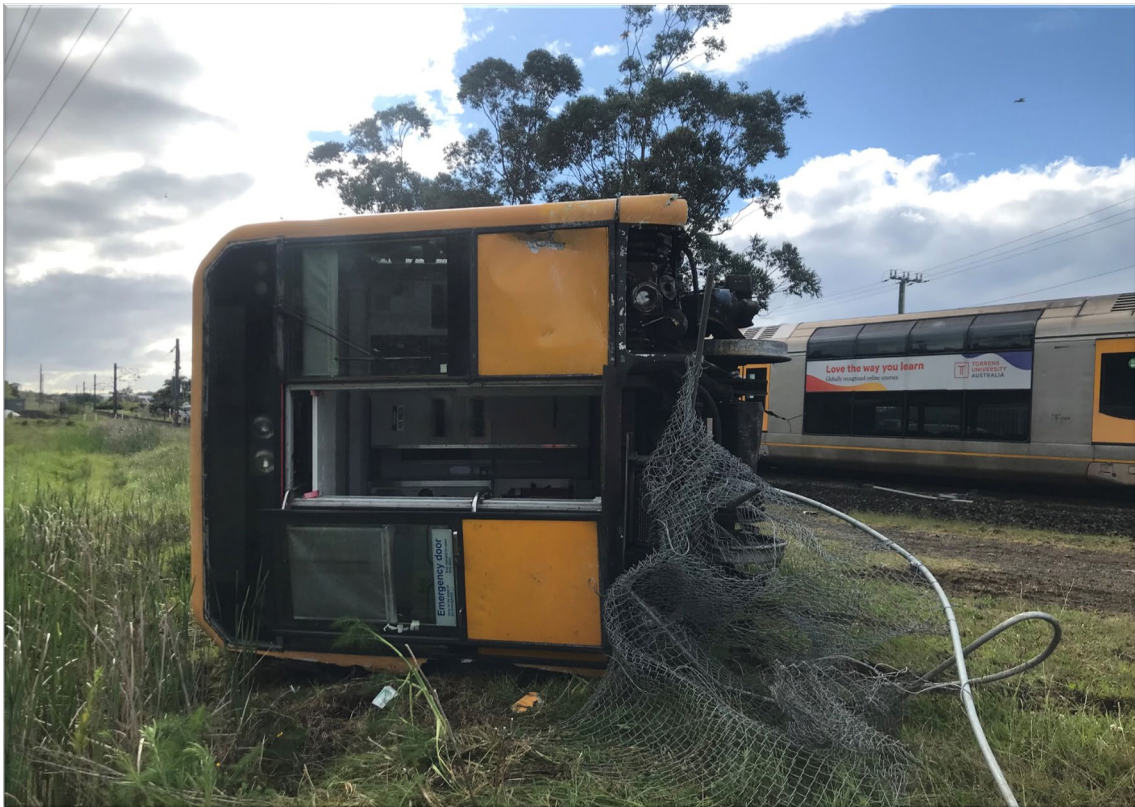
Figure 12: Emergency door at front of train

The driver was extricated from the emergency door at the front of the train.
