Fatality involving a track mounted excavator

Evandale, Tasmania, on 20 July 2022

ATSB Transport Safety Report

RO-2022-008

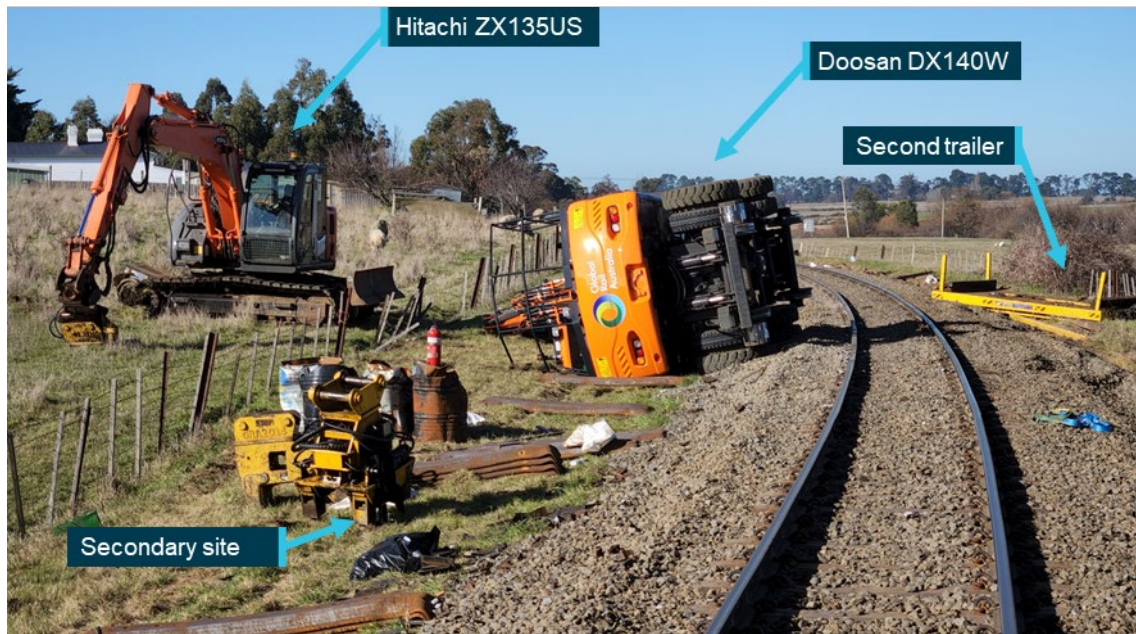
Figure 2: Accident site

At about 1035, while stationary, the site supervisor used the excavator boom, at or near full extension, to lift the infrastructure trailer loaded with the infrastructure trailer draw bar and timber dunnage. The spotter was positioned between the excavator and infrastructure trailer being lifted. The infrastructure trailer was lifted just above rail level before the load gradually slewed laterally.

The spotter reported that, at some point during the lift and slew, the excavator operator realised that the lift was out of control and immediately lowered the boom arm in an effort to stabilise the excavator and/or to avoid striking the spotter. The spotter recalled the rail threader attachment ramming the infrastructure trailer at this time. The spotter, standing between the excavator and the trailer, immediately evacuated the area as the excavator toppled onto its side (Figure 2). The spotter did not directly witness the topple. The excavator boom arm scraped down the back of the spotter as they evacuated the area, resulting in minor injury.

*Note: Track curvature is 650 m with an average track cant of about 8 mm.
Source: Tasmania Police, annotated by the ATSB*

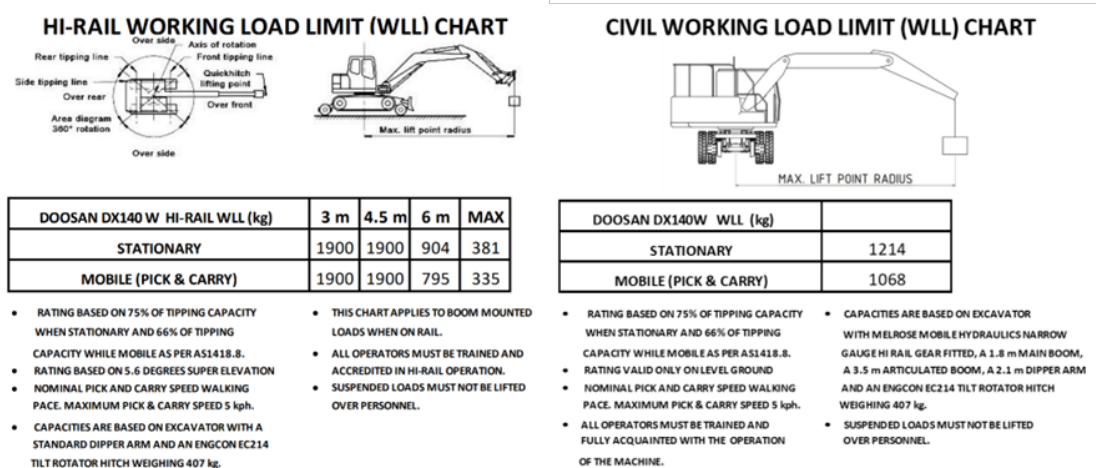
Figure 3: Hi-rail and civil mode working load limit chart

When in the hi-rail mode, with the boom arm (the lift point radius) fully extended, the maximum weight that could be lifted when stationary was 381 kg. This weight increased to 904 kg with a reduction in the boom arm length to 6 m. When in the civil mode, the lifting capacity was 1,214 kg at any boom arm length. These weight limits reduced when the excavator was moving (mobile) with the load. For both modes, these weights were based on 75% (stationary) and 66% (moving) of the tipping capacity respectively, which is the point at which the machine will begin to tip or lift off the ground.

The capacities presented in the chart are based on the excavator having a standard boom arm and a tilt rotator weight of 407 kg. Therefore, the tilt rotator was excluded from the working load limit weights. The tilt rotator and rail threader are shown in Figure 4.

On-site observations indicated the excavator boom arm was at near or full extension. Referring to the lift chart for the stationary hi-rail mode (Figure 3), the maximum working load limit was between 904 kg at 6 m and 381 kg at maximum extension. Given the items being lifted from the track, the excavator was lifting between 1,362 kg (150%) and 1,885 kg (495%) over the working load limit (Figure 7).

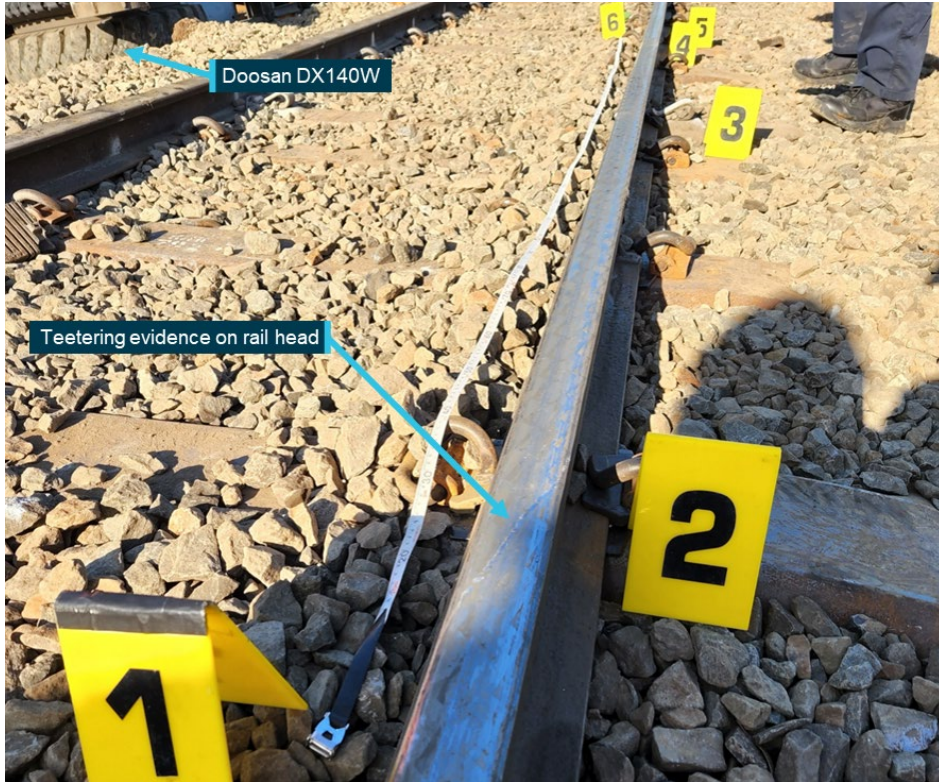
Figure 5: Teetering evidence on the rail head

- there was evidence of lateral wheel movement (teetering) on the rail head over about 4 m, which correlated with the excavator rear rail wheels (Figure 5)

Evidence found on-site showed the rear wheels of the excavator teetered along the rail head, leading up to the excavator toppling. The spotter observed that the site supervisor was in the cabin, with the door latched open, immediately before the excavator toppled. Following the topple, the spotter had assumed that the site supervisor had evacuated as the cabin was found empty. However, the site supervisor was found under the excavator. As the spotter did not witness the evacuation, it could not be determined if the site supervisor either evacuated the cabin during the

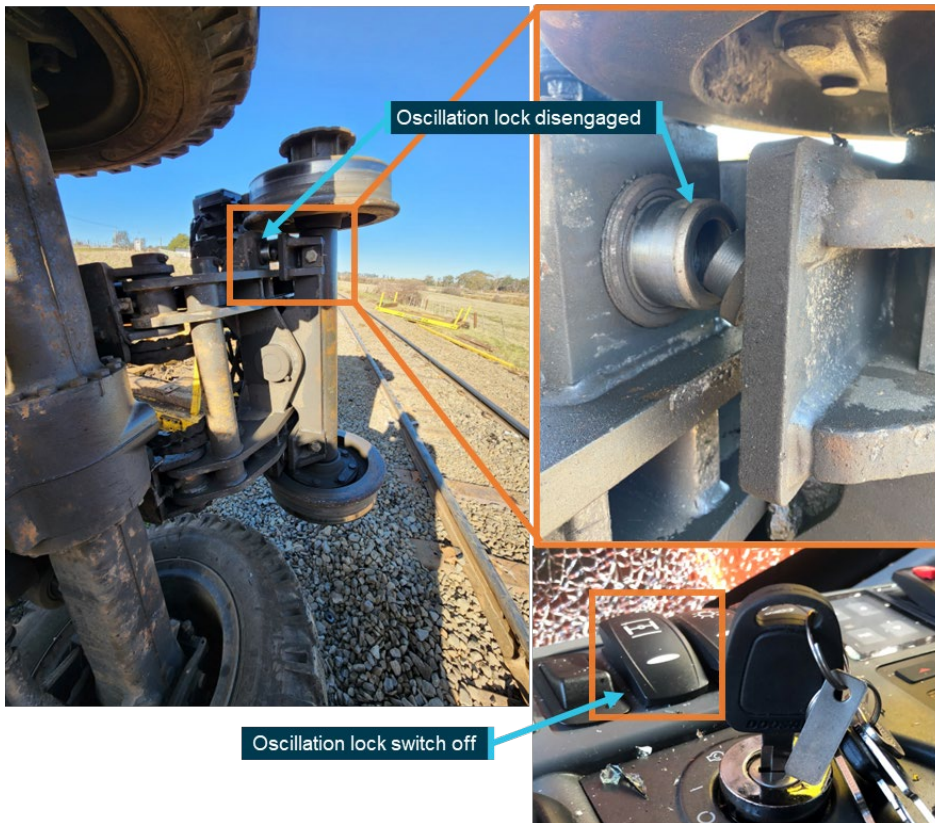
Figure 6: Oscillation lock disengaged and off

- the excavator rail wheels were fully lowered in high rail mode
- the suspension oscillation lock was disengaged and selected off in the cabin (Figure 6)

On 26 July 2022, an ONRSR rail safety officer inspected the excavator at the storage facility, and the accident site. The officer concluded that, aside from accident damage, the excavator was in a good condition with no signs of poor maintenance. It was noted that the excavator's front rail axle was in travelling mode during the inspection, suggesting it was pivoting rather than locked (suspension oscillation locking system).

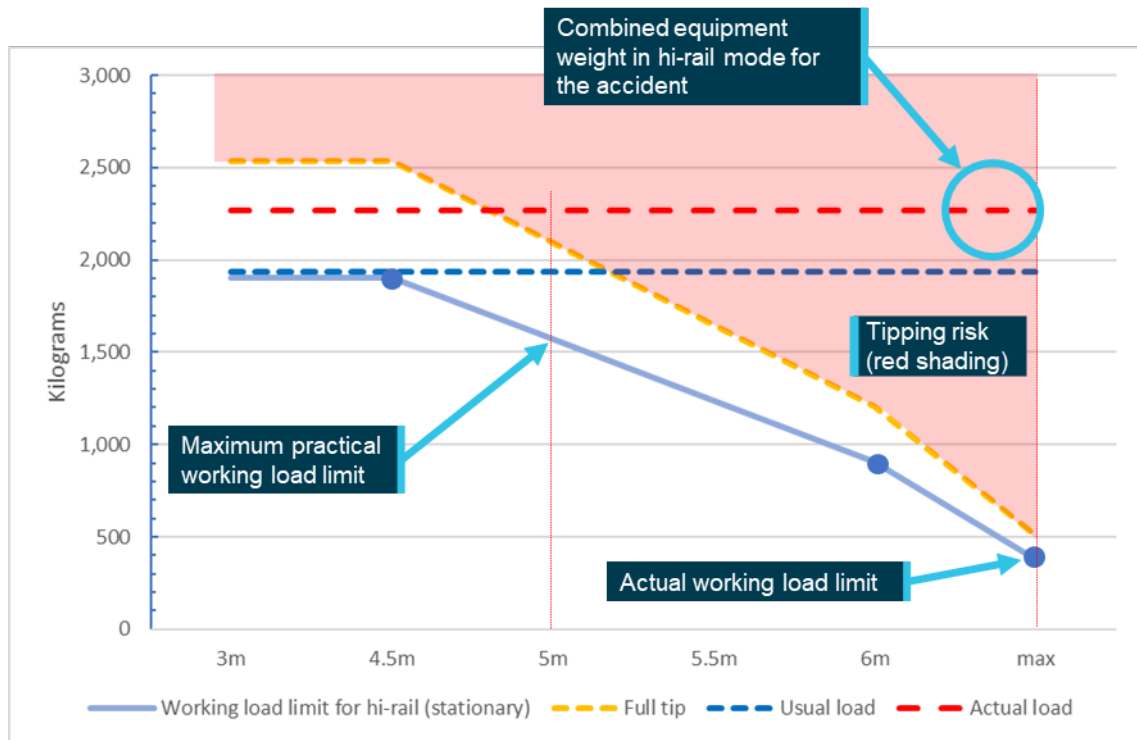
Figure 7: Combined equipment weight, working load limit, lift point radius (boom arm extension), and tipping capacity for hi-rail mode

Using the stationary hi-rail mode working load limit chart (Figure 3), the ATSB linearly extrapolated an indicative limit for a 5 m extension or lift radius as 1,568 kg.¹ This meant that, at the closest possible distance, the excavator would be lifting 698 kg (45%) above the working load limit (with an empty trailer, rail threader and short draw bar, similar to the accident (Figure 7).

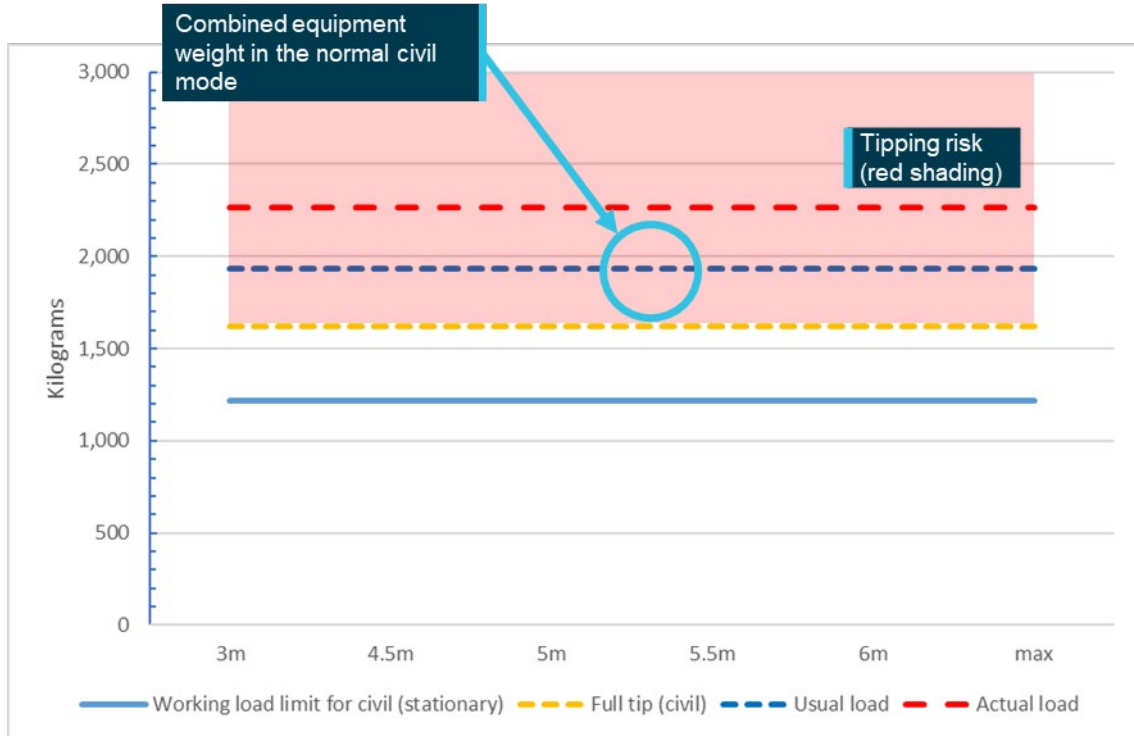
Figure 8: Combined equipment weight, working load limit, lift point radius (boom arm extension), and tipping capacity for civil mode]

For comparison, and as noted above, the civil working load limits remained the same irrespective of the boom arm extension. Therefore, for the normal operating configuration as reported by the primary operators, it would be 722 kg (61%) overweight (Figure 8).
