Controlled flight into terrain involving Boeing 737-3H4 Fireliner, N619SW

Fitzgerald River National Park, Western Australia on 6 February 2023

ATSB Transport Safety Report

AO-2023-008

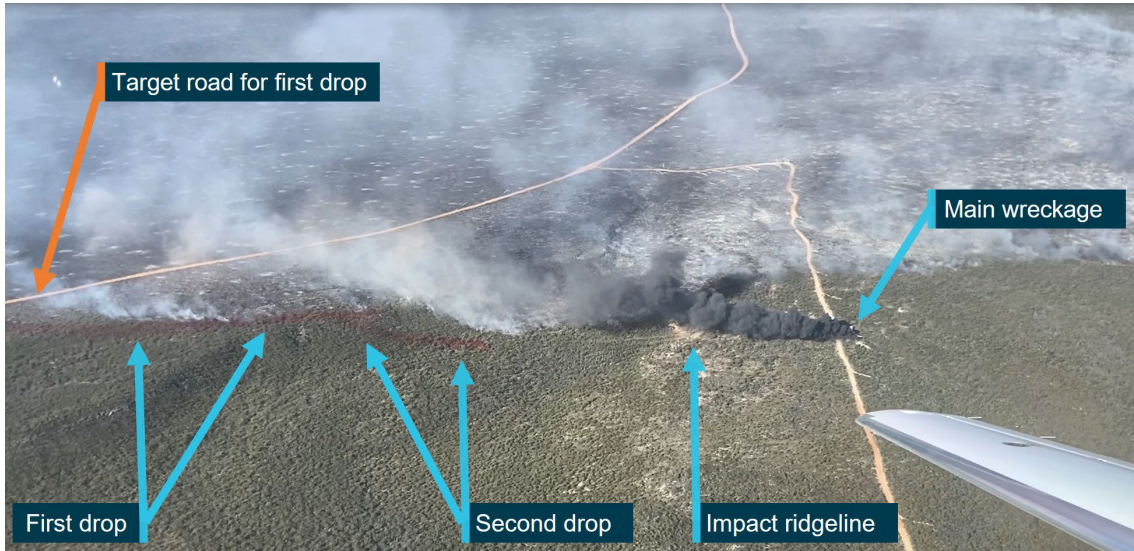
Figure 2: Bomber 139 retardant drops and accident site

Bomber 139 descended to a minimum height¹¹ of 78 ft and completed a 9-second partial drop¹² of three-quarters of their tank at about 70% N1¹³ with a minimum computed airspeed¹⁴ of 124 kt before the captain stopped the drop because their retardant line was starting to enter area that was already burnt. The captain reported the partial drop to BD123, and another Lead profile was set up to tag and extend the first drop with the remaining retardant, with the captain remarking to the crew of BD123 '...and head down off the hill'.

The engines did not immediately respond to the movement of the thrust levers and the captain started to pitch the nose up, which resulted in a reversal of the rate of descent and a decay of the airspeed. The captain then announced 'fly airplane' followed immediately, at about 1614,¹⁶ by the activation of the stick shaker¹⁷ and an abrupt vertical acceleration associated with the aircraft impacting a ridgeline at an elevation of about 222 ft at 104 kt with the engines at 85–89% N1.

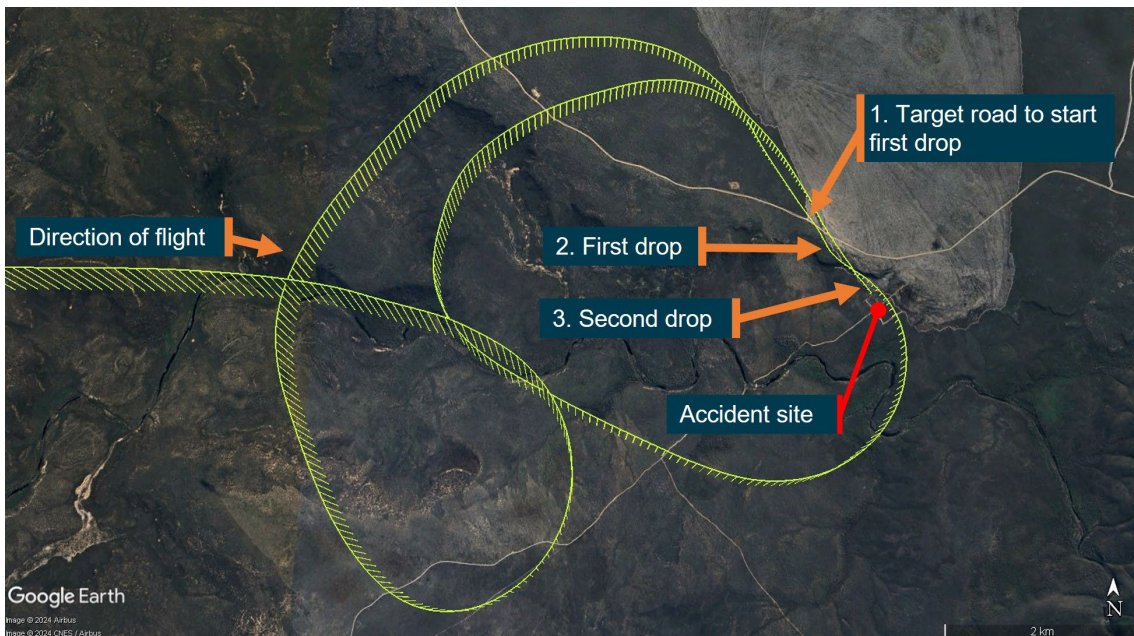
Figure 3: Bomber 139 recorded accident flightpath at Fitzgerald River National Park

After motion had ceased, the co-pilot started the evacuation checklist. Both pilots were unable to open the cabin door as it had buckled and the co-pilot was unable to open the right-side window. The captain observed out of the left side window that a post-impact fire had started and managed to open that window on their second attempt. Both pilots then exited out of the left window and moved clear of the wreckage and fire. They were subsequently rescued by a helicopter involved in the fire control activities after 2 single-engine air tankers had dropped water with foam on the aircraft fire, believing the crew were still inside. The crew suffered minor injuries and the aircraft was destroyed. Figure 3 depicts Bomber 139's recorded accident flightpath.

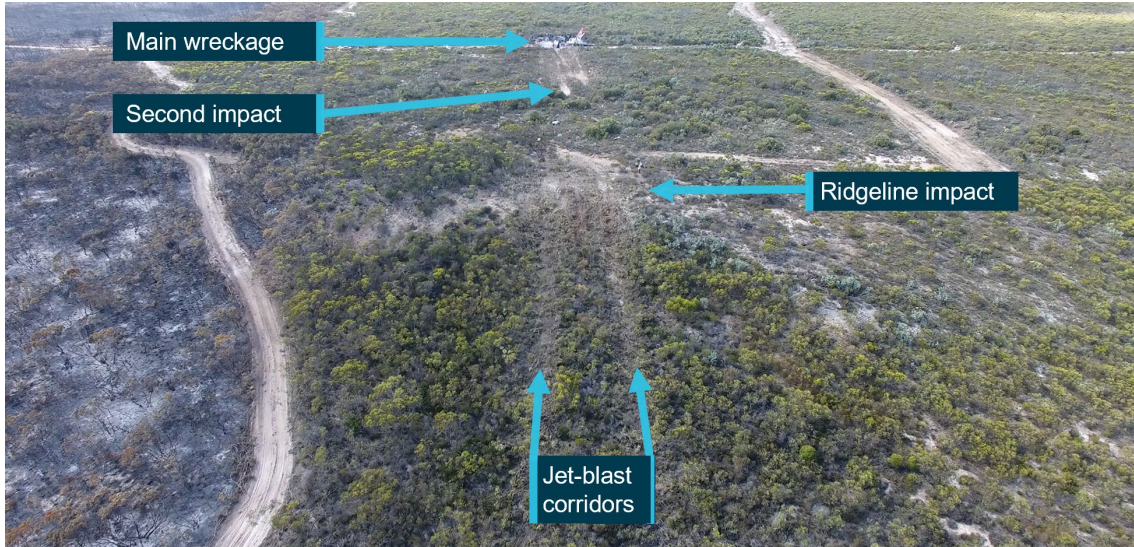
Figure 5: Jet-blast corridors and ridgeline impact

The aircraft’s approach to the ridgeline left 2 distinct jet-blast lines, evidenced by trees broken in the opposite direction of travel (Figure 5). Closer to the ridgeline, trees were broken in the direction of travel, likely from contact with the aircraft’s engines and airframe with evidence of retardant transfer from the airframe to the foliage just below the ridgeline. The length of the jet-blast lines were about 74 m and 62 m respectively for the left and right engines. After contacting the ridgeline, the aircraft became airborne for about 69 m, shedding engine, wing, and

fuselage debris before impacting a second time in a slight nose down attitude on a heading of about 140°.

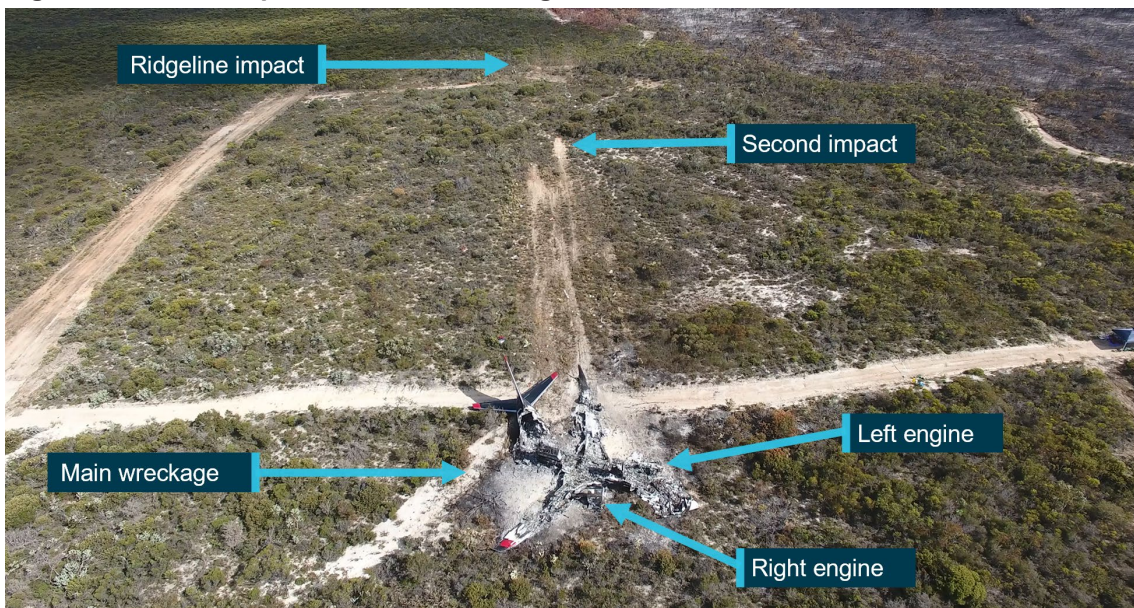
Figure 6: Second impact and main wreckage

The aircraft came to rest about 176 m from the ridgeline and yawed left to the direction of travel onto a heading of about 080°. The fuselage had a main fracture near the tail and the left engine had separated from the left pylon and was resting adjacent to the forward fuselage (Figure 6). The left engine pylon exhibited a 70° upward bend, which was likely from the impact with the ridgeline, noting the left engine debris field started from the ridgeline and there was no evidence of left engine drag marks. The aircraft was consumed by fire, but there was no evidence of:

- fire trail²⁴ or fuel spill before the aircraft came to rest
- any debris separating from the aircraft before it impacted the ridgeline.

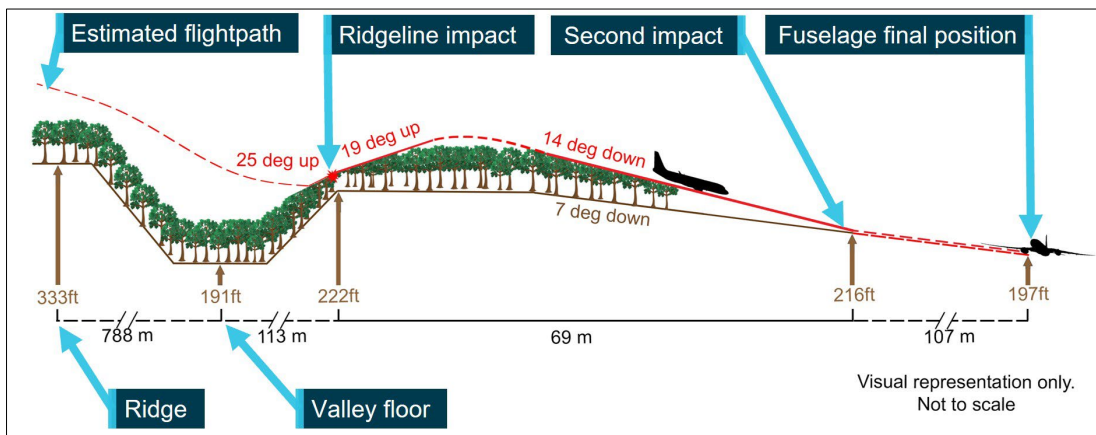
Figure 7: Accident sequence distances and elevations

The left main landing gear was found adjacent to the aircraft and part of its support structure was in the debris field indicating it was torn from the aircraft prior to it coming to rest. The nose and right main landing gear were retracted in place. The extent of the fire damage precluded an inspection of the cockpit and flight instruments. Figure 7 depicts the horizontal distances and elevations (measured with a differential global positioning system), and the angles presented by the foliage damage associated with the accident sequence.

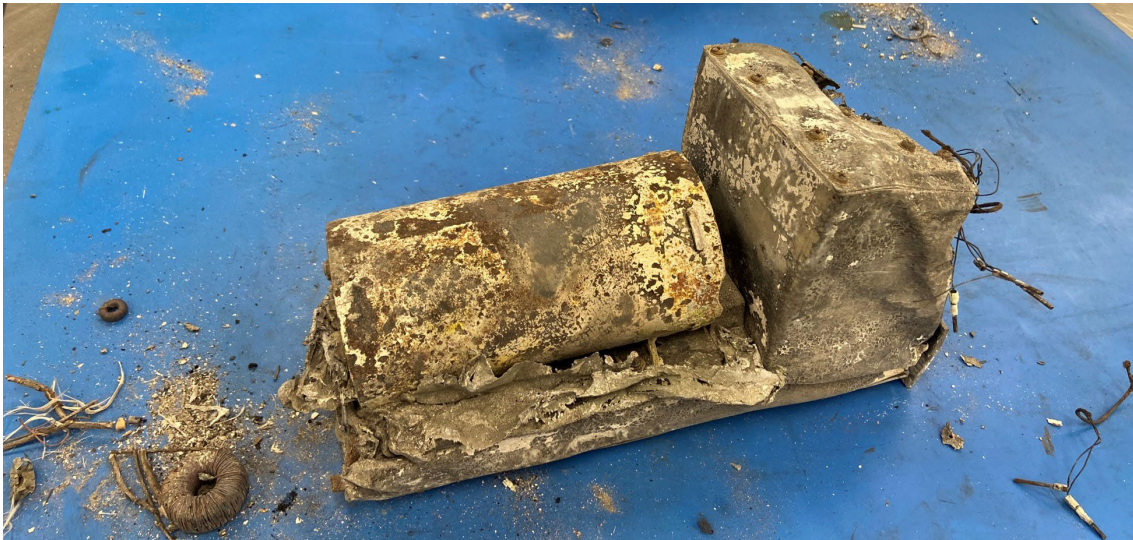
Figure 8: CVR prior to disassembly

As a result of fire damage to the recorders the data recovery process required disassembly, inspection, and repair of the memory boards inside the crash survivable memory unit. The FDR memory board exhibited discoloration, melting and flow of the conformal coating with multiple controller pins desoldered. The CVR exhibited discoloration of the heat indicator, several controller pins had separated from the memory board and multiple short-circuits were identified.

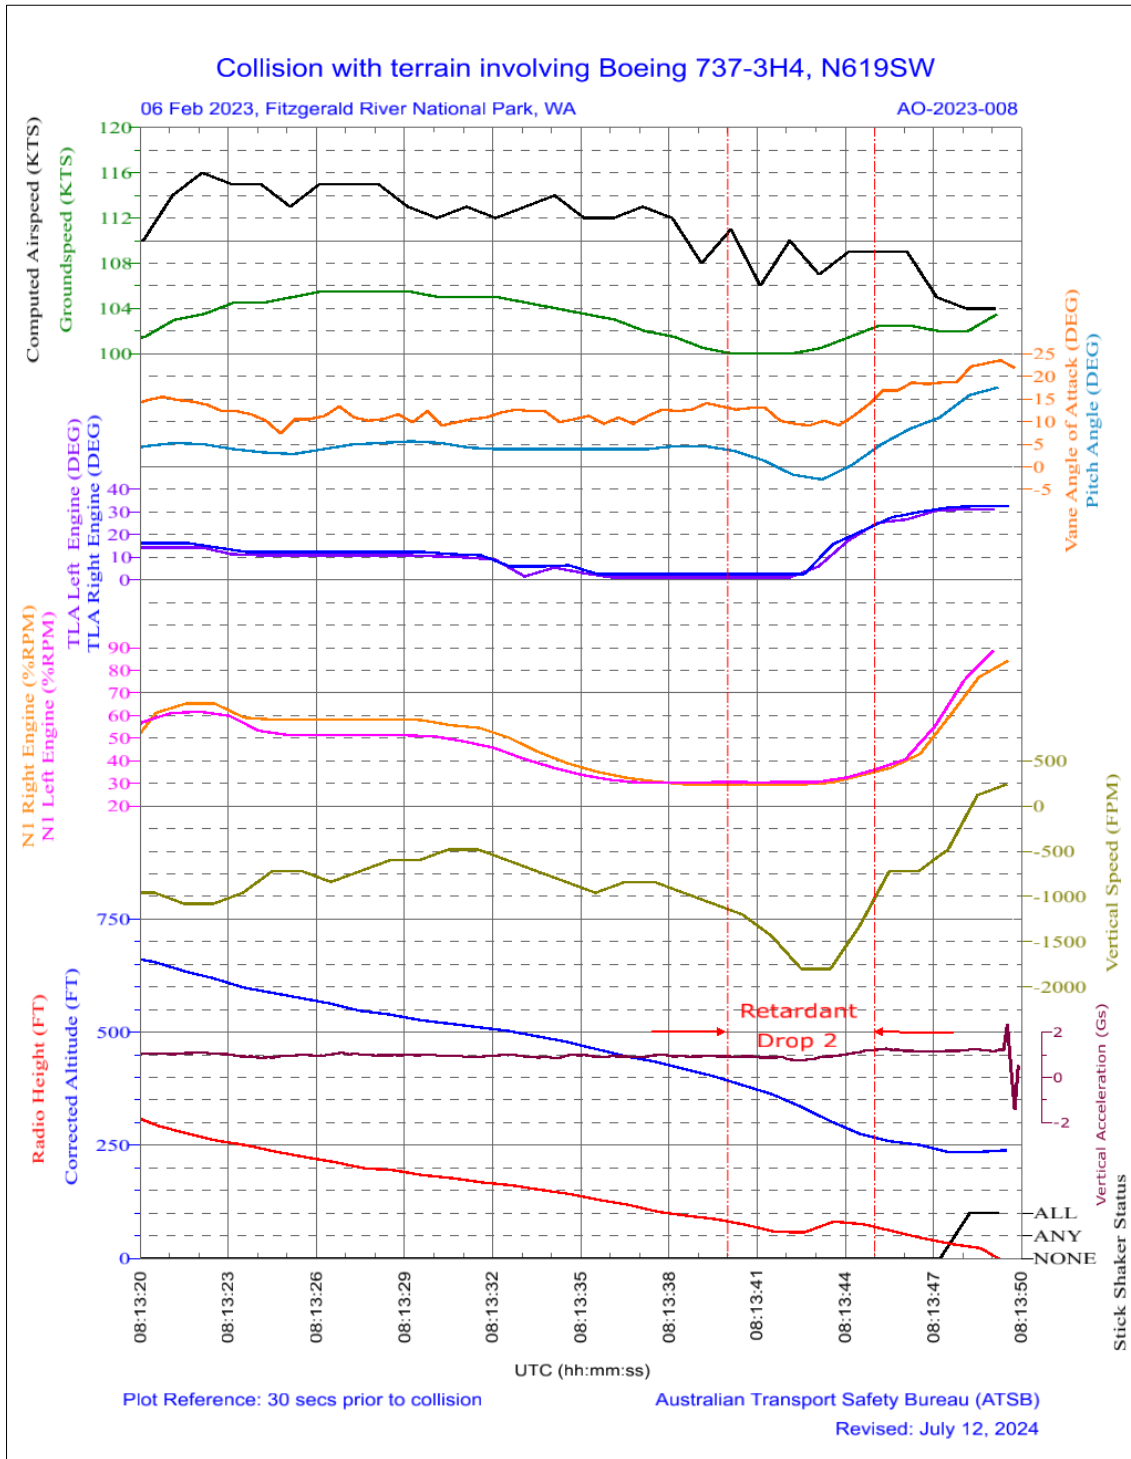
Figure 10: FDR plot of final 30 seconds of accident drop

Final 30 seconds of flight data showing corrected altitude, radio height, pitch angle, angle of attack (same scale), thrust lever angle, engine N1 speed, computed airspeed, groundspeed, vertical speed, stick shaker and approximate position of the retardant drop. The vertical acceleration spike indicates the initial impact.
Source: ATSB

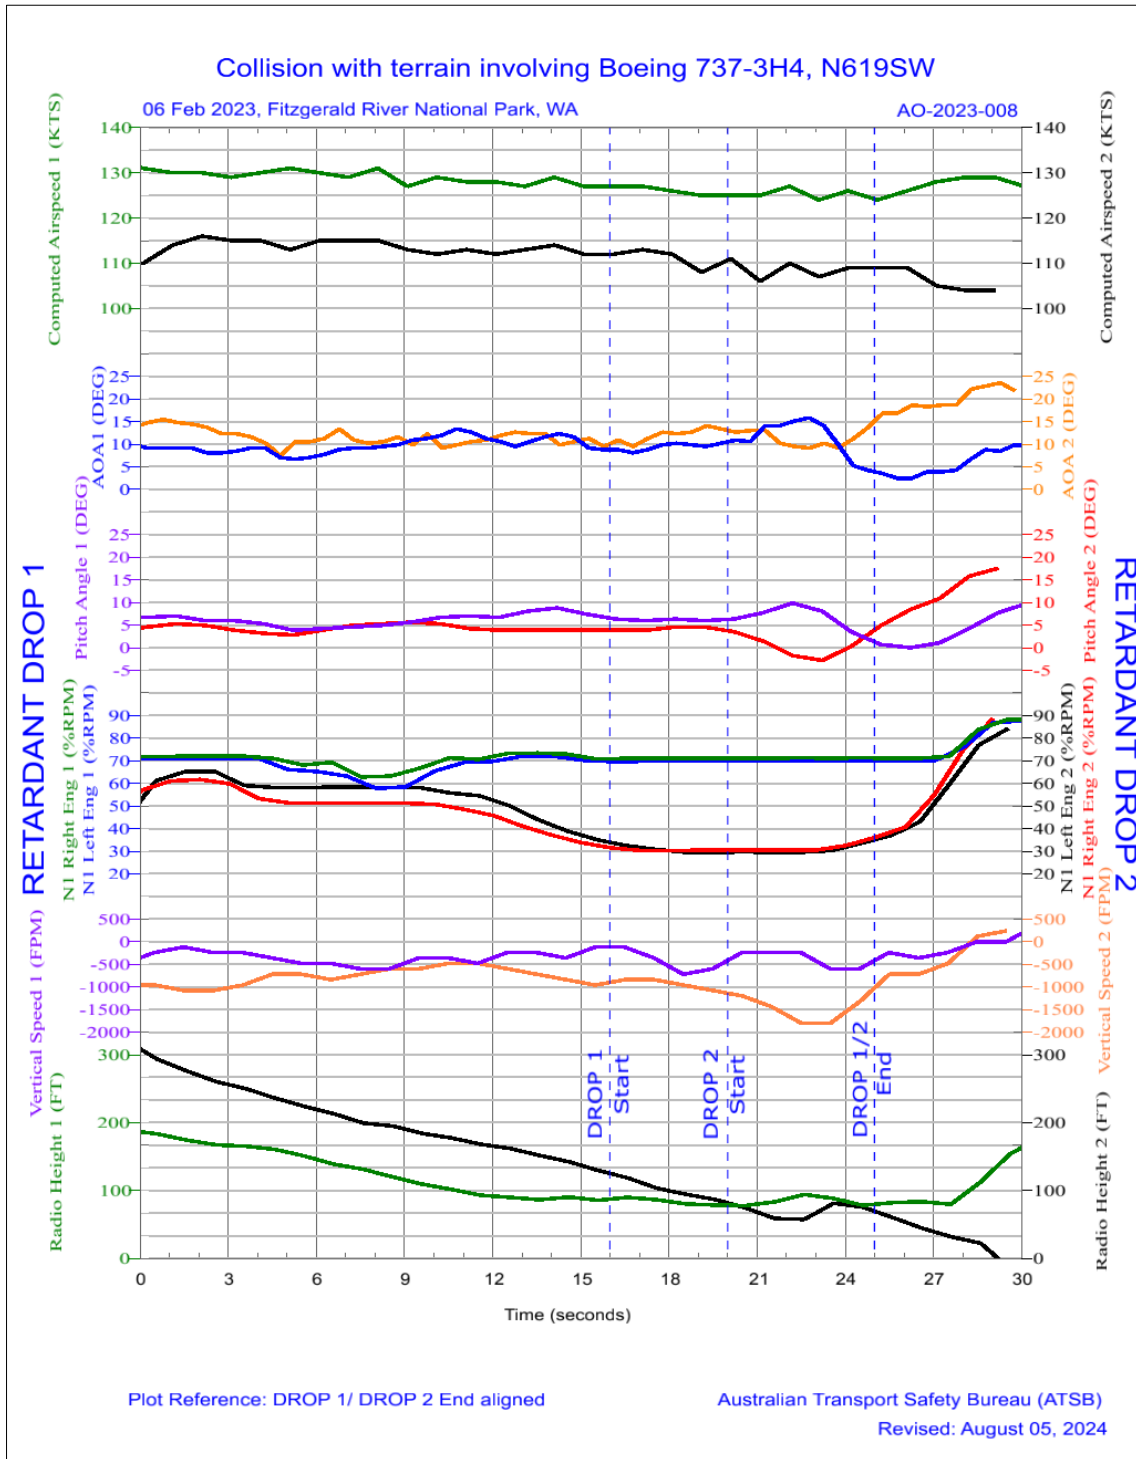
Figure 16: FDR plot of the third (left labels) and final (right labels) drops

The divergence in the go-around performance of Bomber 139 between the end of the third drop and the final drop is presented in the following FDR plot (Figure 16), in which the parameters are aligned with the end of each drop. The ATSB noted the following from the plot:

- the third drop (RETARDANT DROP 1) exits with a higher N1, airspeed, vertical speed, and lower angle of attack (AOA) than the final drop (RETARDANT DROP 2)
- the pitch attitudes and radio heights diverge at the exit, noting the third drop overflow the depression
- the airspeeds diverge as the vertical speeds and N1 converge.
