Collision with terrain involving Robinson R22 Beta II, VH-PSC,

near Limbunya Station, Northern Territory, on 27 June 2023

ATSB Transport Safety Report

AO-2023-031

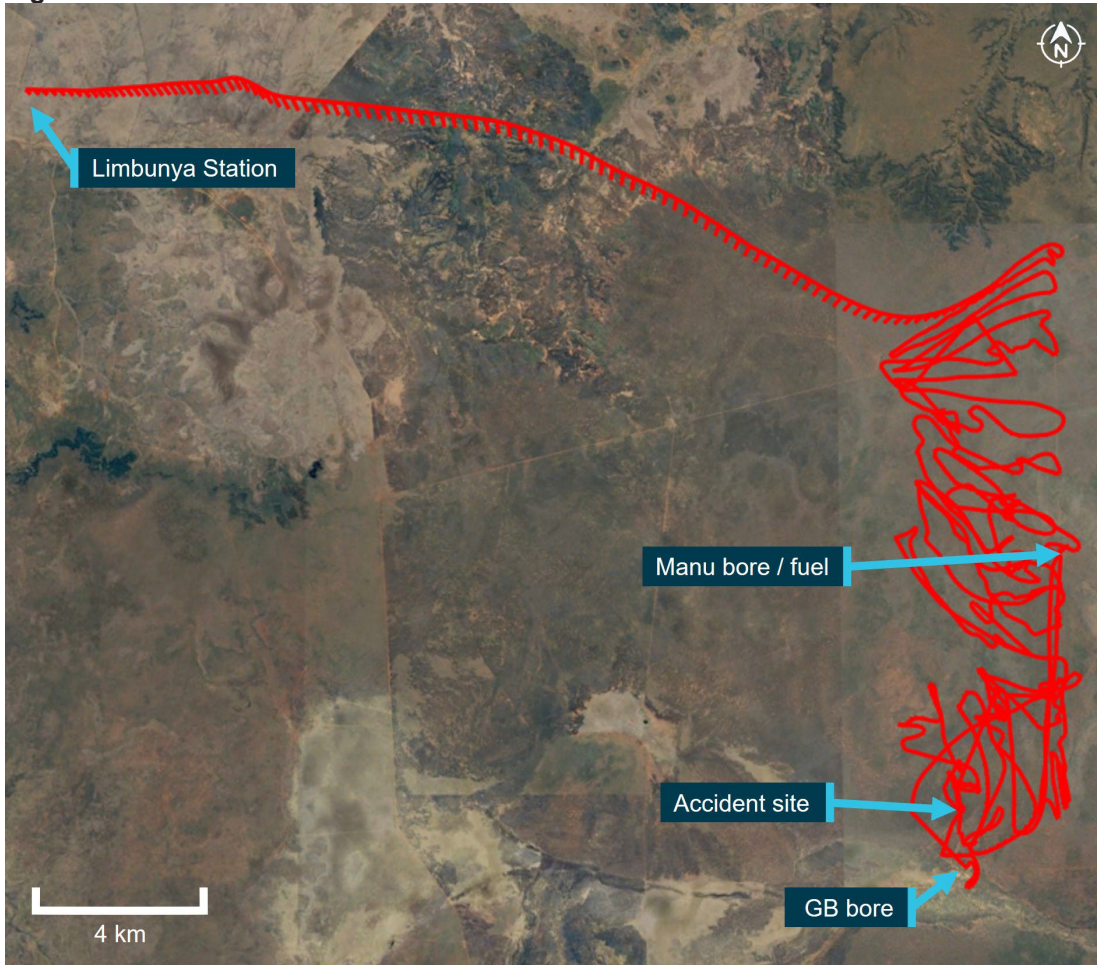
Figure 4: VH-PSC track data

analysis of the final stages of flight. It could not be determined if this lack of recorded data was consistent with earlier dropouts, or due to the collision with terrain interrupting normal function.

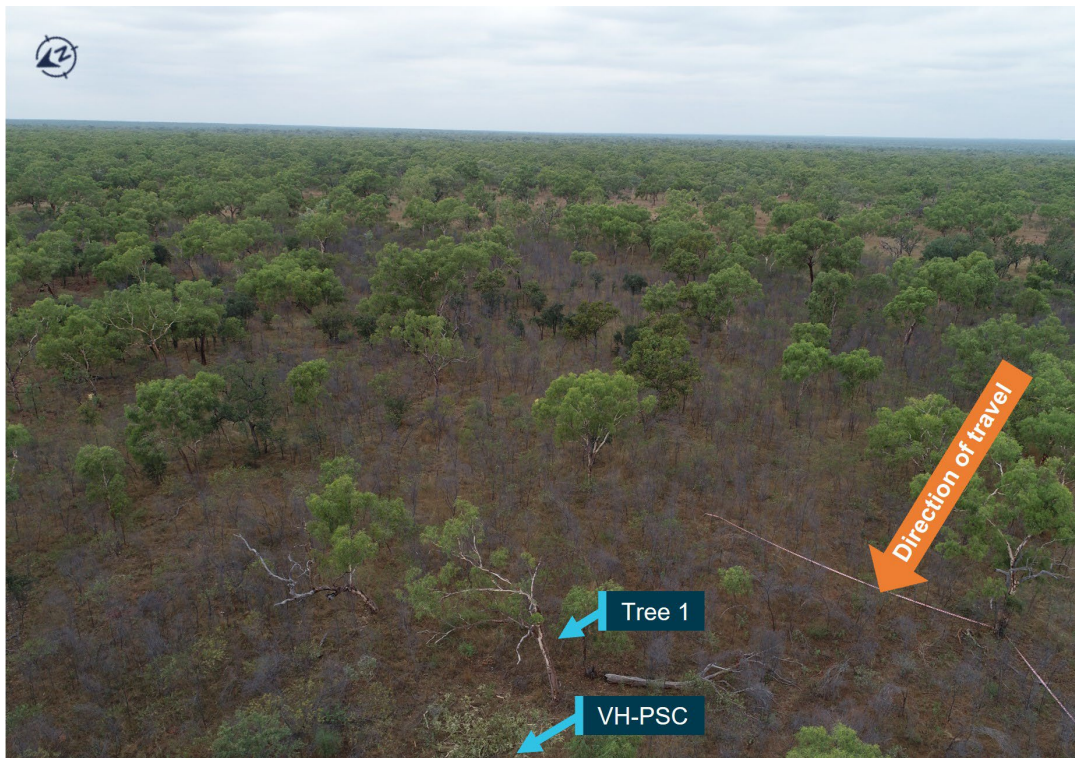
Figure 5: Site location, showing surrounding vegetation

The accident site was located in an area that was flat and moderately wooded (Figure 5). There were no power lines or wires in the surrounding area. The helicopter collided with several branches of a tree (Tree 1) about mid height (5.7 m above the ground). The forward fuselage then impacted terrain in a nose-down, right side low attitude at the base of the second tree (Tree 2). The descent angle through the trees was calculated to be 45–48°. There was a short wreckage trail of about 18 m, on an approximate north-west heading. All helicopter parts were present at the accident site and there was no evidence of an in-flight break-up or a post-impact fire.

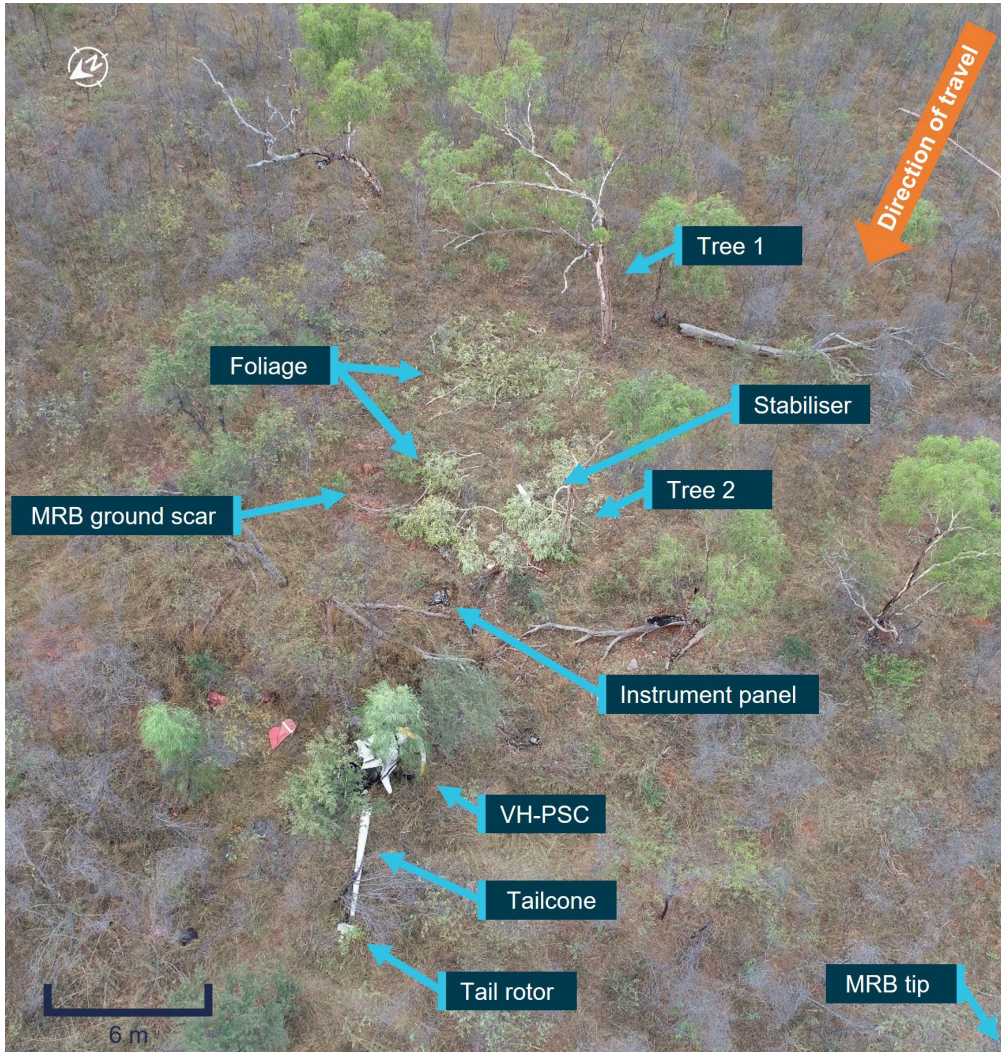
Figure 6: Site overview

The stabiliser assembly, with branch impact damage, was located just prior to Tree 2, the base of which exhibited impact damage and black paint transfer consistent with the landing gear. Pieces of windshield, the instrument panel and other forward fuselage components were located in the impact zone at the base of Tree 2. Fallen foliage was cleared from around Tree 2, and a distinct main rotor blade (MRB) ground scar was identified, with tip components embedded at the start. The fuselage came to rest, upright and to the right of a small tree, with the detached tailcone assembly nearby (Figure 6). The outboard section of the other MRB (MRB tip) had liberated during the tree strikes and was located about 40 m to the left of the debris trail. Rotary fuel hand pump components were located in the vicinity of the fuselage.
