In-flight upset involving Boeing 737-8FE, VH-YQR

143 km west of Ballina/Byron Gateway Airport, New South Wales
on 6 September 2023

ATSB Transport Safety Report

AO-2023-042

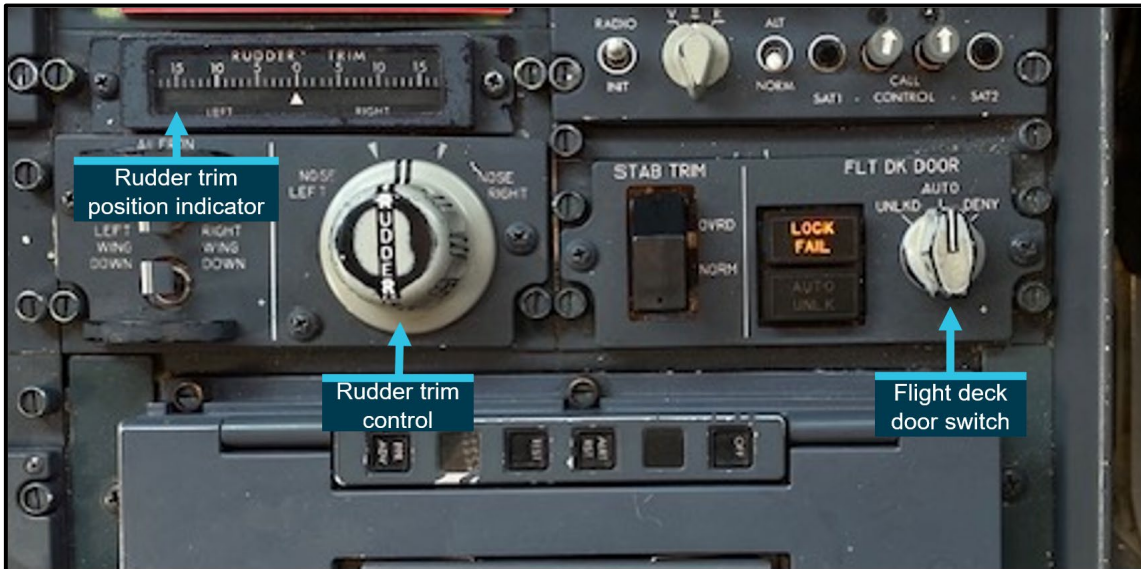
Figure 3: Rudder trim and door lock switch

However, just prior to grasping the switch, the PM transferred their gaze from the aisle stand to the rear of the flight deck and to the door. In doing so, they inadvertently grasped and, at 1625:22, activated the rudder trim control to the full left position instead of selecting the FLT DK DOOR switch.

The rudder trim control (Figure 3), located on the aft electronic panel (Figure 1), adjusted the rudder's neutral position by electrically positioning the rudder. The rudder pedals are also displaced proportionately to any rudder trim adjustment. The rudder trim indicator displayed the rudder trim position in non-dimensional units.

The rudder trim control was spring-loaded to return to the neutral (centre) position and activation was through rotating the control in the direction of required trimming. The trim control was a circular rotary switch with segmented straight knurling.

As it was routine to operate the door switch, the PM probably did not give sufficient attention to this task. This was further compounded by the physical similarities in the switches and their operation, and their co-location on the aisle stand panel. However, a Boeing human factors examination of possible mitigations to these factors in response to a similar previous occurrence found that changing the switch design was unlikely to mitigate the mis-selection risk, and that the current generic aisle stand configuration and an emphasis on confirmation of switch selection prior to manipulation was the most effective control measure. Finally, Boeing identified the risk of unintentional rudder trim application in an FOTB issued to operators 2 years prior to the occurrence. The FOTB specifically acted as an alert to flight crew of the risk of mis-selection of rudder trim in circumstances identical to those in this incident.

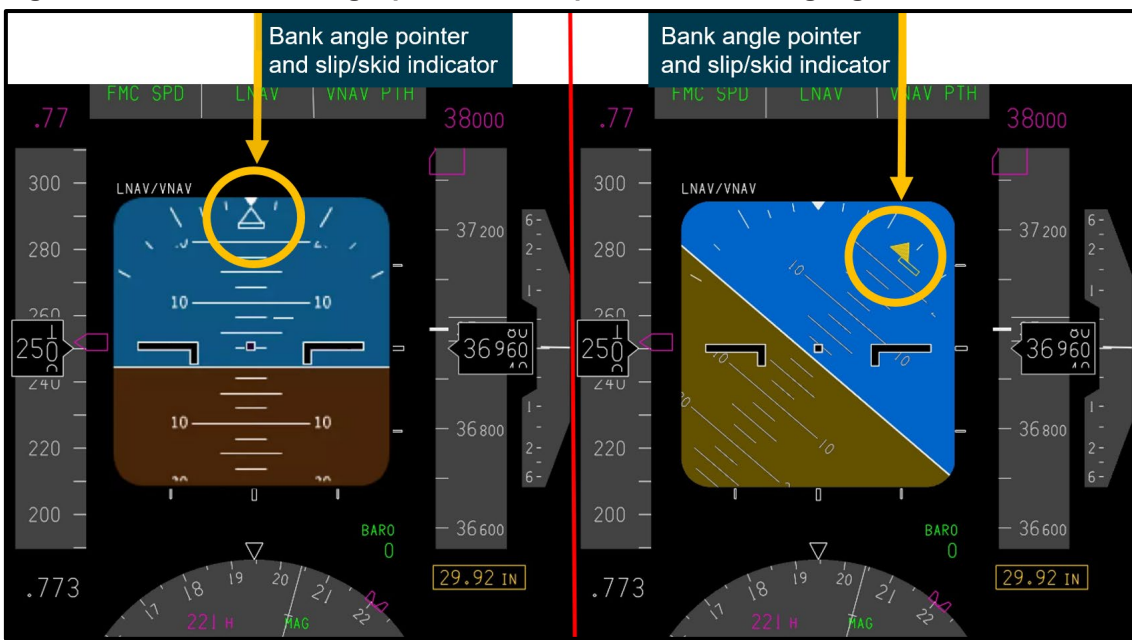
Figure 4: PFD with bank angle pointer and slip/skid indicator highlighted

The outline of the slip/skid indicator will turn amber when the aircraft is banked to 35° or more (see right panel of Figure 4). The indicator turns solid white when at full scale deflection and the bank angle is less than 35°, and solid amber when at full scale deflection and bank angle is 35° or more.

Boeing provided a simulated recreation of the occurrence event’s PFD indications at the maximum bank angle of 42° (right panel of Figure 4). The recreation showed that the bank angle indicator and outline of the slip/skid indicator had turned amber, but the slip/skid indicator was not at its maximum displacement and therefore not solid amber.
