Foreign object debris event involving Airbus A380, VH-OQI

Los Angeles International Airport, United States on 1 January 2024

Aviation Occurrence Investigation (Short)

AO-2024-006

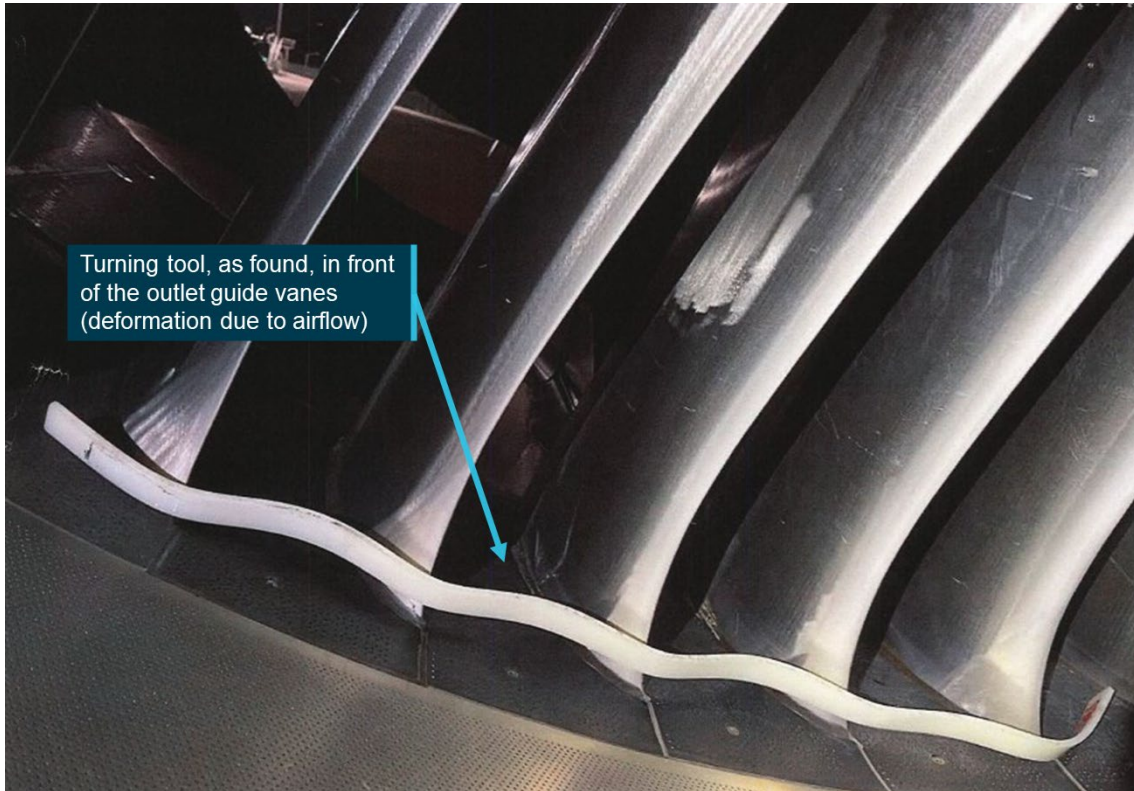
Figure 1: Location of the turning tool as found in front of the low-pressure compressor outlet guide vanes

The turning tool was found behind the rotating low-pressure compressor blades, in approximately the 6 o'clock position (Figure 1 and Figure 2). It had been deformed by high energy airflow around the low-pressure compressor outlet guide vanes (non-rotating). There was no damage observed to any engine components.

The turning tool was last used by engineering staff to turn the compressor during a borescope inspection and found wedged against the low-pressure compressor outlet guide vanes and deformed by engine airflow. It is likely that this is where the tool was left as, if the turning tool was left in front of the low-pressure compressor, it would likely have displayed more damage from passing through the rotating low-pressure compressor blades during engine operation and been more visible to AME 2 and LAME 1 during their foreign object inspections.
