# Fuel exhaustion involving Aero Commander 500-S, VH-MEH

6 km east of Bathurst Airport, New South Wales on 8 March 2024

## **ATSB Transport Safety Report**

AO-2024-008

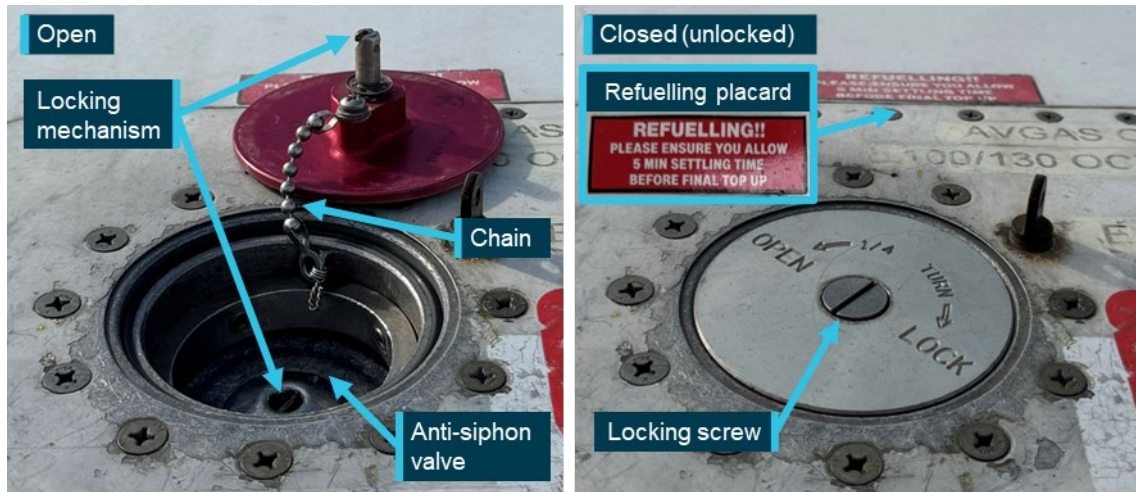
**Figure 2: Fuel cap and filling point components (not incident aircraft)**

The maintenance engineer inspected the fuel cap and found that the chain securing the fuel cap to the inside of the filler neck had disconnected from its attachment point and lodged under the anti-siphon valve, holding it slightly open. This also prevented the fuel cap locking mechanism from engaging. The engineer removed the chain from its lodged position, re-attached it to the filler neck, and successfully closed and locked the fuel cap. They also observed minor blue fuel dye

Any obstruction preventing the anti-siphon valve from closing would provide an opening for fuel to vent should the fuel cap become dislodged. Additionally, the fuel cap locking mechanism would be unable to engage as the locking point of the anti-siphon valve would be held away from the locking component of the fuel cap, making it more likely to dislodge.

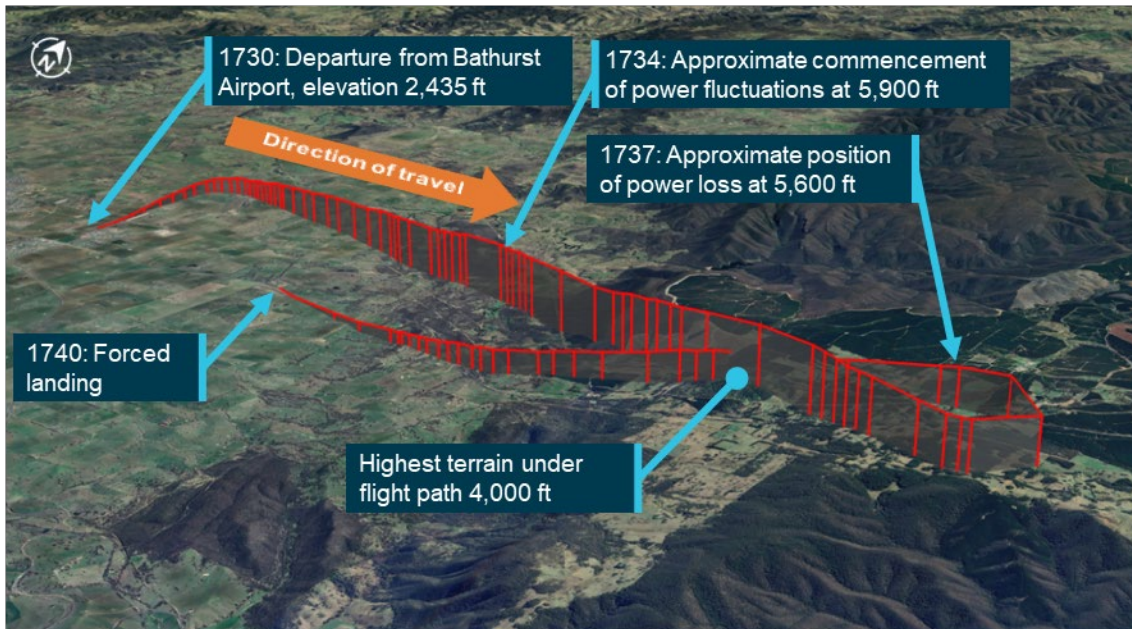
**Figure 4: Incident flight path**

The pilot reported that, approximately 4 minutes after departure, while climbing through 5,900 ft above mean sea level (AMSL), the aircraft yawed<sup>4</sup> significantly to one side, and then shortly afterwards, yawed to the other side. The pilot recalled performing initial engine failure actions, while using rudder to control the yaw as the engine noise and power fluctuated on both engines.

After completing the turn, both engines stopped making power, and the pilot prepared for a forced landing. The pilot selected a large field ahead as a suitable landing area. The pilot elected not to

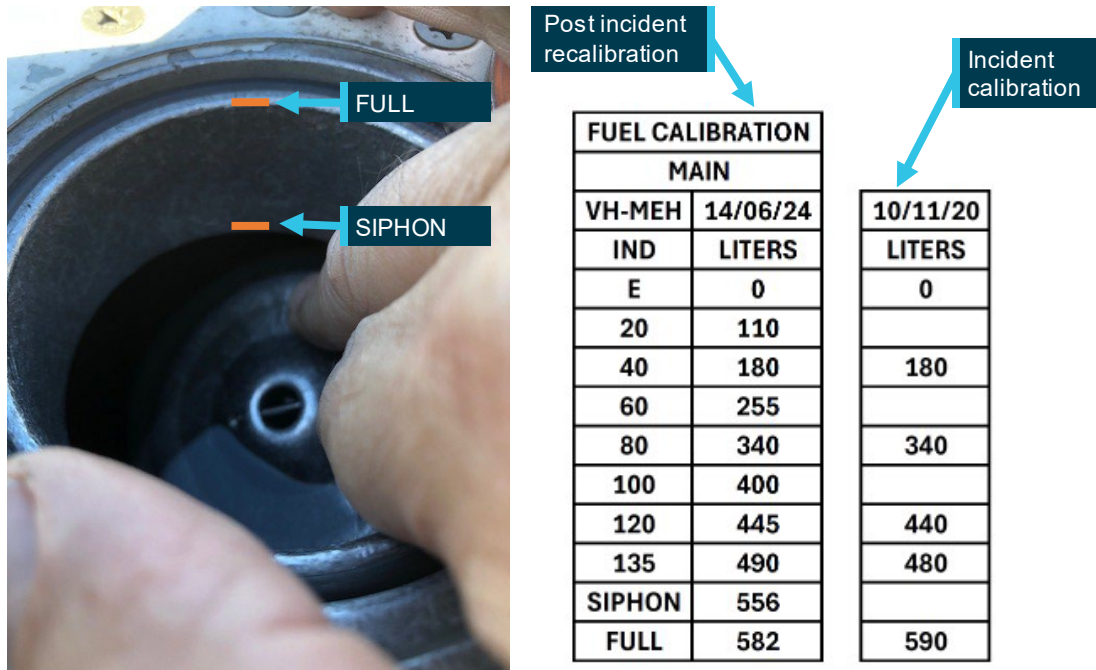
Figure 6: Fuel gauge recalibration and observations (photo not VH-MEH)

The fuel cap was inspected and tested and was found to attach and remain on, with an observation that the retention spring in the locking screw was noted to be in weak condition, meaning that it could be turned by pressure from a finger or thumb rather than requiring a screwdriver. The fuel cap was replaced as a precautionary measure. Inspection and testing of fuel system components and a general inspection on the aircraft found no issues.

Fuel gauge calibration was required to be conducted every 4 years and prior to the incident was last conducted for VH-MEH on 10 November 2020. Before the aircraft was returned to service, the fuel gauge was recalibrated to verify the correct operation of the fuel indication system, and to fulfil the periodic recalibration requirement. The calibration was expanded to 10 increments from the initial 6. Additionally, a new visual fuel level, annotated as SIPHON, was added. Figure 6 shows how these 2 visible levels were observed and compares the re-calibration with the calibration values available to the pilot during the incident flight.

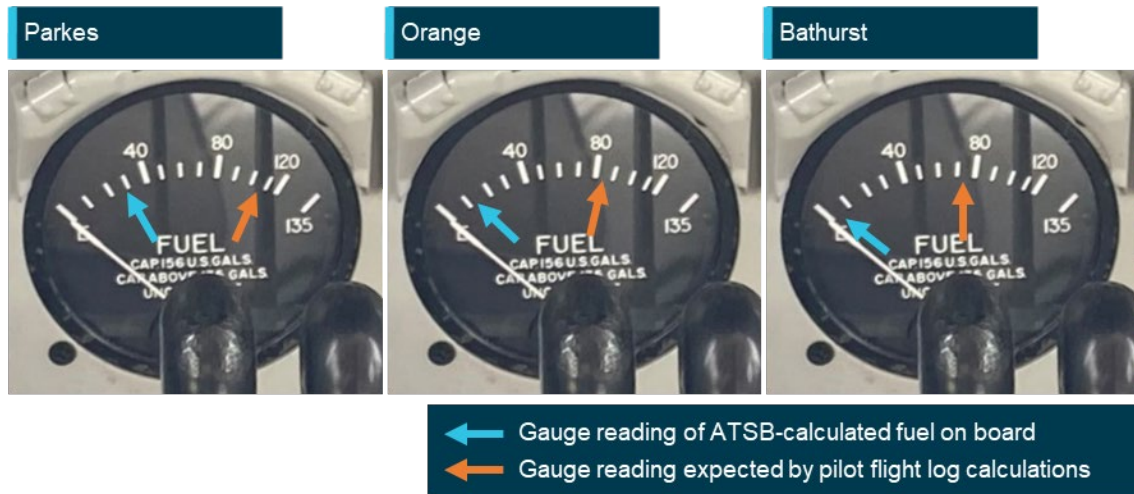
**Figure 7: Pre-departure fuel gauge indications**

The pilot estimated the start fuel to be 560 L based on observing the fuel level 3–4 cm below the anti-siphon valve. Post-incident fuel calibration found the siphon level to be 556 L on VH-MEH and 490 L to be the maximum that could be shown on the fuel gauge. Based on that, the ATSB estimated that initial fuel was between 556 L and 490 L, as less than that would have indicated on the fuel gauge prior to departure. This indicated that the pilot overestimated the initial fuel by up to 70 L.

Based on the unaccounted-for fuel, for each of the return sectors, the fuel gauge reading that would have been showing according to the ATSB-calculated start fuel was compared against the reading expected by the pilot based on their flight log (Figure 7).

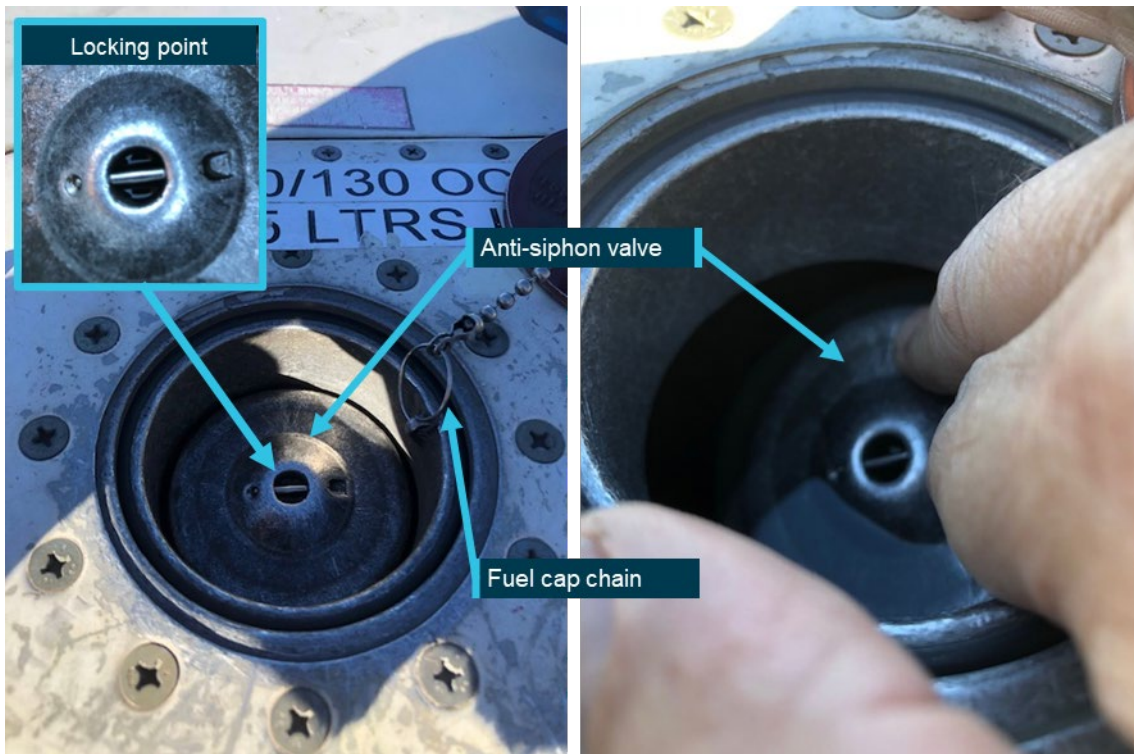
Figure 8: Anti-siphon valve

As the pilot found the fuel cap off and replaced it after landing at both Orange and Parkes airports, it was likely that the fuel cap was also unsecured in-flight during those sectors. The maintenance engineer in Parkes found that the fuel cap chain had been holding the anti-siphon valve slightly open, preventing the fuel cap locking mechanism from engaging, and reported advising the pilot of

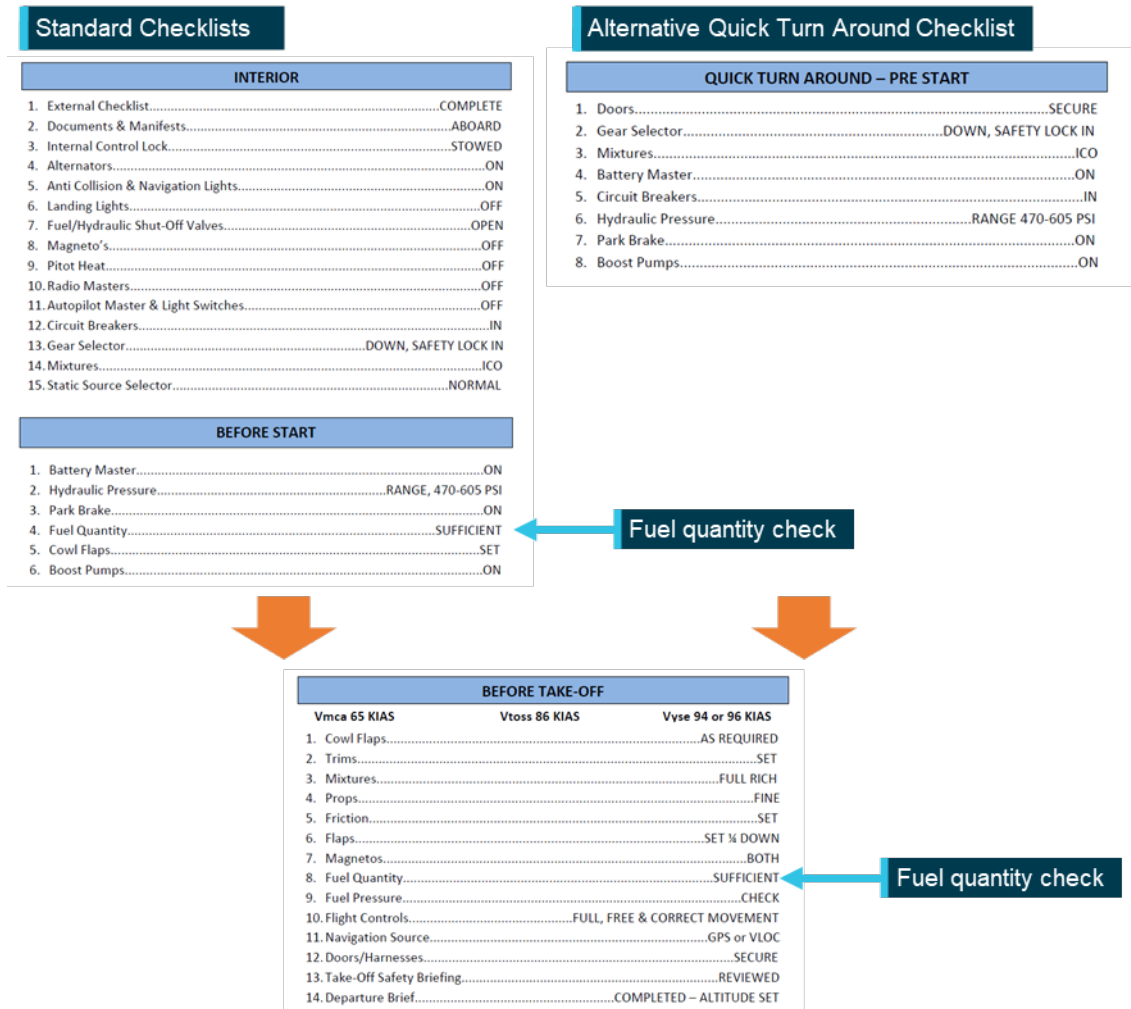
Figure 9: GAM Air Aero Commander 500 checklists

The ATSB also found that GAM Air's Quick Turn Around – Pre-Start checklist did not include a fuel quantity check before start, contrary to the aircraft flight manual's before-start checklist.

To enable expediency during multiple sectors such as cargo operations, the operator provided a QUICK TURN AROUND – PRE-START (QTA) checklist as an alternative to those 2 checklists. The QTA checklist did not include a fuel quantity check. However, regardless of whether the standard or QTA checklists were used before aircraft start, a subsequent fuel quantity check was required to be conducted in the BEFORE TAKE-OFF checklist before the aircraft departed.

The ATSB compared the operator’s checklists with equivalent checklists in the manufacturer’s aircraft flight manual (AFM) (Figure 10). While standard checklists closely followed the checks included in the AFM, several checks were excluded when a pilot conducted the operator’s QTA Checklist.

GAM Air also commenced periodic auditing of pilot fuel calculations and advised an intention to discontinue use of the Quick Turn Around – Pre-Start checklist. The fuel supplier at Bankstown was also reminded of the requirement to let fuel settle when refuelling.
