Wheels-up landing involving Beechcraft King Air B200, VH-XDV

Williamtown Airport, New South Wales on 13 May 2024

Aviation Occurrence Investigation (Short)

AO-2024-031

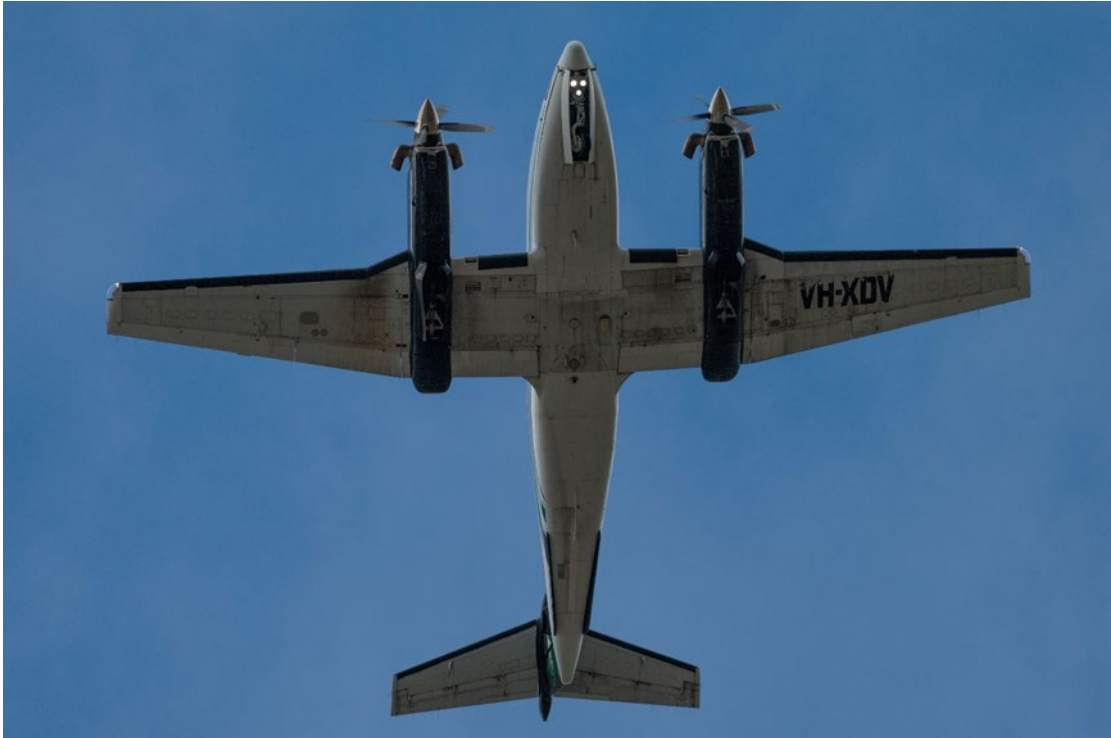
At about 0930, while the aircraft was still in the circuit, the pilot confirmed the problem with ATC and that a wheels-up landing would be required. ATC then upgraded its response to a Level-1 emergency and notified the civil emergency services of the situation. An image of the aircraft as it flew overhead Williamtown Airport was recorded by an observer, it showed the landing gear partially retracted and the nose wheel tilted to the left (Figure 1).

Figure 1: VH-XDV with landing gear partially retracted as it overflew Williamtown Airport

During a normal retraction cycle of the landing gear the nose wheel automatically centres.
 Source: Department of Defence

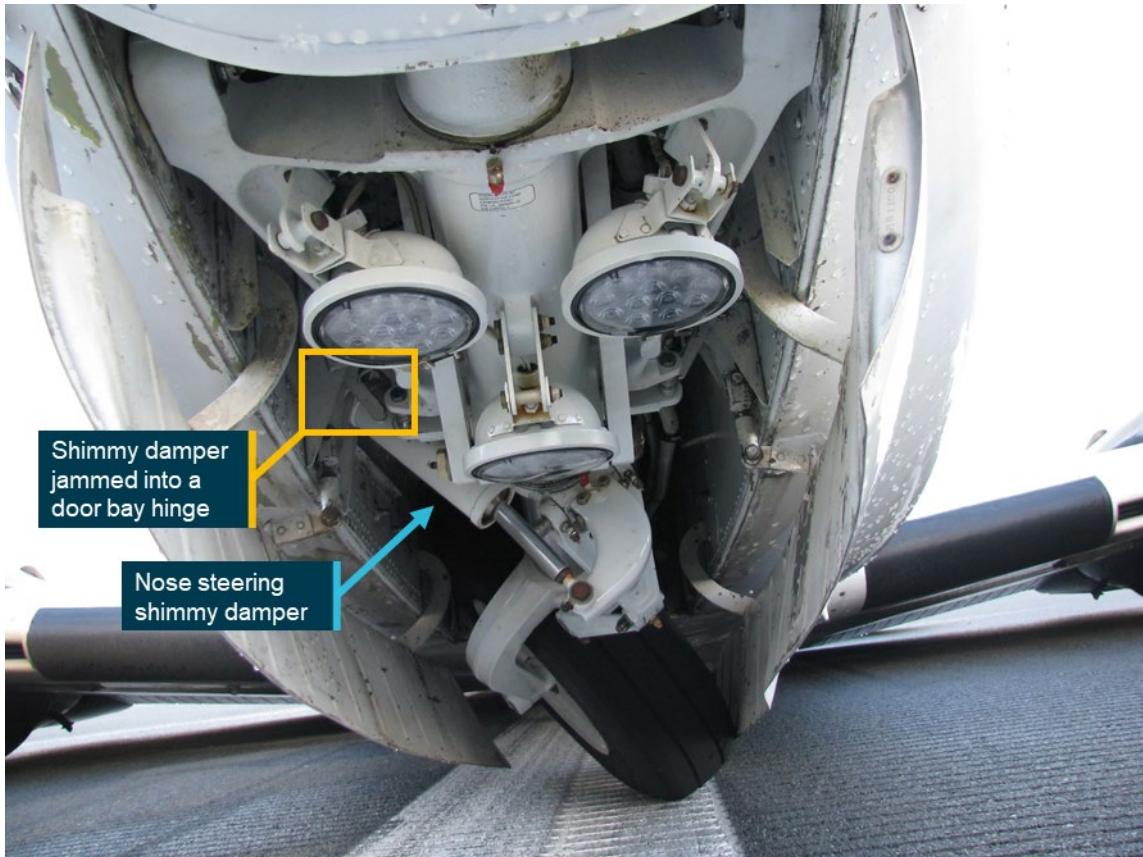
During their examination of the landing gear system, the operator identified that the shimmy damper that was attached to the nose gear leg had become bent and jammed against a door hinge within the wheel bay (Figure 3). A link in the nose steering system had also fractured, resulting in a disconnection between the pilots steering input and the nose landing gear (Figure 4). The steering barrel had bent where it connected to the steering link. The operator's examination of the electrical system identified that a circuit breaker had opened during the incident flight. They commented that this had likely occurred automatically to prevent electrical overload of the landing gear system.

damper remained clear of all components of the wheel bay area. They further identified that the shimmy damper could only contact the wheel bay area if the nose wheel became mechanically disconnected from the steering system. That disconnection enabled the nose wheel to rotate left beyond its operational limit sufficiently for the shimmy damper to contact the undercarriage door bay area during the nose gear retraction sequence.

Figure 3: The nose landing gear tilted to the left with the shimmy damper jammed against a hinge in the undercarriage bay

The ATSB’s visual examination of the shimmy damper identified that it had sustained bending of the centre shaft. The body of the shimmy damper also contained a significant gouge. The location of that damage was consistent with the operator’s reporting and the post-occurrence photographs that the shimmy damper had become wedged against a door hinge in the nose wheel bay.

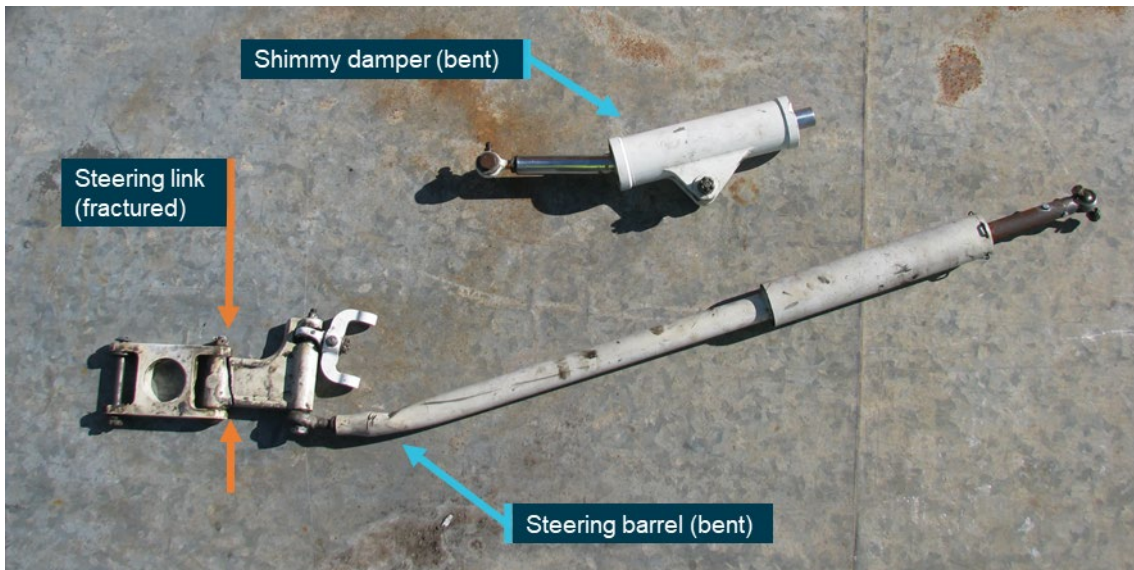
Figure 4: Damaged nose gear steering components

Following replacement of the fractured steering link, functional testing of the landing gear was completed as part of the operator's fault-finding investigation. That testing showed that, under normal circumstances during a landing gear retraction sequence, the nose steering shimmy

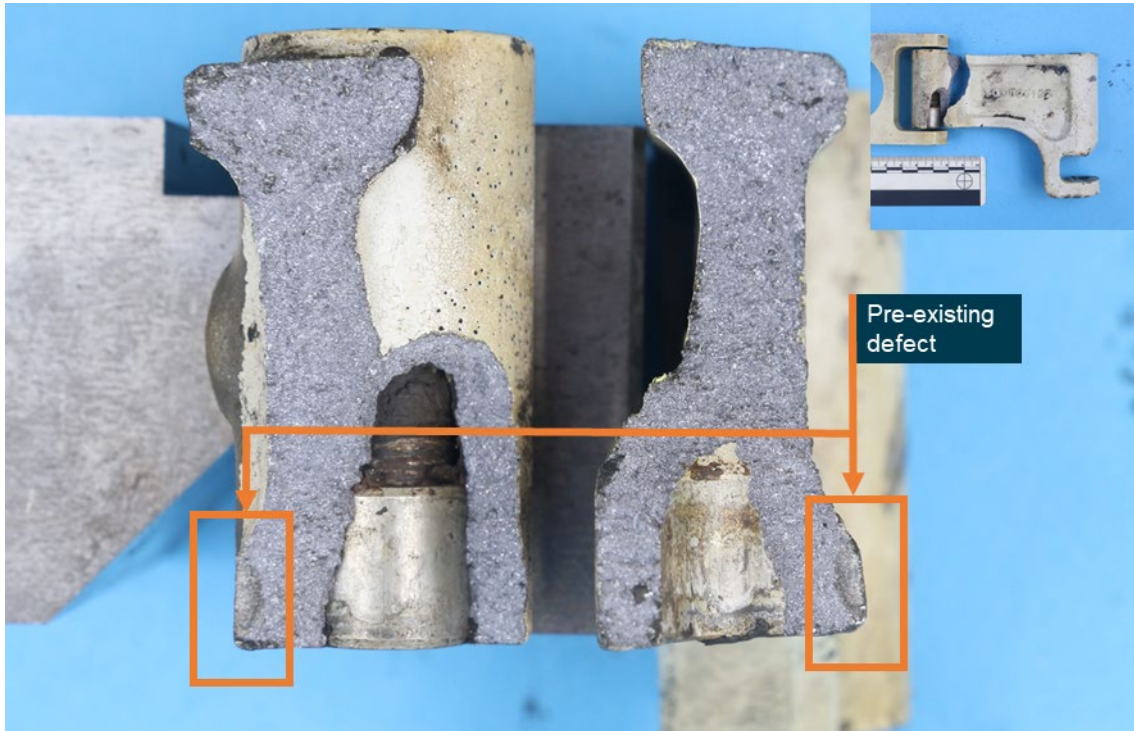
The aircraft manufacturer indicated the steering link had been cast from an aluminium alloy, which was confirmed through chemical analysis of the part by the ATSB. General visual examination of the steering link fracture surfaces was followed by detailed high-magnification examination using a scanning electron microscope. A semi-circular feature was identified on the steering link fracture surface and its aspects were consistent with that of a pre-existing defect (Figure 6). Surface staining on the defect area was also consistent with the development of corrosion.

The origin of the fatigue cracking was associated with a region of porosity at the component surface. The porosity was a manufacturing flaw that had been introduced during the casting process. The remainder of the fracture surface was comprised of brittle features produced during overstress of the steering link.

Figure 6: A semi-circular pre-existing defect (labelled) was identified on both halves of the steering link fracture surface

ATSB's laboratory examination of the steering components identified the presence of a fatigue crack on the fracture surfaces of the steering link that had initiated from a surface flaw. The pre-existing, high-cycle fatigue crack was small in comparison to the overall steering link cross section, indicating that the final fracture likely occurred over a relatively short number of loading cycles.

The operator further advised that it is reviewing its B200 maintenance program to consider including a non-destructive inspection of the steering link, which would be additional to the manufacturer's existing maintenance requirements.

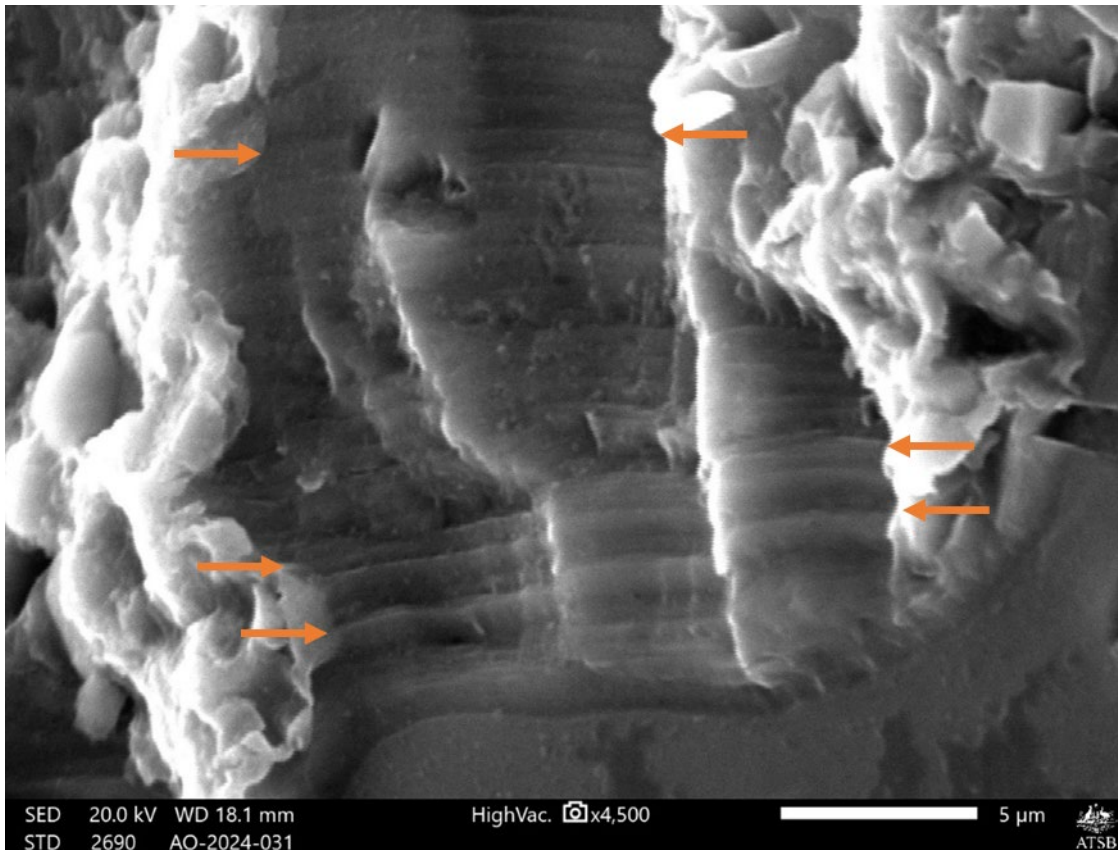
High-magnification imagery confirmed the presence of very fine crack progression striations throughout the defect area (Figure 7). The striations confirmed that a fatigue crack had progressed into the steering link prior to its complete fracture.

Figure 7: Microscopic striations (arrowed) were identified on the steering link fracture surface within the region of the pre-existing defect

The above image was captured using a scanning electron microscope at x4,500 magnification
Source: ATSB
