Collision with building involving Robinson R44 II, VH-ERH

Cairns, Queensland on 12 August 2024

Aviation Occurrence Investigation (Short)

AO-2024-046

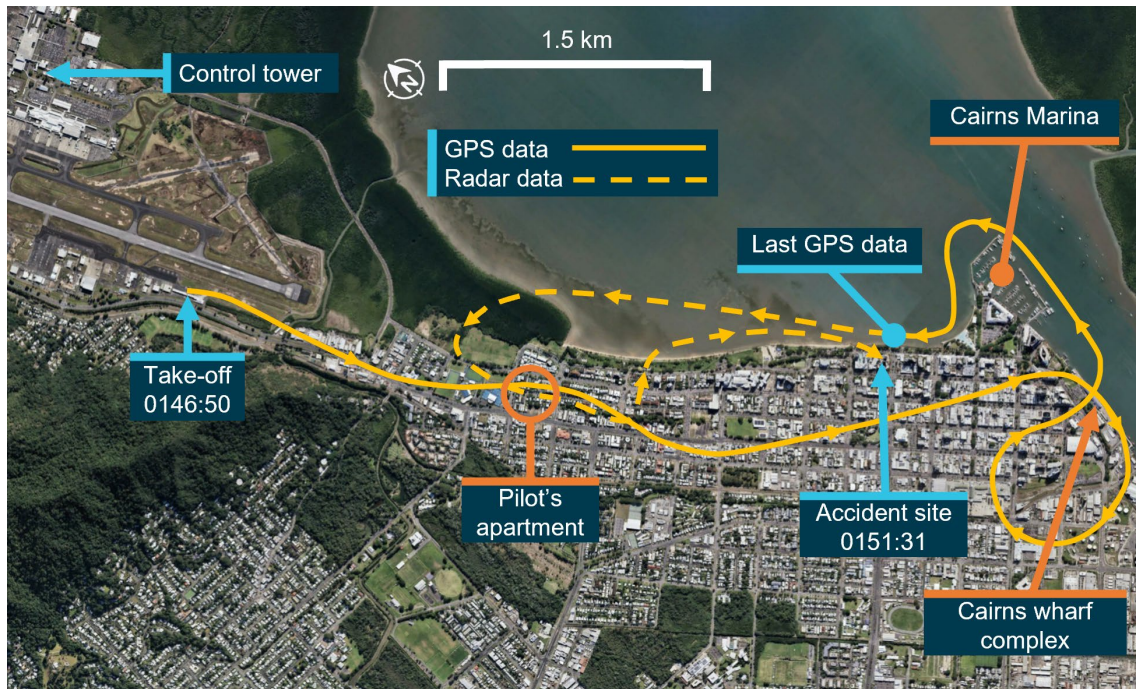
Figure 1: Flightpath of VH-ERH

Position data (Figure 1) from an onboard global positioning system (GPS, see *Recorded data*) showed the helicopter tracking along a highway towards the city, before making a slight turn to a new track that corresponded with the location of the pilot's shared apartment. The helicopter then turned to the right and tracked directly to the northern end of the Cairns wharf complex. The helicopter orbited the complex then headed north towards the Cairns marina and continued along the coastline. Recorded data from the GPS ended about 70 seconds prior to the collision.³

Ground-based radar data recorded by Airservices Australia (see *Recorded data*) showed the helicopter's track crossing from the coastline and flying over the pilot's apartment a second time. The helicopter circled back towards the coastline, following it for about 1 km before crossing the coastline again. The helicopter's altitude did not exceed 500 ft throughout the flight.

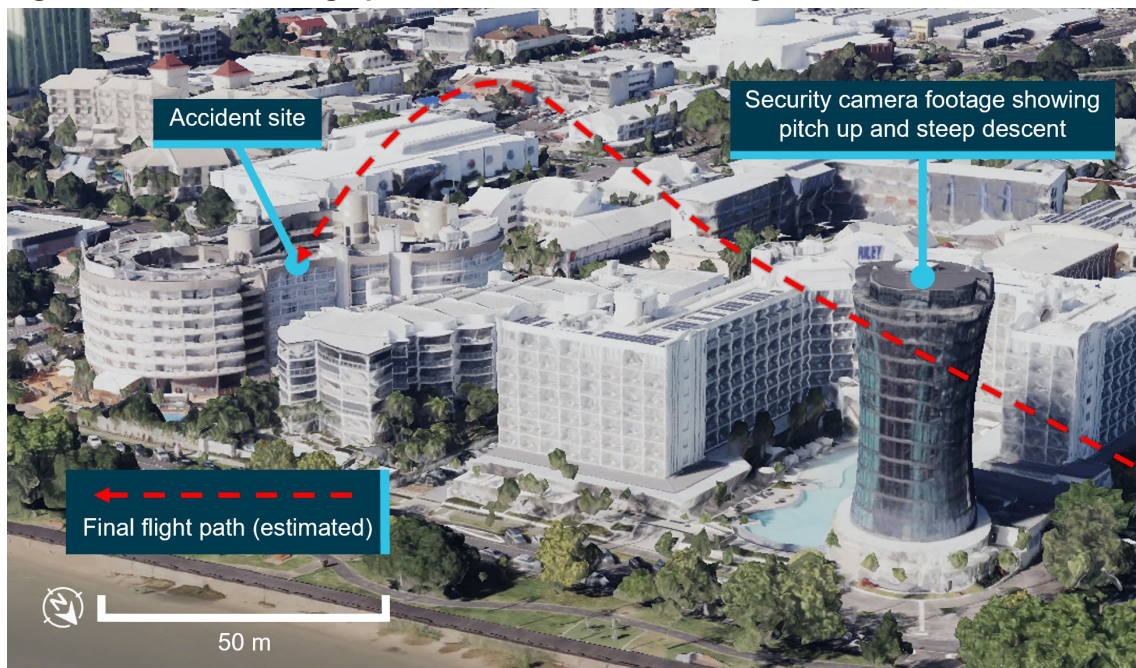
Figure 2: VH-ERH final flightpath and collision with building

Two security cameras recorded very brief portions of the final part of the flight (Figure 2). These show the helicopter pitching up, then almost immediately descending steeply before colliding into the roof of the hotel at about 0151:31.

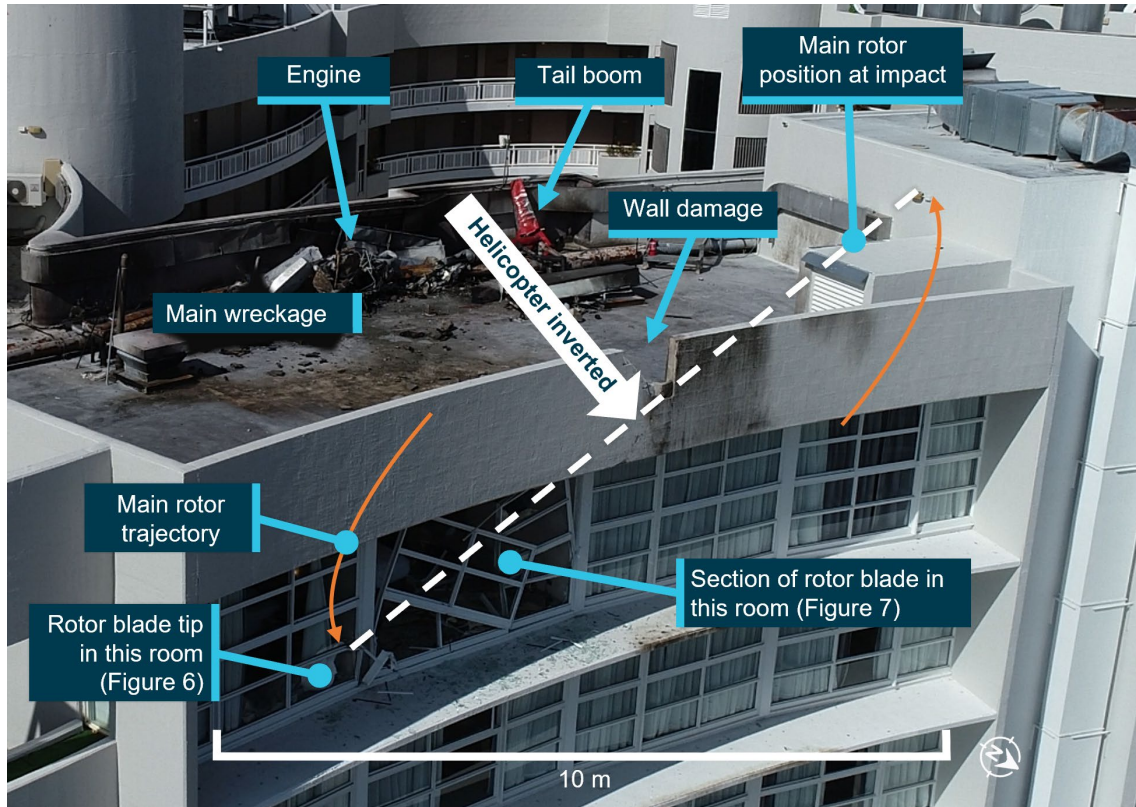
Figure 3: Impact location and hotel room damage

The distribution of the wreckage and impact marks (including the main rotor impact marks underneath the accident site) indicated that the helicopter was inverted at impact (Figure 3). Most of the helicopter, including its skids, came to rest on the hotel roof and was destroyed by impact forces and a fuel-fed post-impact fire.

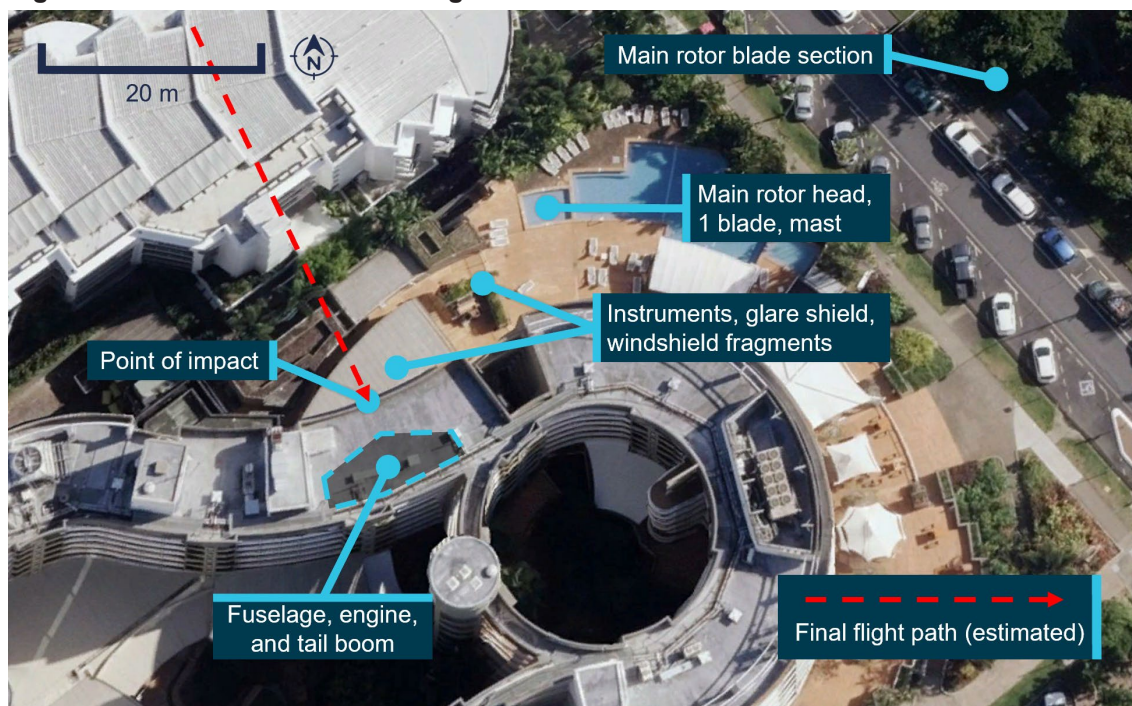
Figure 4: Accident site and wreckage distribution

Parts of the main rotor were found in the rooms underneath the accident site. The helicopter instrument panel, glareshield-mounted GPS, mast, main rotor head and blades were separated from the helicopter's fuselage during the accident sequence. They were located within the hotel grounds below the impact location. The remaining portion of the rotor blade that impacted the windows was found in parkland across the road from the hotel (Figure 4).

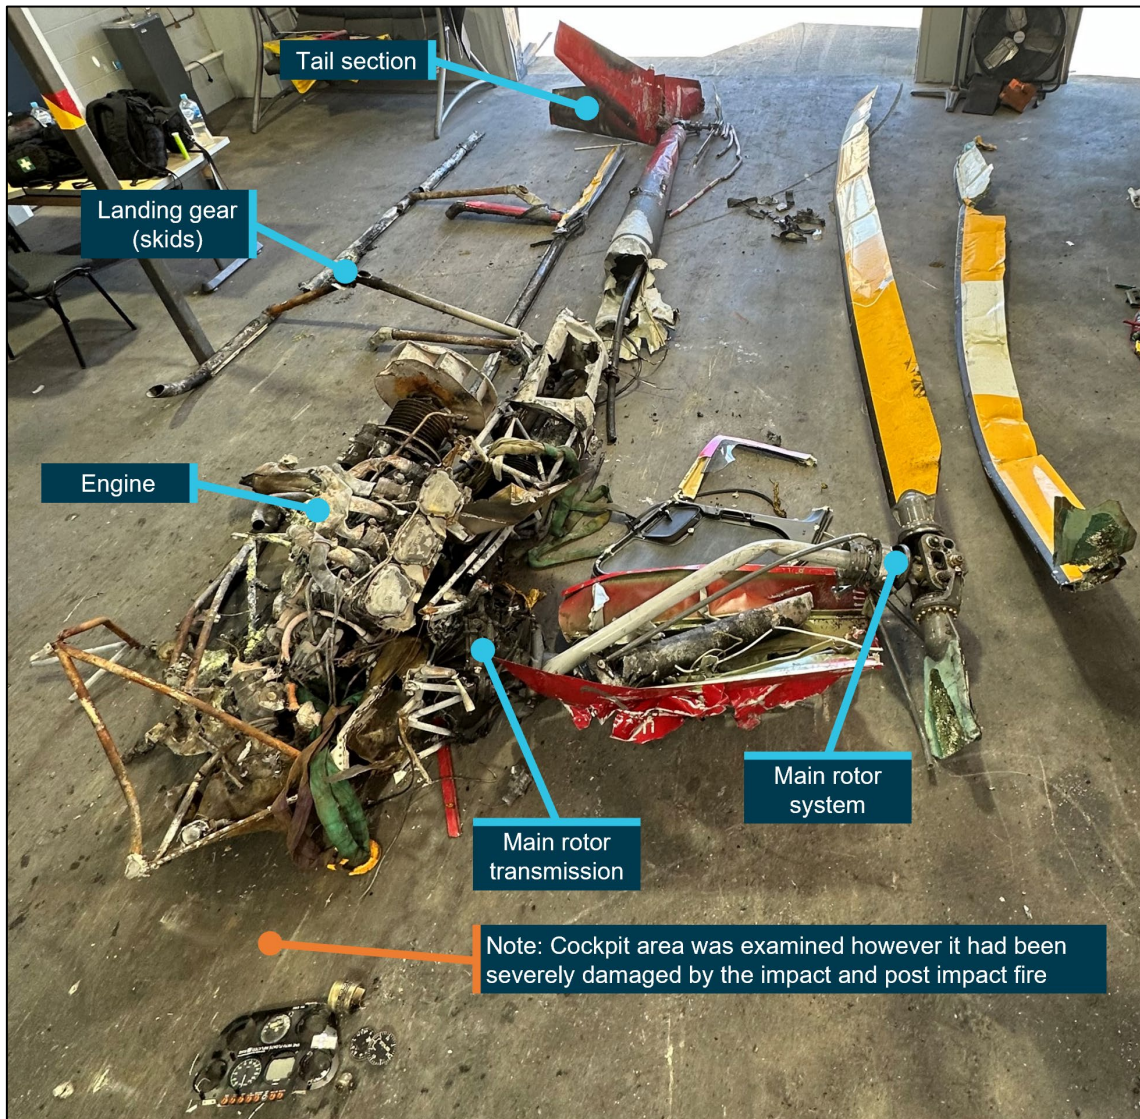
Figure 5: Examination of wreckage

The ATSB conducted a basic examination of the helicopter wreckage on the hotel roof and within the hotel grounds. The helicopter was subsequently transported to a secure facility where a detailed examination was carried out (Figure 5).

The helicopter's cockpit, systems and engine were severely damaged by the impact and post-impact fire. Within the limitations of the available evidence, there were no indications of in-flight fire or defects.

- The absence of noteworthy damage to the helicopter's skids indicated that the helicopter did not impact the hotel roof in an upright position.
- There was no evidence of the main rotor contacting the tail boom, which remained intact.
- Marks on one of the engine oil coolers indicated that the engine and ring gear were rotating at the time of impact.
- Where possible, continuity was established with the main rotor, tail rotor drives and flight controls.
- Main rotor blade damage was indicative of the engine driving the main rotors at a high-power setting.
- The helicopter was fitted with bladder fuel tanks, which were breached during the accident sequence, but it was not possible to assess how the tanks were breached.

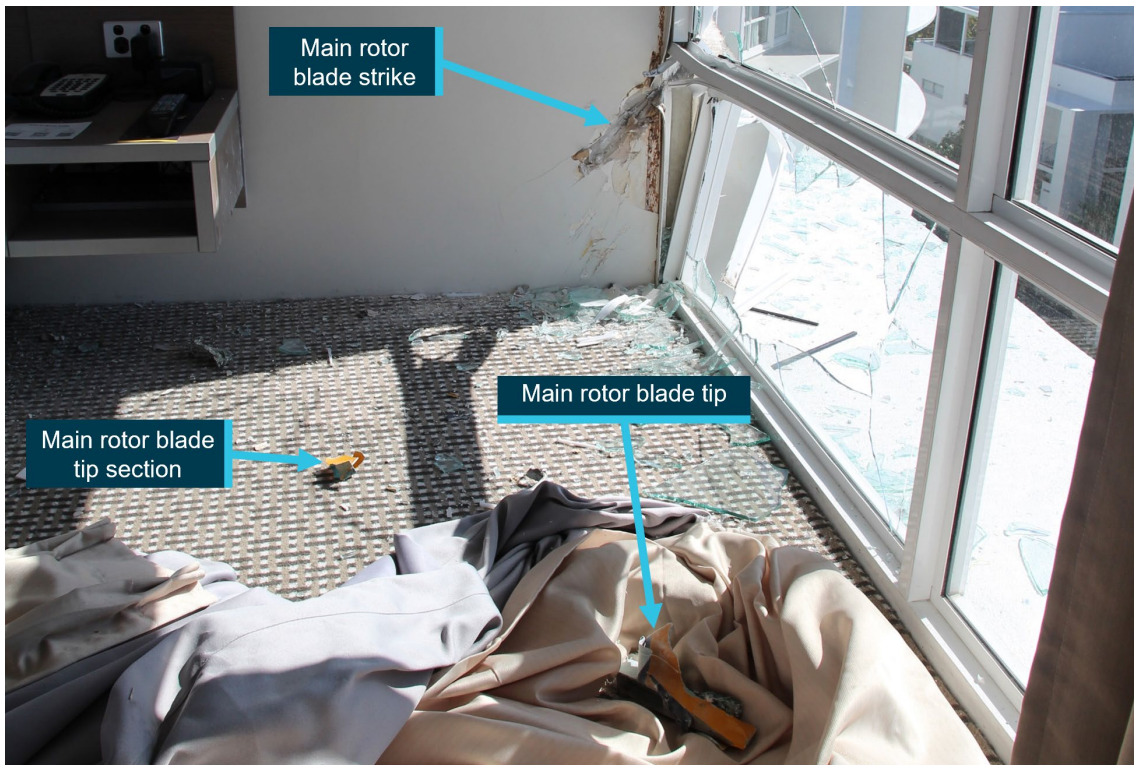
Figure 6: Hotel room damage

A rotor blade tip shattered the window of the room underneath the accident site (Figure 6), and a section from the same rotor blade destroyed the window of an adjacent room (Figure 7).
