# Loss of control and collision with terrain involving Cessna 150L, VH-EYU

Bacchus Marsh aircraft landing area, Victoria, on 22 October 2024

**ATSB Transport Safety Report**  
Aviation Occurrence Investigation  
AO-2024-053  
Preliminary – 16 December 2024

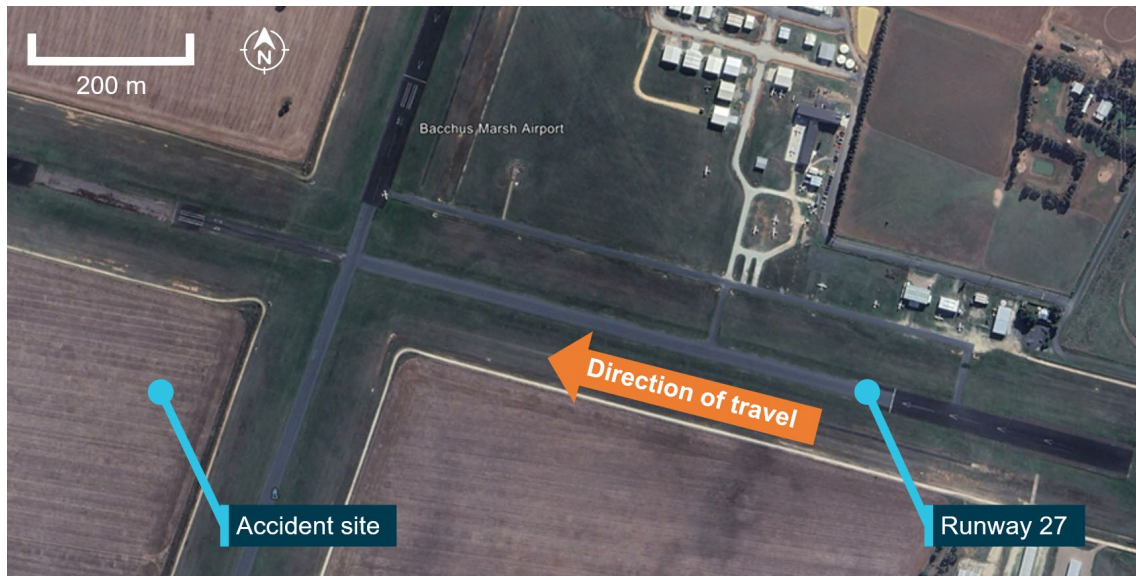
**Figure 1: Bacchus Marsh airfield and VH-EYU accident location**

On 22 October 2024, at about 1110 local time, the pilot of a Cessna 150L registered VH-EYU, commenced the take-off roll on runway 27<sup>1</sup> at Bacchus Marsh airfield, Victoria (Figure 1). Shortly after, the pilot made a radio call stating that they were rejecting the take-off. The aircraft was then taxied off the runway and returned to the threshold of runway 27, where at 1114 the pilot recommenced the take-off.

Several witnesses at the airfield observed the second take-off and identified that, during its initial climb, the aircraft attitude pitched steeply upward. Witnesses described that the left wing dropped rapidly. The aircraft then entered a vertical descent, rotating approximately 270° before colliding heavily with terrain. The pilot (who was the sole occupant) sustained fatal injuries and the aircraft was destroyed. There was no post-impact fire.

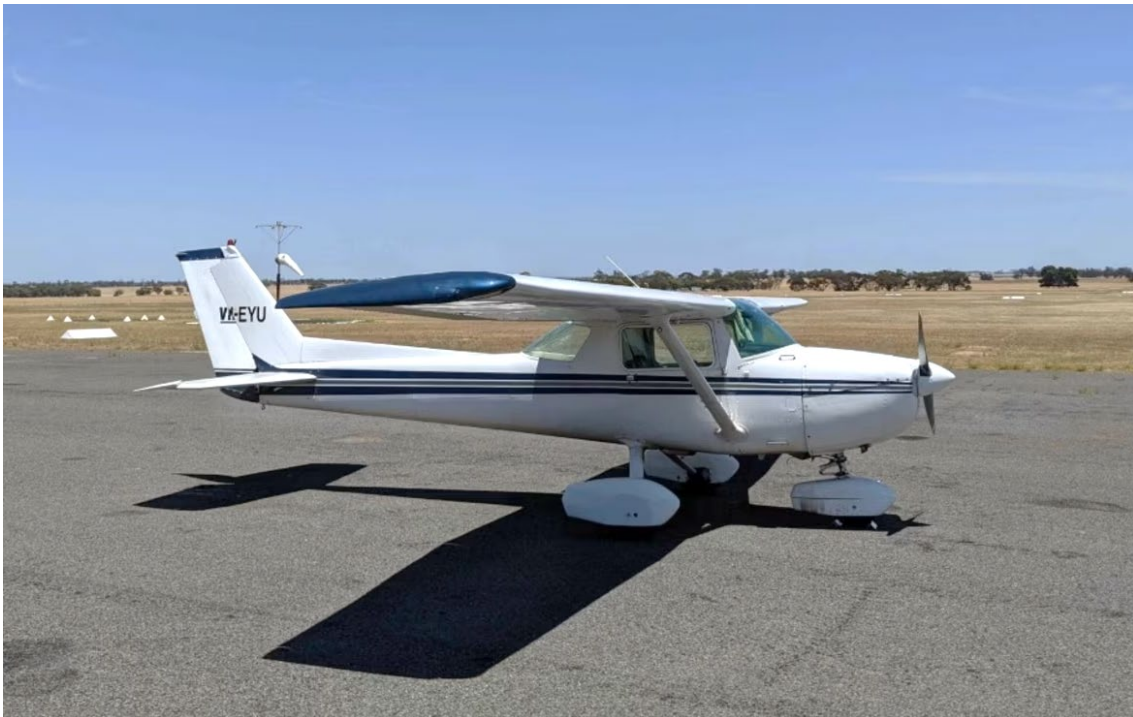
**Figure 2: VH-EYU**

The Cessna 150L is a high wing, all-metal, 2-place, single-engine aircraft with a fixed tricycle landing gear. It is powered by a 4-cylinder Teledyne-Continental O-200-A engine, driving a 2-blade fixed-pitch propeller. The aircraft was manufactured by Cessna in the United States in 1974 and first registered in Australia in May 1974. It had been owned by the Bacchus Marsh Aero Club since December 2023 (Figure 2).

The last 100-hour periodic maintenance inspection was conducted on 19 January 2024. At the time of the accident, it had accrued a total time in service of 8,962.3 hours. The aircraft had flown about 34 hours since the last scheduled maintenance which was conducted on 21 April 2024. There no known defects documented on the aircraft maintenance release.

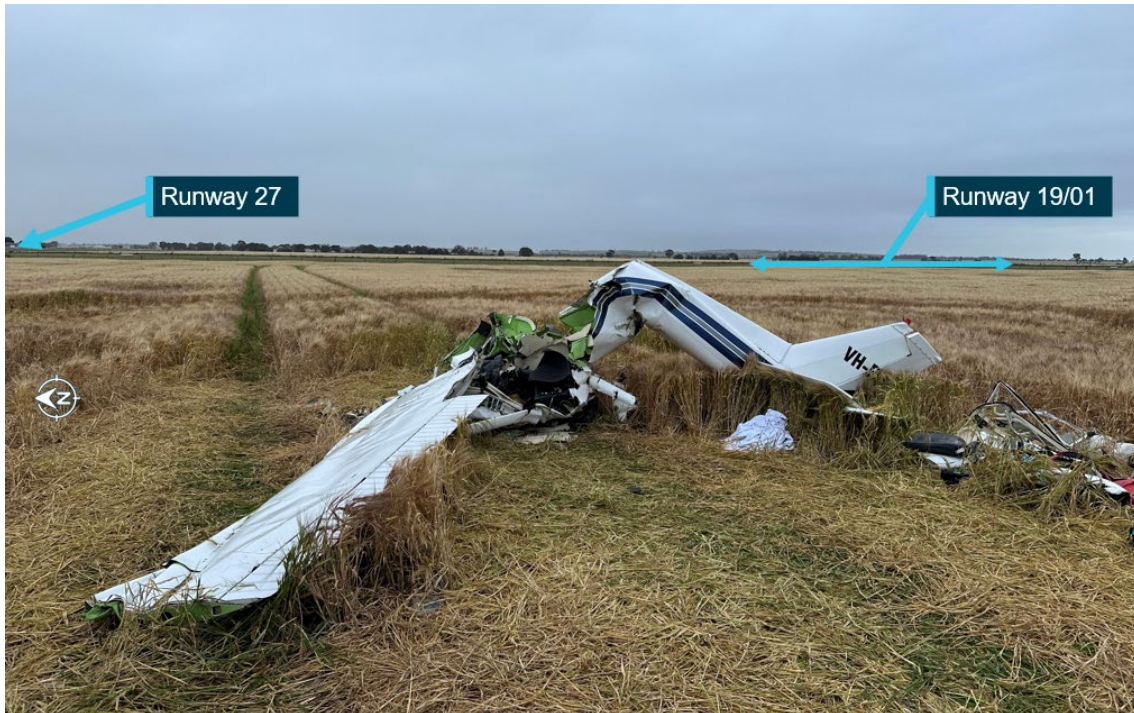
**Figure 3: VH-EYU at the accident site near to the airfield runways**

ATSB investigators first attended the accident site on 23 October 2024. The aircraft had impacted into a barley field 205 m south of the runway 27 centreline and was orientated toward the north. The damage signatures confirmed that it had impacted the field in a steep nose down attitude.

Severe disruption of the cockpit area, the wing assembly and rear fuselage had occurred from the impact (Figure 3).

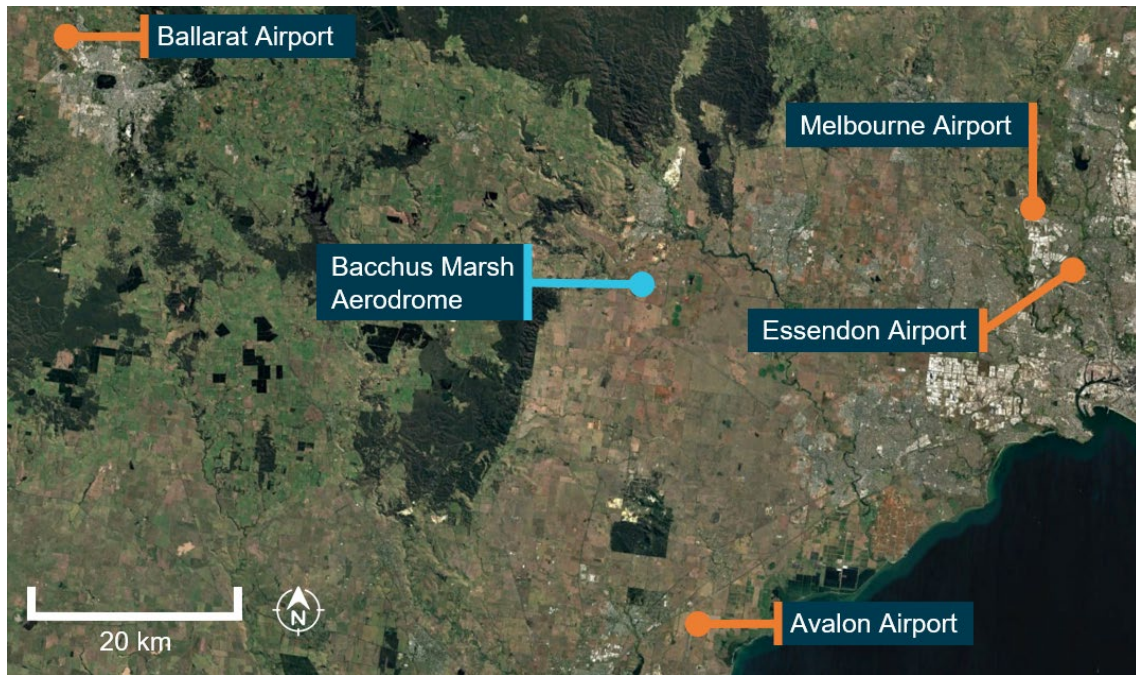
**Figure 4: Location of Bacchus Marsh airfield relative to nearby aerodrome weather forecast locations**

There was no BoM aerodrome weather information specifically for Bacchus Marsh, but the ATSB obtained meteorological observations for the surrounding areas of Melbourne, Essendon, Avalon and Ballarat airports (Figure 4).
