Collision with terrain involving a Morgan Cougar Mk1 aircraft, VH-LDV

19 km north-north-west of West Sale Airport, Victoria on 16 November 2024

ATSB Transport Safety Report
Aviation Occurrence Investigation
AO-2024-058
Preliminary – 18 December 2024

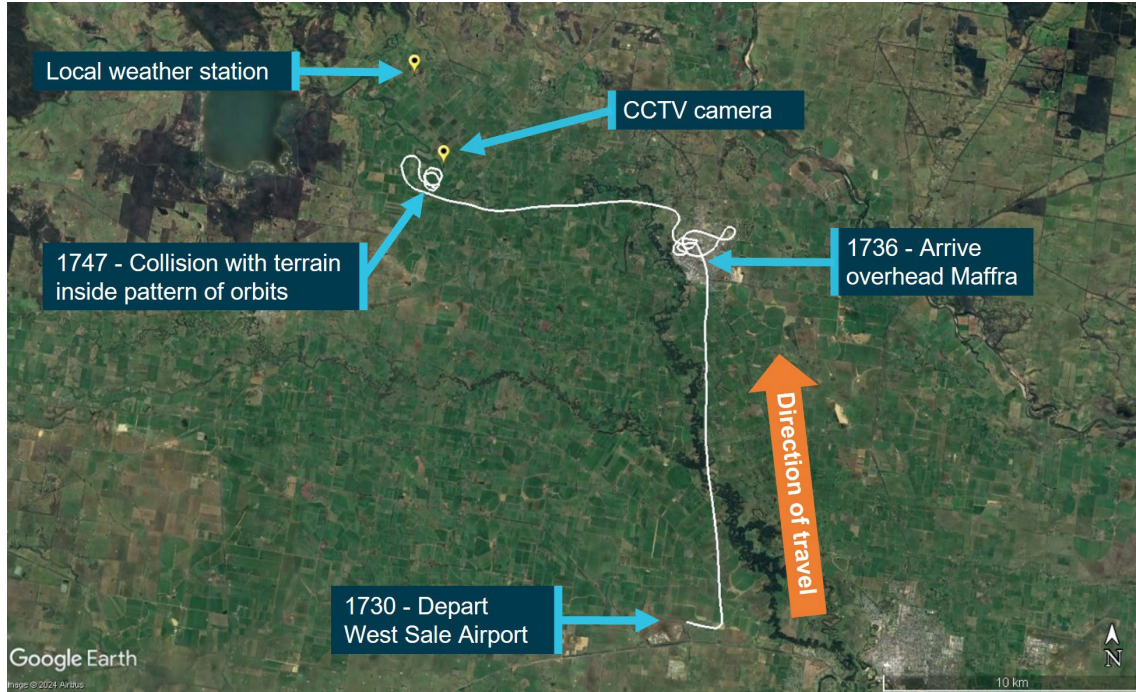
Figure 1: Accident flightpath with key timings and locations

At 1730 local time on 16 November 2024, an amateur-built Morgan Cougar Mk 1 aircraft, registered VH-LDV (LDV) and with a pilot and 2 passengers onboard, departed from West Sale Airport, Victoria for a flight over the local area. Flightradar24 data indicated the aircraft conducted a left turn on departure and tracked 8 NM (15 km) north of West Sale Airport to the town of Maffra. The aircraft arrived overhead Maffra shortly after 1736 where LDV made a series of turns overhead the town for about 4 minutes. At 1740, the aircraft departed from overhead Maffra and tracked about 6 NM (11 km) west-north-west towards Tinamba West (Figure 1).

The aircraft conducted a right-hand turn overhead a property at Tinamba West, which belonged to relatives of the aircraft occupants, before commencing a series of left-hand turns (orbits) around a point about 1 km to the south-east of the property over open paddocks. The last data point was at 1747, after LDV had commenced a third left-hand orbit, which recorded the aircraft at an altitude of 450 ft at a groundspeed of 60 kt on a track of 073° True (T).

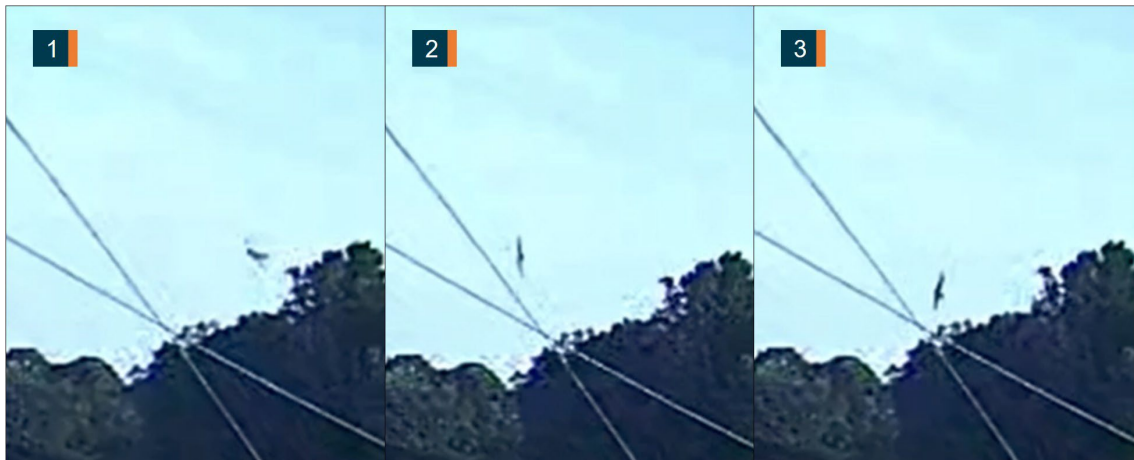
Figure 2: CCTV footage of final turn

A closed-circuit television (CCTV) camera, located about 700 m north-north-east of the accident site, captured LDV in a left turn towards the camera. Subsequently, the nose of the aircraft pitched down and the aircraft descended in the left turn behind trees (Figure 2). About 14 seconds later a plume of dark smoke rose up above the trees. The 3 occupants were fatally injured in the accident and the aircraft was destroyed.

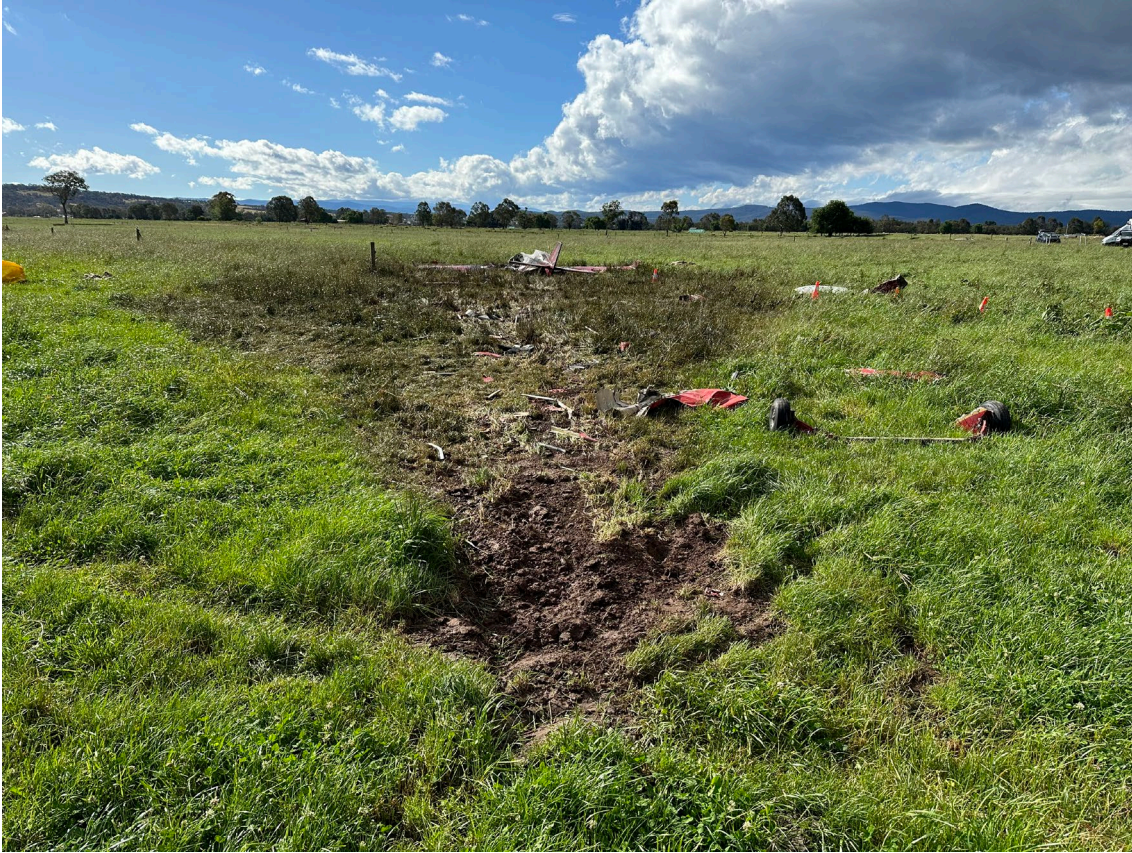
Figure 3: Accident site

The aircraft impacted flat and open terrain at an elevation of about 130 ft and produced a ground scar on a track of 315° T (Figure 3). The length of the wreckage trail was about 30 m from the first ground scar to the propeller spinner, with the fuselage resting on a heading of 303° T. There was a diamond-shaped fuel spray and debris pattern along the wreckage trail.

Fuel was ignited after the ground impact, however, most of the fire damage to the aircraft was confined to the fuselage within the area bounded by the firewall, aft bulkhead (behind rear seats) and the inboard sections of the wings. The wings and tailplane (except the rudder) remained attached to the fuselage. The engine was attached to the firewall and the 3-bladed propeller was attached to the engine. One propeller blade was attached to the hub and the other 2 propeller blades had separated at their roots but were found within the debris field.
