# Grounding of *Hagen Oldendorff*

Port Hedland, Western Australia on 9 April 2022

## **ATSB Transport Safety Report**

MO-2022-007

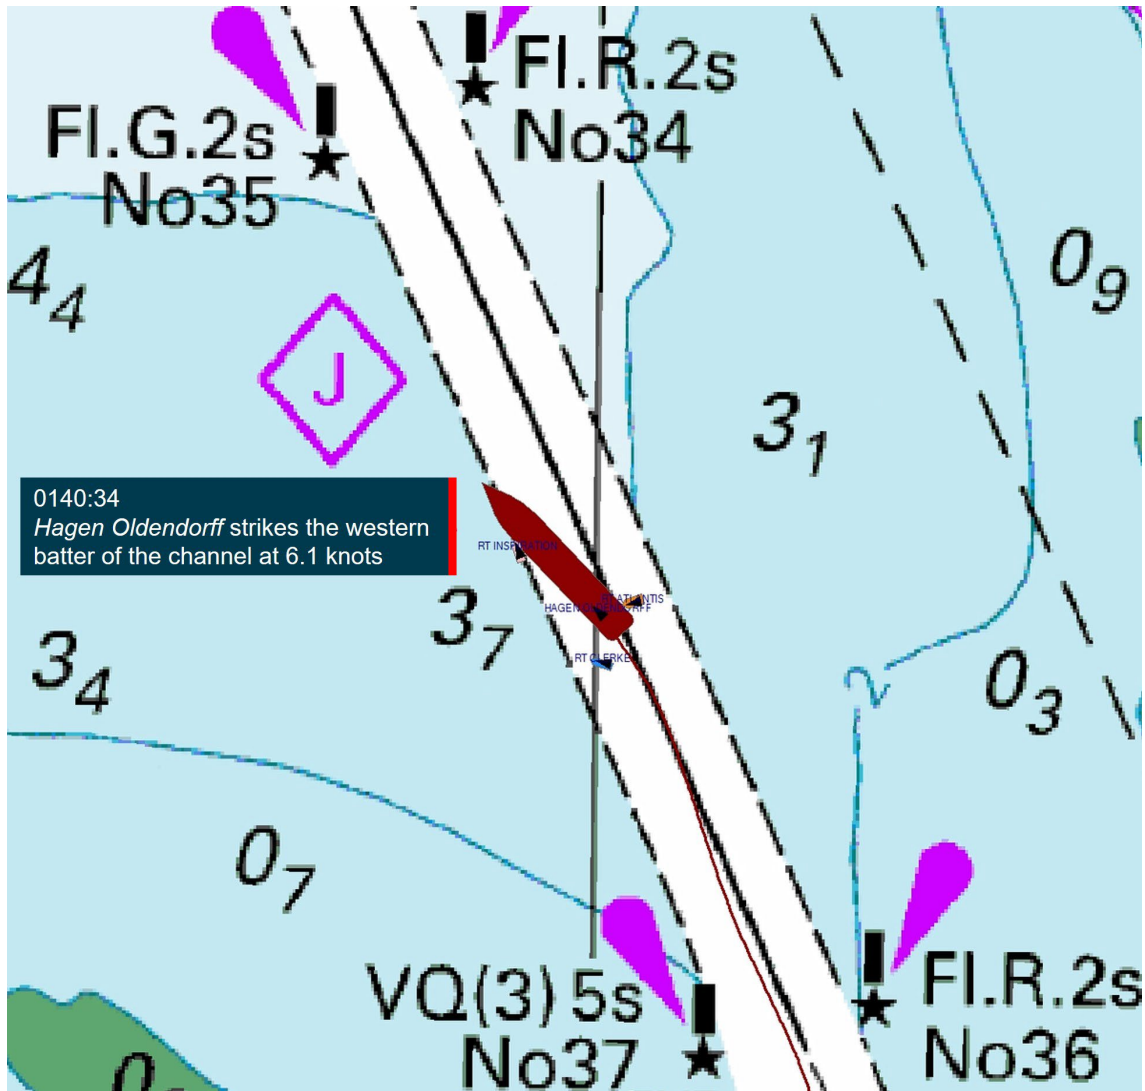
Figure 3: *Hagen Oldendorff* at the time of the grounding

From about 0140:34 onwards, there was a sharp reduction in both the ship's speed and its RoT to port. VDR data confirmed that the ship had contacted the western channel batter (the steep side of the navigable channel), about 4 cables south-east of beacon 35 (Figure 3) at a speed of about 6.1 knots. The ship's bow then swung away from the side of the channel to starboard.

*Hagen Oldendorff* grounded on the western side of the channel in zone 4, between beacons 37 and 35 (Figure 3).

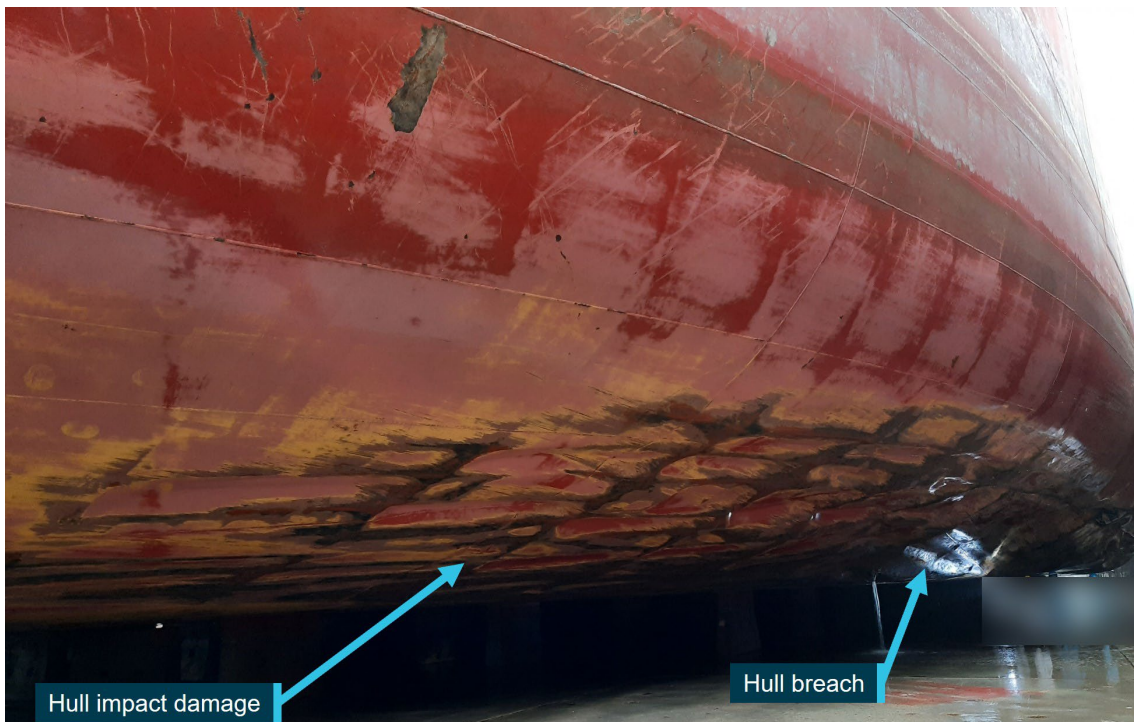
**Figure 5: Damage to *Hagen Oldendorff's* hull**

On 11 April, an underwater hull inspection identified substantial damage to the ship's port side bottom shell plating. The hull was breached in 2 locations – a 0.65 m by 0.95 m breach and a 0.3 m by 0.4 m breach about 10 m forward of the first breach. Additionally, the transverse bulkhead between the 2 tanks had failed, allowing flooding between them. Subsequent inspections also identified extensive impact damage with the most significant damage extending over a length of about 53 m along the forward, port side of the ship's hull near the turn of the bilge (Figure 5). Several structural frames and internal strength members had also buckled or fractured.

On 18 May, following temporary repairs at the anchorage, the ship's flag State (Liberia) approved the ship to undertake a direct voyage to its discharge port in China before proceeding to a shipyard for permanent repairs.

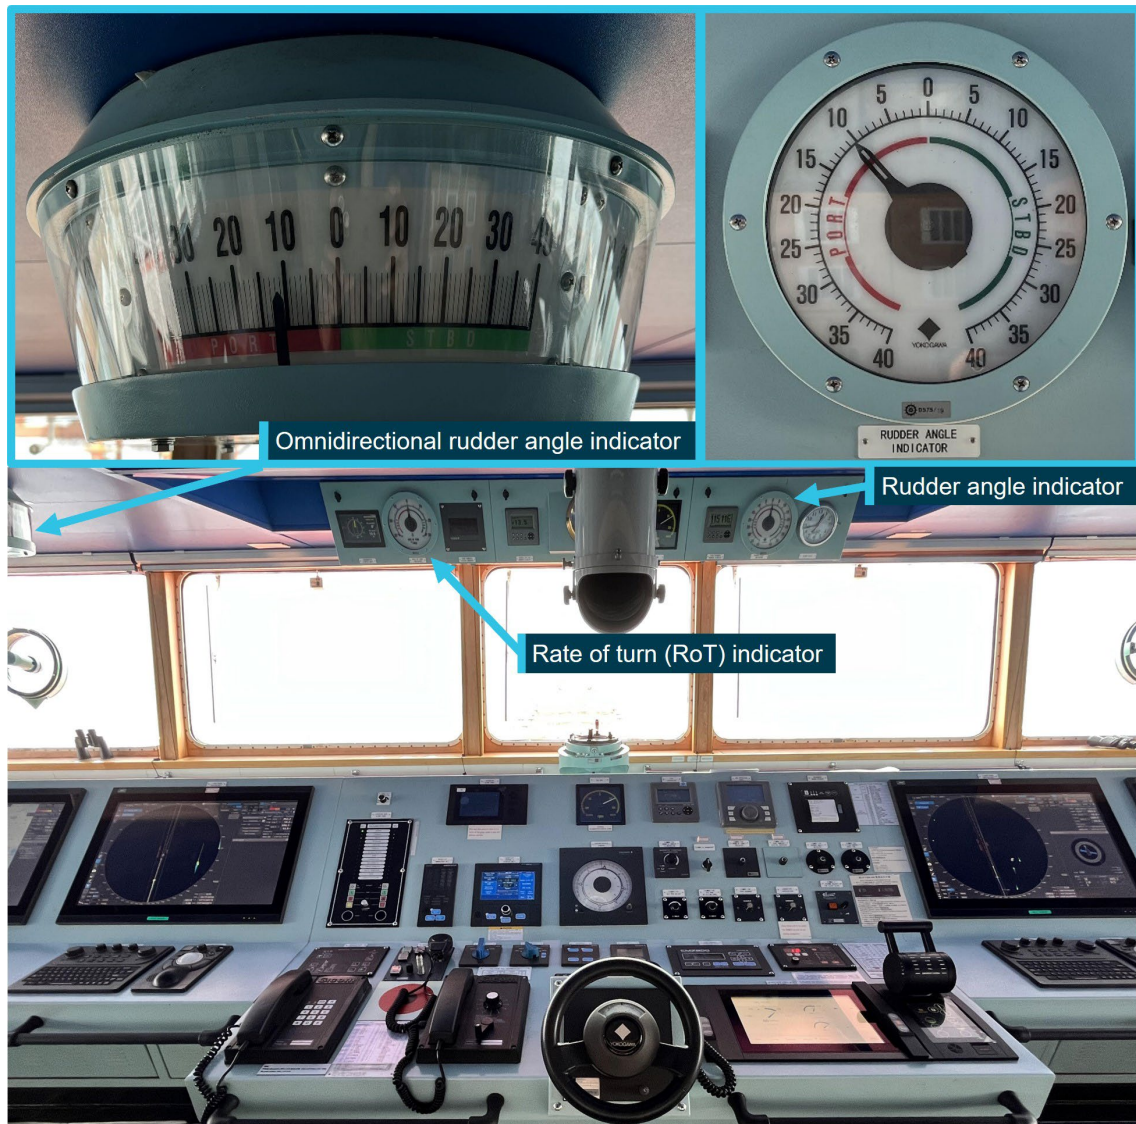
**Figure 7: Hagen Oldendorff's bridge rudder angle indicators**

There were no audible or visual alarms installed to alert crew to the tripping of this breaker or of the loss of electrical power supply to the rudder angle indicators.

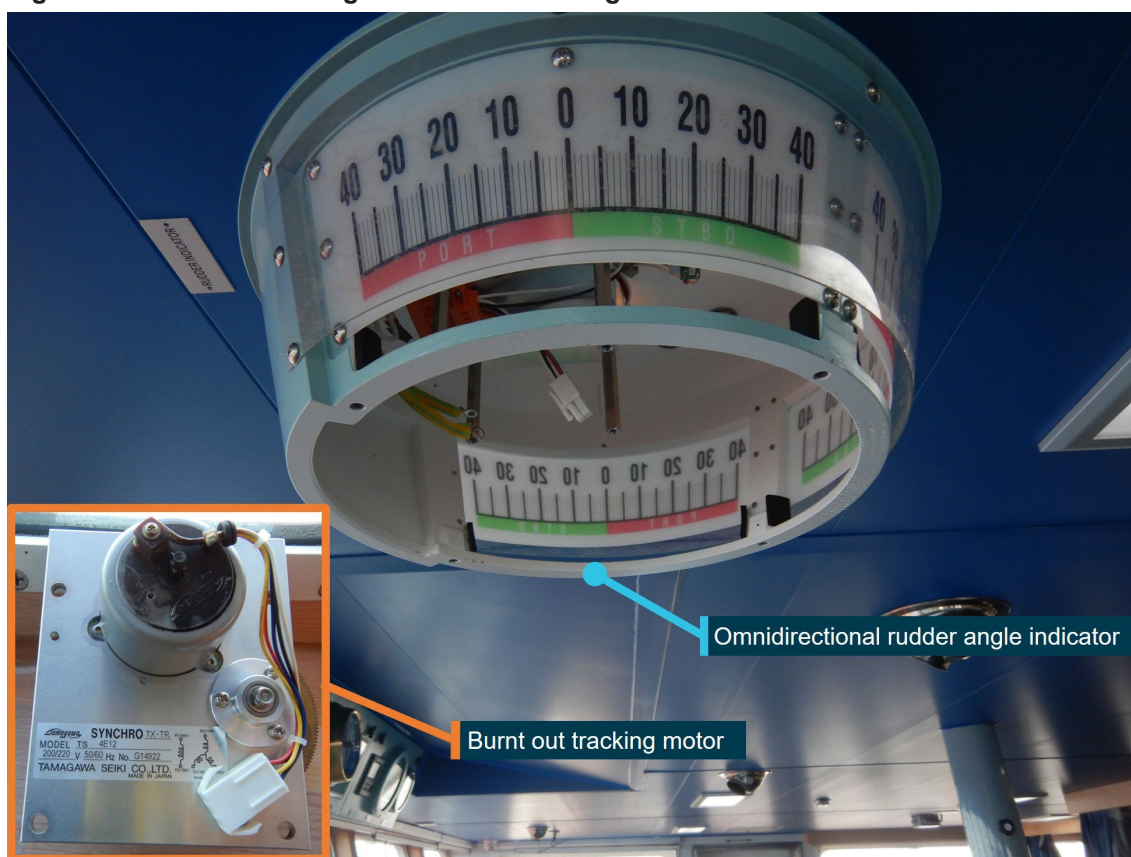
**Figure 8: Burnt out tracking motor of rudder angle indicator**

The post-incident shipboard investigation identified that the tracking motor of the omnidirectional rudder angle indicator (Figure 8, inset) had burnt out and caused a short circuit. This short circuit tripped the common circuit breaker in the bridge cabinet resulting in a loss of electrical power to all the ship’s analogue rudder angle indicators. Consequently, all 6 of the ship’s analogue rudder angle indicators and their associated illumination stopped functioning.

When the omnidirectional indicator was isolated post-incident (when the ship was at anchor), all other rudder angle indicators were found to be functional.

Following the incident, Wah Kwong Ship Management HK conducted a survey of the rudder angle indicator power supply arrangement on all the ships managed or operated by the company. The survey identified that almost all the ships (over 20 ships) had a similar rudder angle indicator circuit breaker arrangement to *Hagen Oldendorff*.

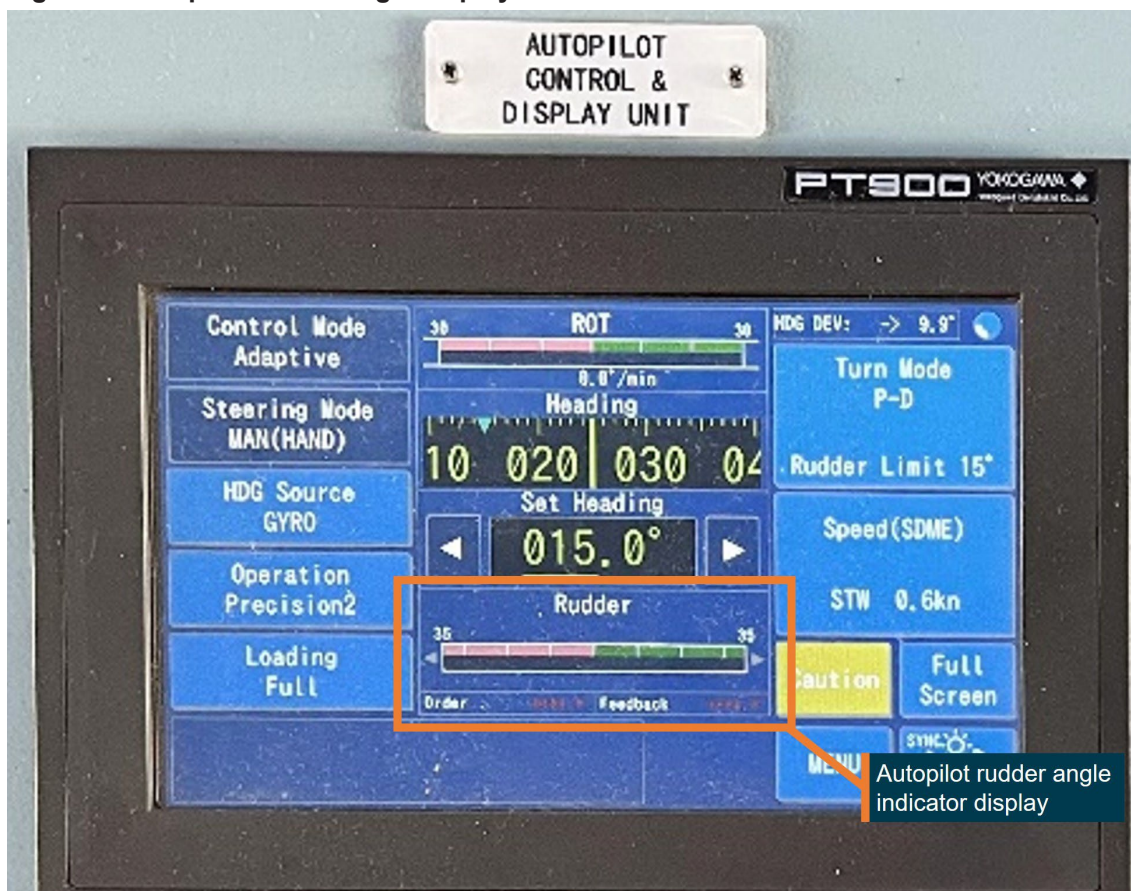
Figure 9: Autopilot rudder angle display

In addition to the 6 analogue rudder angle indicators, the ship’s Yokogawa PT900 autopilot system display unit (Figure 9) also displayed rudder order and feedback (rudder angle). The autopilot system’s power supply and rudder angle feedback signal were independent of the analogue rudder angle indicators’ power supply and rudder angle signal transmitter. The autopilot rudder angle display remained operational throughout the course of the incident. However, neither the ship’s officers, nor the pilot were aware of this functionality.

The ship's bridge team were unaware of the autopilot's rudder angle indicator display and the pilot could not see the display from their location forward of the bridge console. Furthermore, following the loss of rudder angle indication, there was no attempt to check whether any of the other rudder angle indicators (on the bridge wings or on the autopilot display) were operational before initiating steering failure response procedures. Therefore, the possibility of a rudder angle indicator failure was probably not considered, and it is unlikely that knowledge of the autopilot indicator display would have significantly altered the sequence of events that led to the grounding.

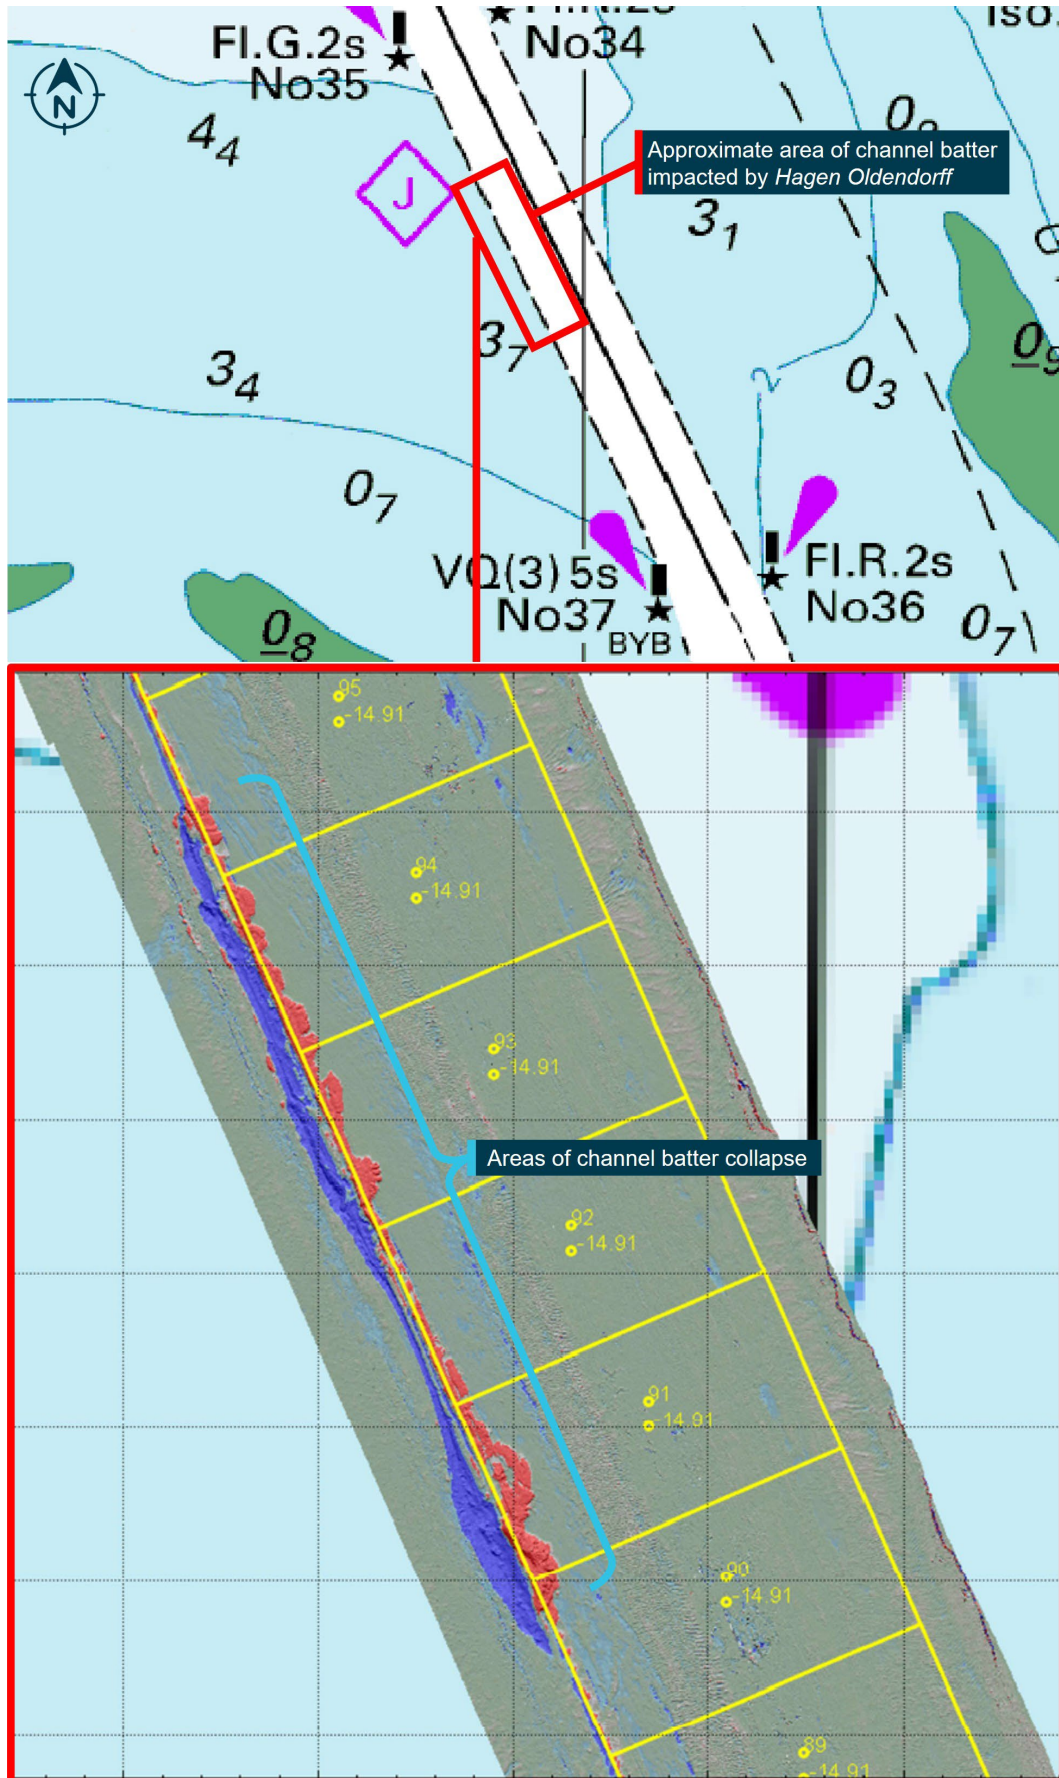
Figure 11: Survey data showing channel batter impact damage

On 11 April 2022, the Pilbara Ports Authority (PPA) commissioned a survey of the area of the channel between beacons 36-37 and beacons 34-35. The survey data identified that *Hagen Oldendorff* had impacted an area of the western batter about 500 m long (Figure 11) resulting in bank collapses extending between 7–21 m into the channel.
