**Australian Transport Safety Bureau**

# Low-speed collision between trains M05519A and M05519B

Finucane Island Balloon Loop, Port Hedland, Western Australia on 2 March 2024

RO-2024-002

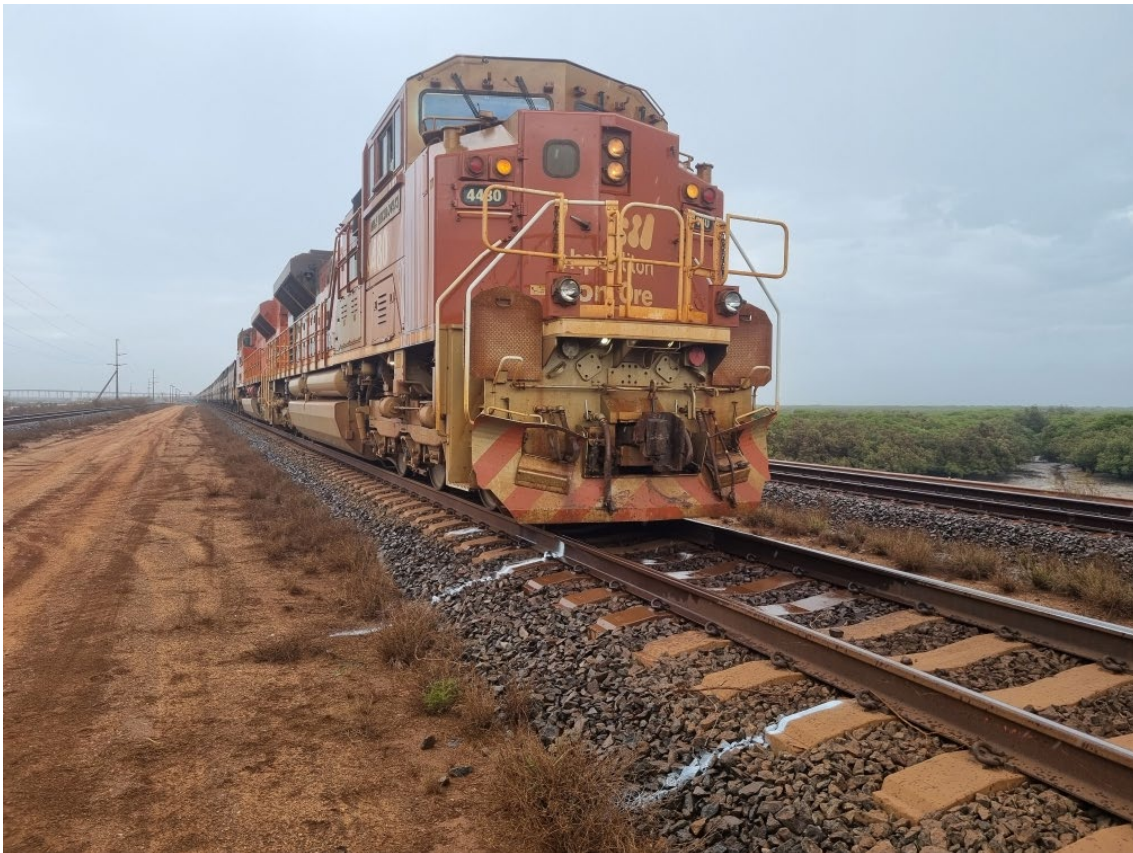
**Figure 4: Lead locomotive of train M05519B after the accident**

The driver also uncoupled the lead locomotive of train B from the rear of train A and checked for any damage. There was no damage to rollingstock (Figure 4) and the driver was uninjured.

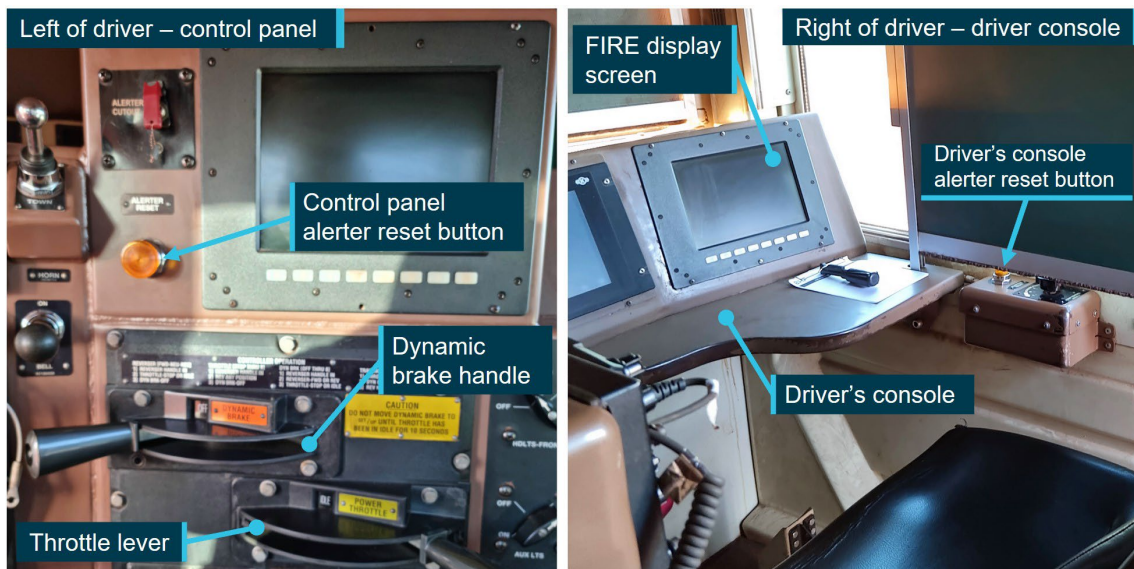
**Figure 5: Alerter reset button on control panel and driver’s console**

A limitation of such systems, as identified in an ATSB investigation into a collision between 2 freight trains in 2019 ([RO-2019-022](#)), was that drivers could acknowledge vigilance systems during periods of acute fatigue, and habituate to these systems, responding to alerts without conscious thought by pressing the reset button through a reflexive motor response. Vigilance systems could identify and intervene in cases of driver absence or total incapacitation but were less effective in detecting and responding when drivers were mildly incapacitated, inattentive, fatigued, or otherwise distracted.

The first 2 of these listed alerter reset buttons, together with the FIRE display screen, are shown in Figure 5.

BHP also proposed several changes to the vigilance system installed on their SD70Ace/LCi locomotives, including changing from fixed-time intervals to random intervals for the countdown, and limiting consecutive alerter resets to require different inputs and eliminate 'muscle memory'.
