# Level crossing collision between freight train 6839 and truck

Gooray Road, Gooray, Queensland on 23 May 2024

## **ATSB Transport Safety Report**

RO-2024-004

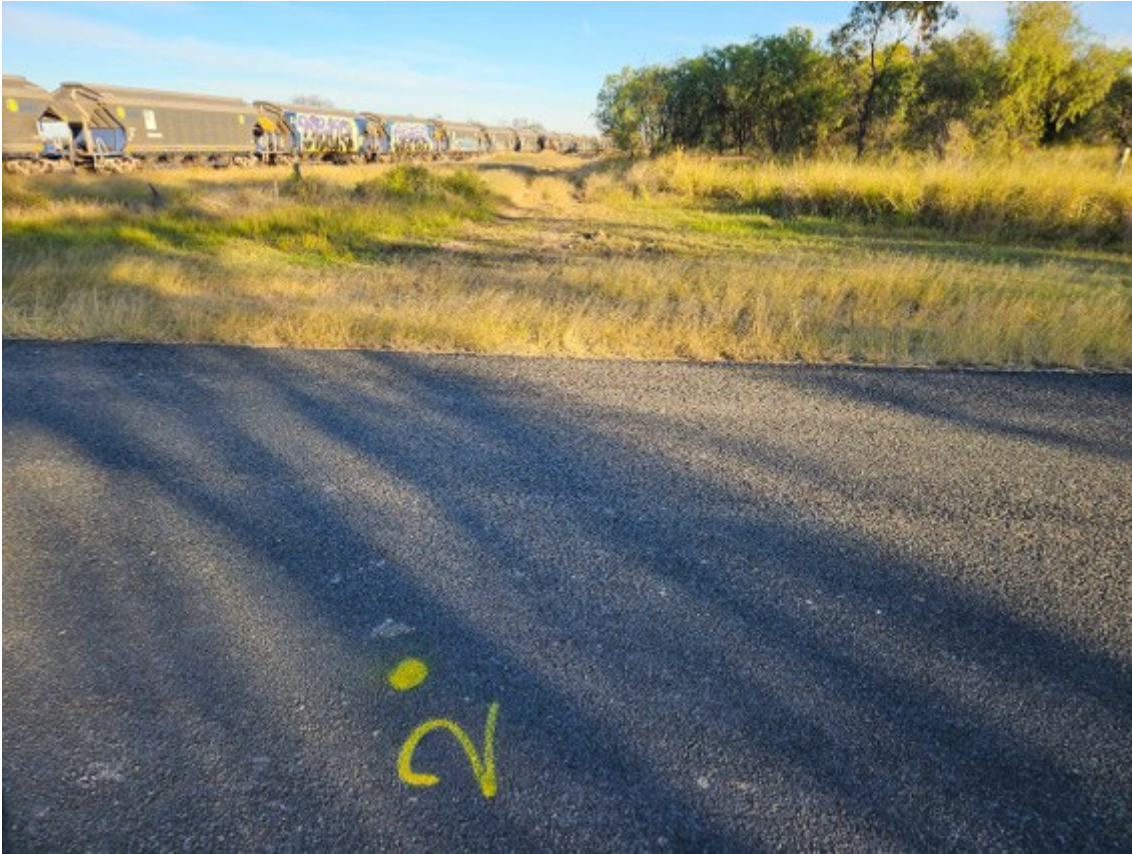
**Figure 4: View of railway line as the truck passed the vegetation**

The truck was then about 210 m from the level crossing, and the truck driver recalled taking their foot off the accelerator. Aware they were approaching the rail corridor, the truck driver then coasted towards the level crossing where they were required to stop. However, the truck driver was not aware of the train until they passed the vegetation (Figure 4), but the truck driver reported that the train horn was audible from the roadway as the train and truck both approached the crossing.

As the truck driver passed the trees and rounded a slight bend in the road, they saw the train, which was just over 100 m from the crossing. At that point, the truck was around 50 m from the crossing and travelling at around 40 km/h. The truck driver reported that they started to brake but that it felt like the trailer was pushing the prime mover, and assessed that they did not have sufficient braking power to stop before the crossing. As a result, the truck driver decided to accelerate past the stop sign and across the railway line into the path of the train.

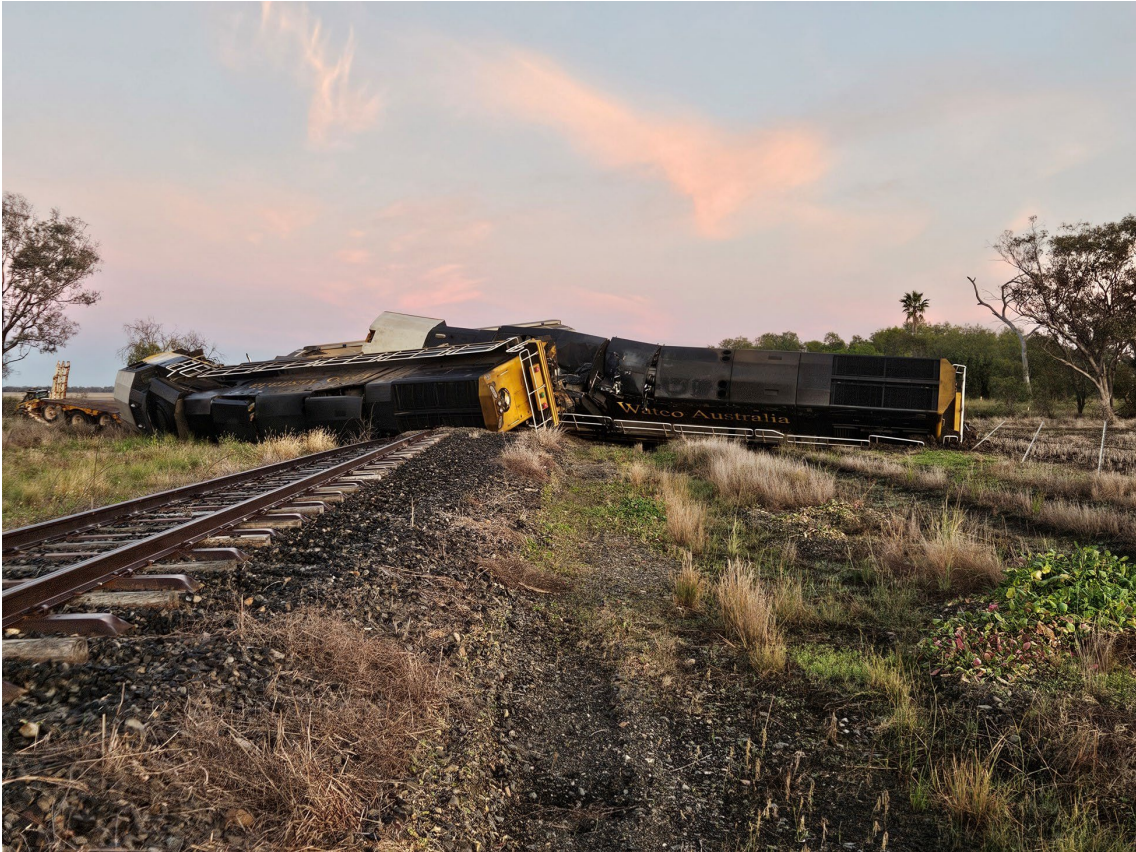
**Figure 5: The WRA-class locomotives, post-collision**

The lead locomotive of train 6839 hit the middle of the trailer. The locomotive body was sheared off the leading bogies and forced perpendicular to the track before coming to a rest on its side in muddy ground within the rail corridor. The trailing locomotive was also turned perpendicular to the track and impacted the lead locomotive during the collision sequence (Figure 5), and 14 grain hoppers derailed and bunched up in a concertina effect. The locomotives and a dozen grain hoppers were damaged beyond repair, and another 2 grain hoppers sustained substantial damage.

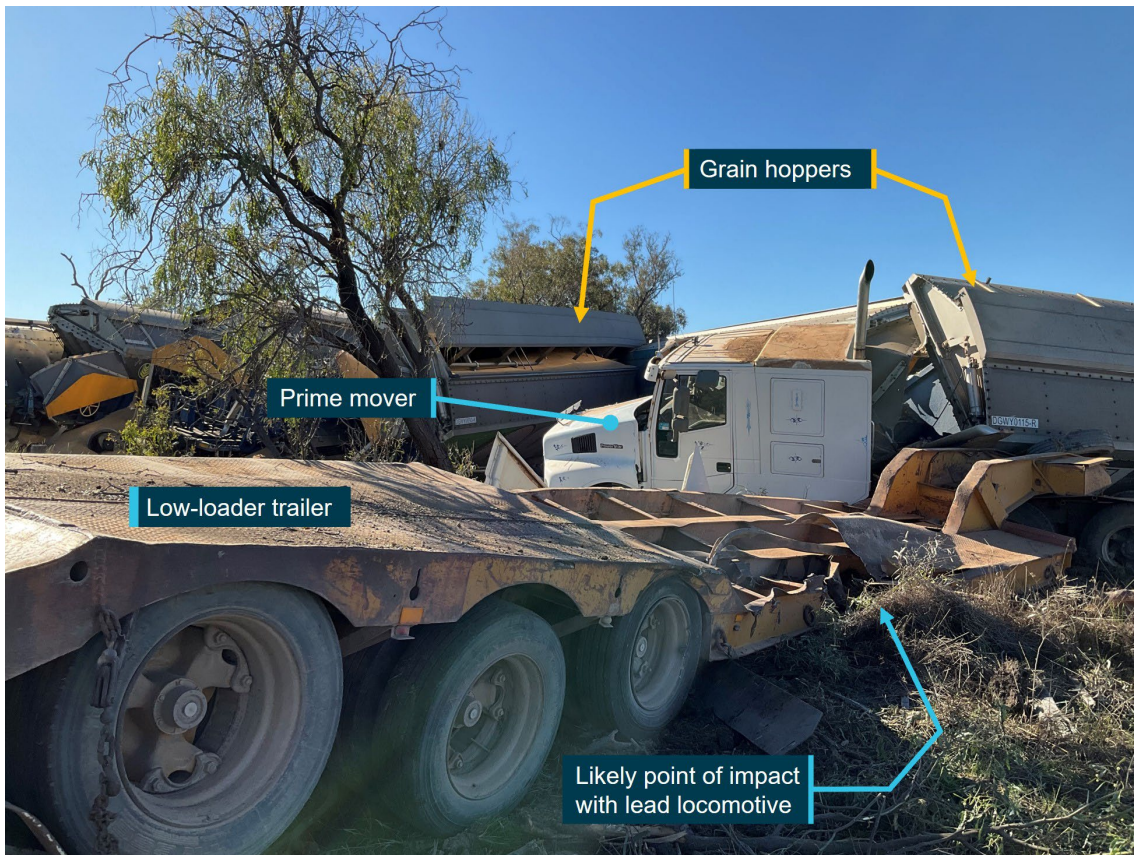
**Figure 6: Grain hoppers, prime mover, and low-loader trailer post-collision**

The prime mover experienced secondary impact damage most likely from the grain hoppers (Figure 6), and the bobcat on the trailer landed a short distance away. The prime mover and low-loader trailer were damaged beyond repair and the bobcat was substantially damaged.

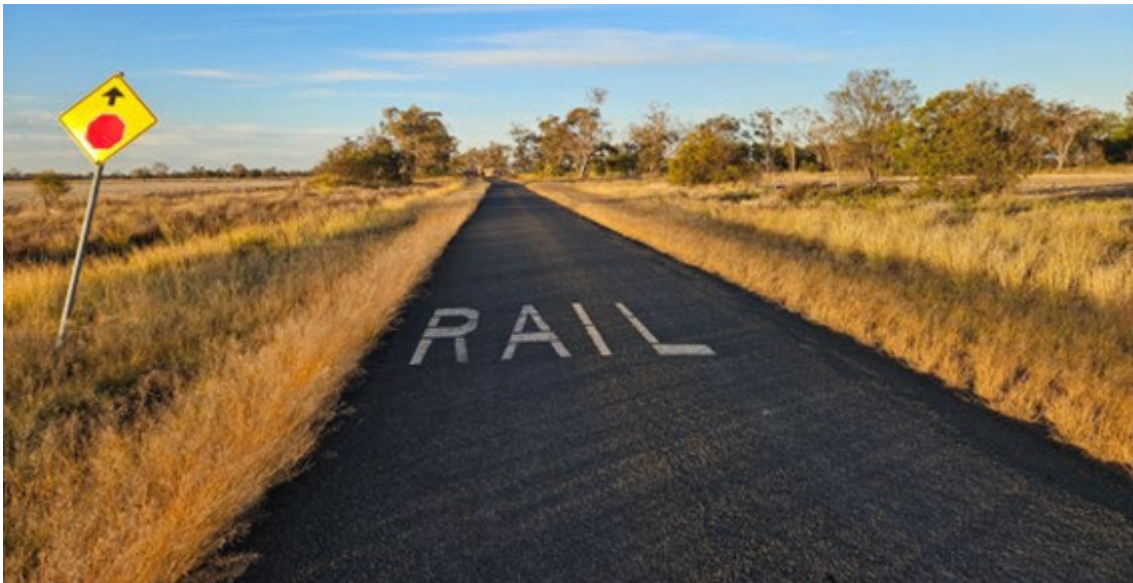
**Figure 7: First advance warning, northern approach**

The first advance warning, about 270 m from the crossing, consisted of W3-1 Stop Sign Ahead signage, and a ‘RAIL’ marking on the road surface, which was required due to the high-speed approach (Figure 7).

According to the Australian Standard,<sup>5</sup> the W3-1 Stop Sign Ahead sign was required to be placed 180–250 m before the stop sign at the crossing, and the W7-7 Rail Crossing Ahead sign was required to be placed 70 m before the W3-1 sign. The 'RAIL' and 'X' road markings were in the correct order, but the signs were in the reverse order.

Following the incident, Queensland Rail initiated an Australian Level Crossing Assessment Model (ALCAM) assessment and looked at road geometry, traffic volumes (road and rail), visibility and sighting distances, and the existing passive controls. The assessment determined that there were no obstacles to sighting distances or the visibility of signage, which, on the northern side of the crossing was deemed to be compliant. However, the Office of the National Rail Safety Regulator identified that the advance warning signs on the northern side of the crossing were in the incorrect order. Goondiwindi Regional Council advised that it would schedule works to alter the order of the signs.

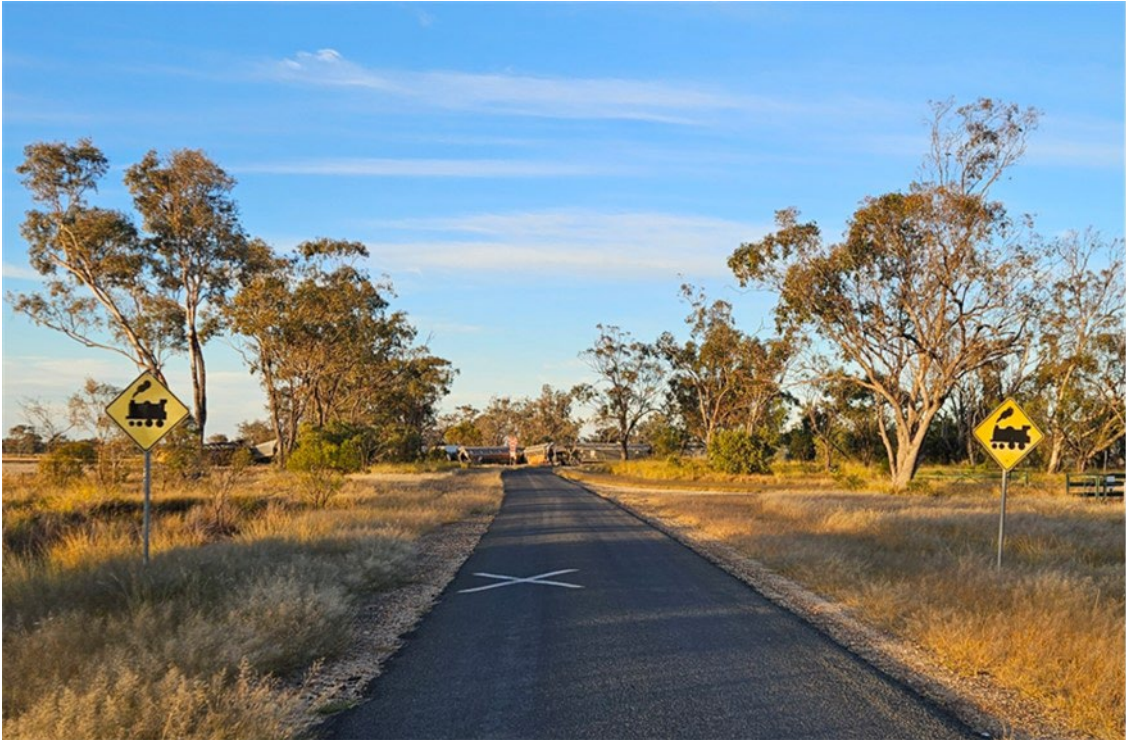
**Figure 8: Second advance warning, northern approach**

The second advance warning, about 180 m from the crossing, consisted of W7-7 Rail Crossing Ahead signage on both sides of the road and an ‘X’ marking on the road surface (Figure 8).

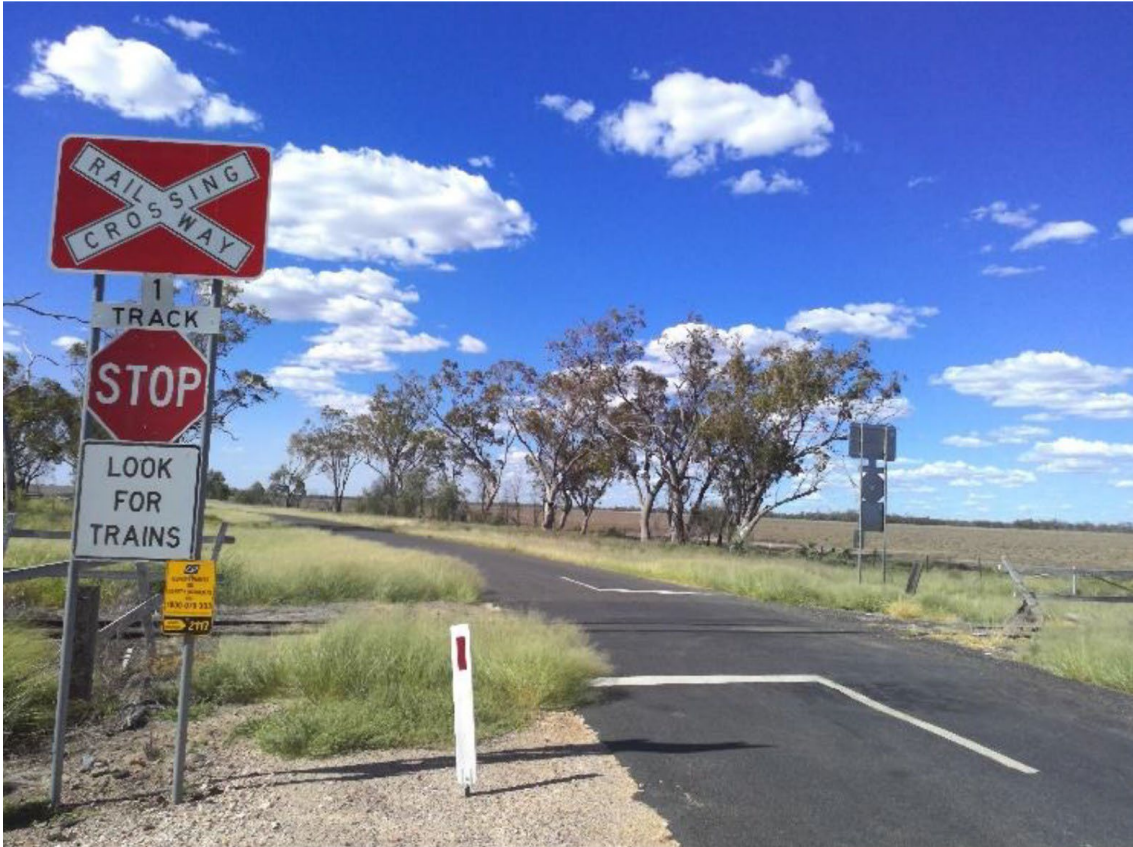
**Figure 9: Stop sign assembly and stop line, northern approach**

The assessment found that the signage on the southern side of the crossing lacked an additional advance warning sign, although this had no bearing on this accident. It also found that the stop lines on both sides of the crossing had become faded and scuffed, most likely through a combination of spillage and impact damage during the collision sequence, and vehicle movements and dirt transfer during recovery activities. Although the stop lines remained compliant and visible, it was recommended that these be repainted. Under the existing interface agreement, this work is the responsibility of Goondiwindi Regional Council, and it has been notified.

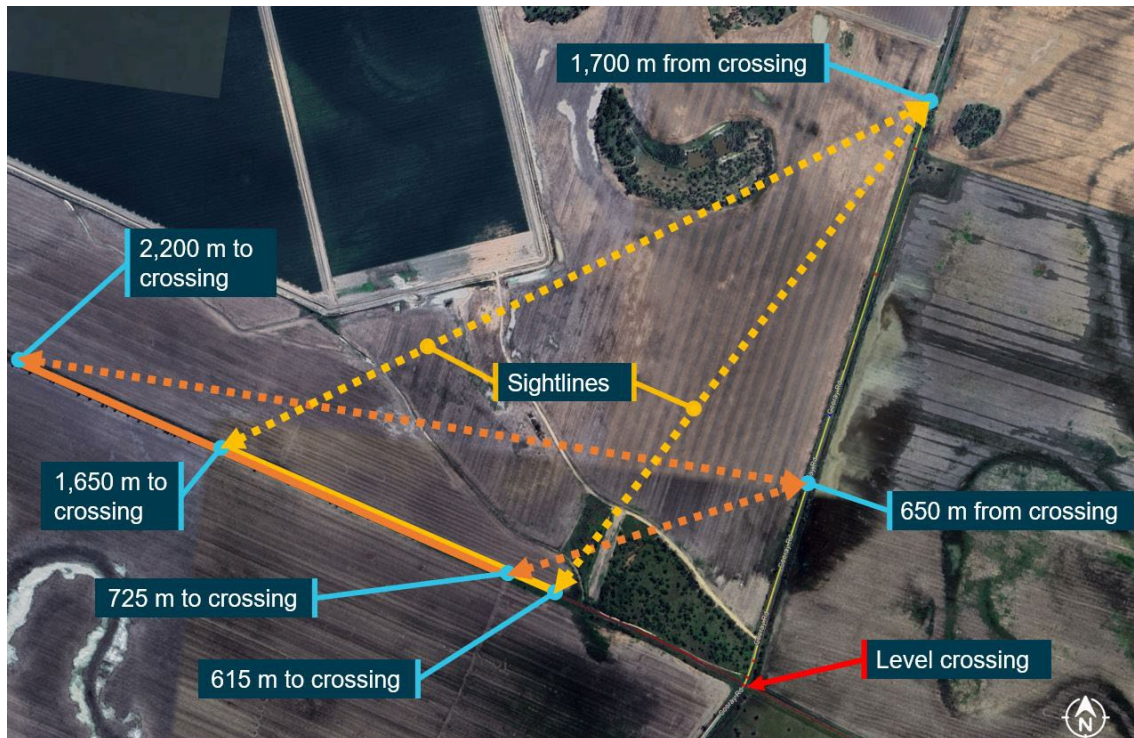
**Figure 10: Available sightlines as the train and truck approached the crossing**

Queensland Police also found that road users approaching the crossing from the north had ‘clear, unobstructed views’ in an arc of 180° from 1,700 m before the crossing, including of the rail corridor. Further, at the truck’s reported speed, the truck driver had an opportunity of 60–75 seconds to see the train before the vegetation blocked their view.

Similarly, Gooray Road should have been visible to rail traffic from about 1,650 m before the crossing. These sightlines did not change greatly until about 650 m before the crossing, when the vegetation started to obstruct them (Figure 10). However, the train crew reported first seeing the truck about 320 m prior to the crossing and the truck driver first sighted the train after passing the end of the vegetation 20 m before the stop line.

QR calculated that the sightlines down the rail corridor were at least 1 km at the Stop Sign Assembly in both directions. However, 120 m from the crossing, vegetation obstructed the view of the western side of the rail line from the northern approach on Gooray Road. The rail corridor was then not visible until about 20 m prior to the crossing where the vegetation cleared, after which the sighting distance increased exponentially to almost 1 km at the stop line. This vegetation was the primary factor for the installation of the Stop Sign Assembly in 2004.

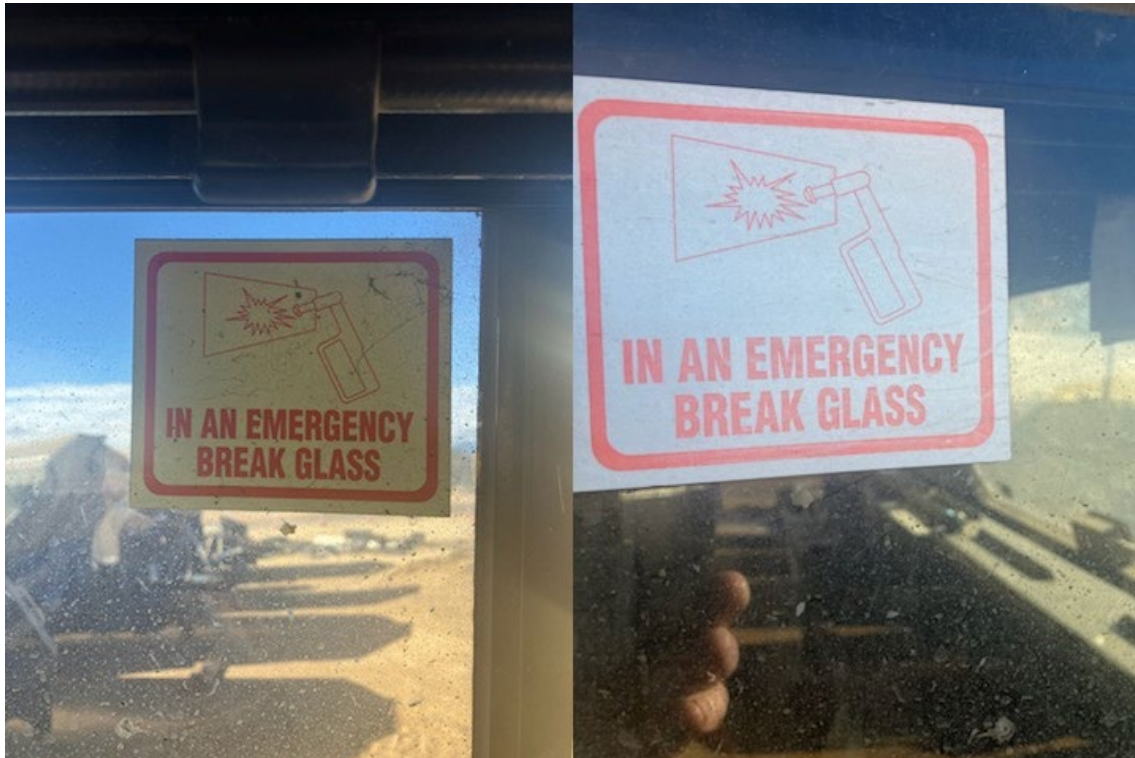
**Figure 11: Emergency exit sticker with illustration and block text**

The WRA-class locomotives entered service in 2020 and had been designed so that the windscreen panels in the cabs could be used for emergency egress, unlike older locomotives, which did not have designated emergency exits. Inside the WRA-class cab, 2 stickers were fixed to the windscreen to assist emergency egress. The first sticker illustrated the use of a fire hammer to crack the glass and consisted of a graphic in the corner of the windscreen. This graphic was accompanied by block text which stated ‘In an emergency break glass’ (Figure 11).

The train DIC reported that they had difficulty seeing and reading the instructions after the collision due to debris and dust inside the cab. They also noted that reading the instructions and escaping from the cab would be more difficult at night or in low-light conditions. However, the train DA and truck driver were able to follow the instructions and remove the glass, although the final position of the locomotive and the sticker location may have made it harder to do so. The train DA reported that the glass came out easily, and that the space and access available was sufficient to escape through the window despite the build-up of mud in the cab.

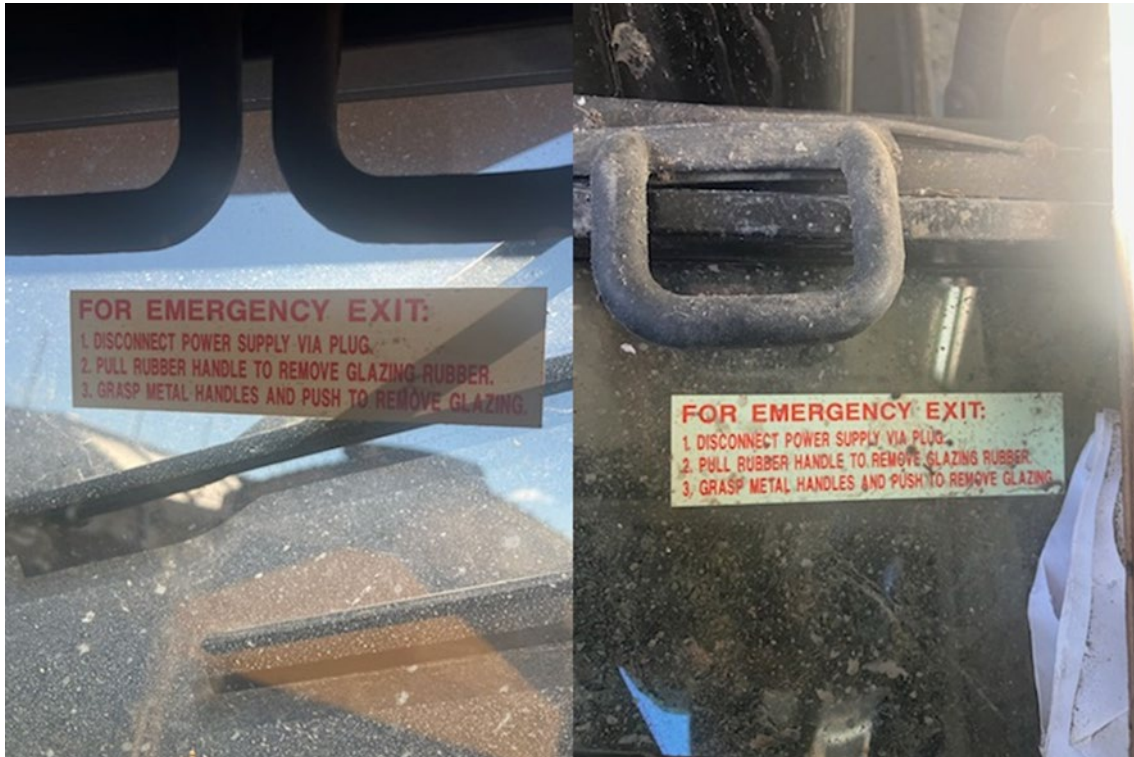
Figure 12: Emergency exit sticker with written instructions

The second sticker was affixed to the top of the windscreen under 2 black handles and listed a 3-step process to remove the window. On the exterior of the cab, an identical sticker with these instructions enabled people outside to remove the glass (Figure 12).
