# Incorrect configuration involving Bombardier DHC-8, VH-QOI

Horn Island Airport, Queensland on 26 June 2024

**ATSB Transport Safety Report**

AO-2024-038

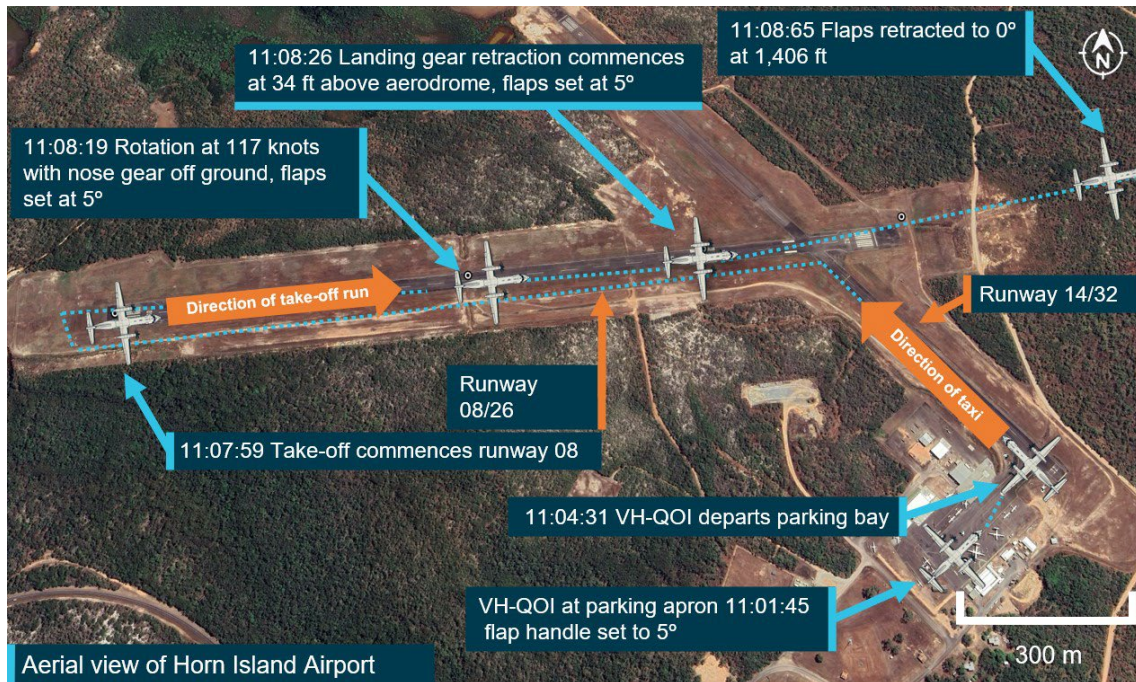
Flight data from the aircraft's quick access recorder (QAR) was provided to the ATSB and contained about 70 seconds of data, recorded at one-second resolution, commencing at the beginning of the take-off on runway 08 at Horn Island (Figure 1). The data indicated that the Dash 8 had the flaps set to 5° prior to taxi and were retracted as the aircraft was flying through 1,406 ft above mean sea level.

Figure 1: QAR derived flight data depicting aircraft position and flap setting

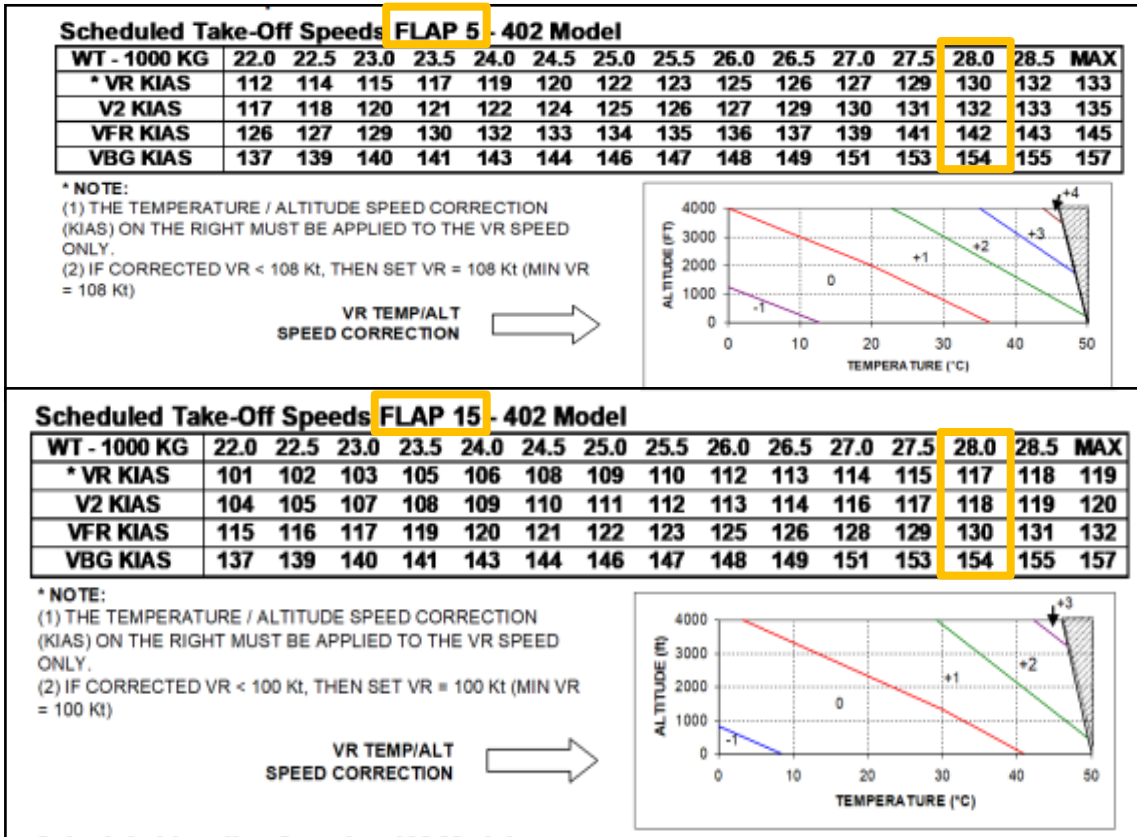
The QAR data determined that the mismatch in actual versus intended take-off flap configuration meant that the calculated take-off reference speeds and aircraft performance differed. The Dash 8 aircraft scheduled speeds for flap settings are stipulated in the operator’s aircraft performance manual (APM) (Figure 2).

Figure 2: APM specified take-off performance for flap settings 5 and 15 degrees

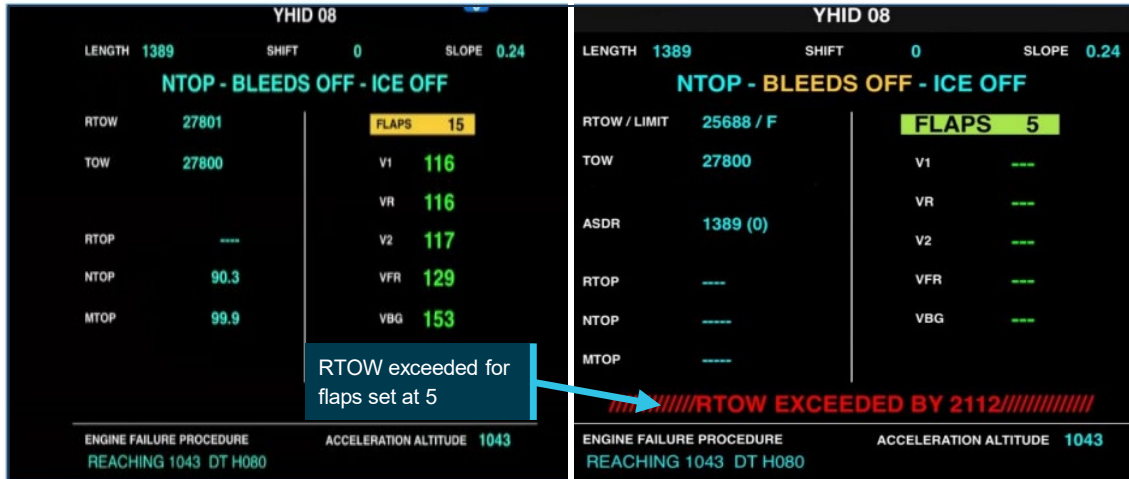
The findings from the operator’s internal safety investigation report stated that the flap setting of 5° increased the risk for tailstrike and reduced the margin for obstacle clearance. The aircraft would have been 2,112 kg overweight for take-off configured with a flap setting of 5° (Figure 3). The report determined that the required take-off distance with flap setting of 5° was 1,680 m which was greater than the available runway distance. However, the report concluded that as the aircraft was configured with flap 15° speeds set for take-off, the decision to reject the take-off would have been

made with reference to the bugged<sup>7</sup> V<sub>1</sub> speed of 116 kt and the accelerated stop distance required (ASDR)<sup>8</sup> would have been adequate. Therefore, the operator calculated that in the event of a rejected take-off, at or below the V<sub>1</sub> that was set, the aircraft would have had sufficient deceleration to come to a stop before the runway threshold.

**Figure 3: Aerodata performance calculations for VH-QOI for a flap settings of 15° and 5°**
