Smoke in aircraft and descent below lowest safe altitude involving Fairchild Industries SA227-DC, VH-WBQ

25 km north-east of Perth Airport, Western Australia on 15 August 2024

Aviation Occurrence Investigation (Short)

AO-2024-048

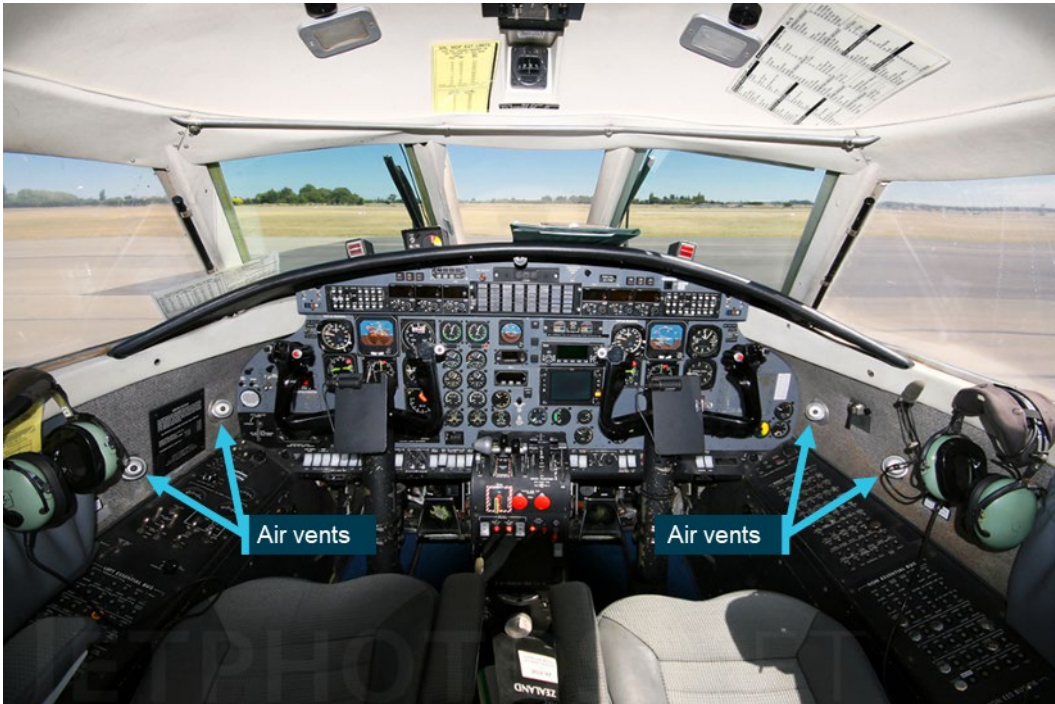
Figure 1: Exemplar Metroliner 23 flight deck

As the aircraft climbed above about 3,000 ft AMSL, the first officer attempted to reduce the high cabin temperature by selecting 'auto' on the temperature controller before then reselecting 'full cold'. At about this time, the crew noted that vents on the captain's (left) side of the flight deck (Figure 1) were blowing very hot air while the vents on the first officer's (right) side blew the expected cool air.

In response, the captain attempted to close the vent but found it too hot to touch. At the same time, they observed light smoke emanating from the vent. The smoke quickly increased, and the crew commenced the quick reference handbook (QRH) 'smoke in aircraft' checklist memory items.²

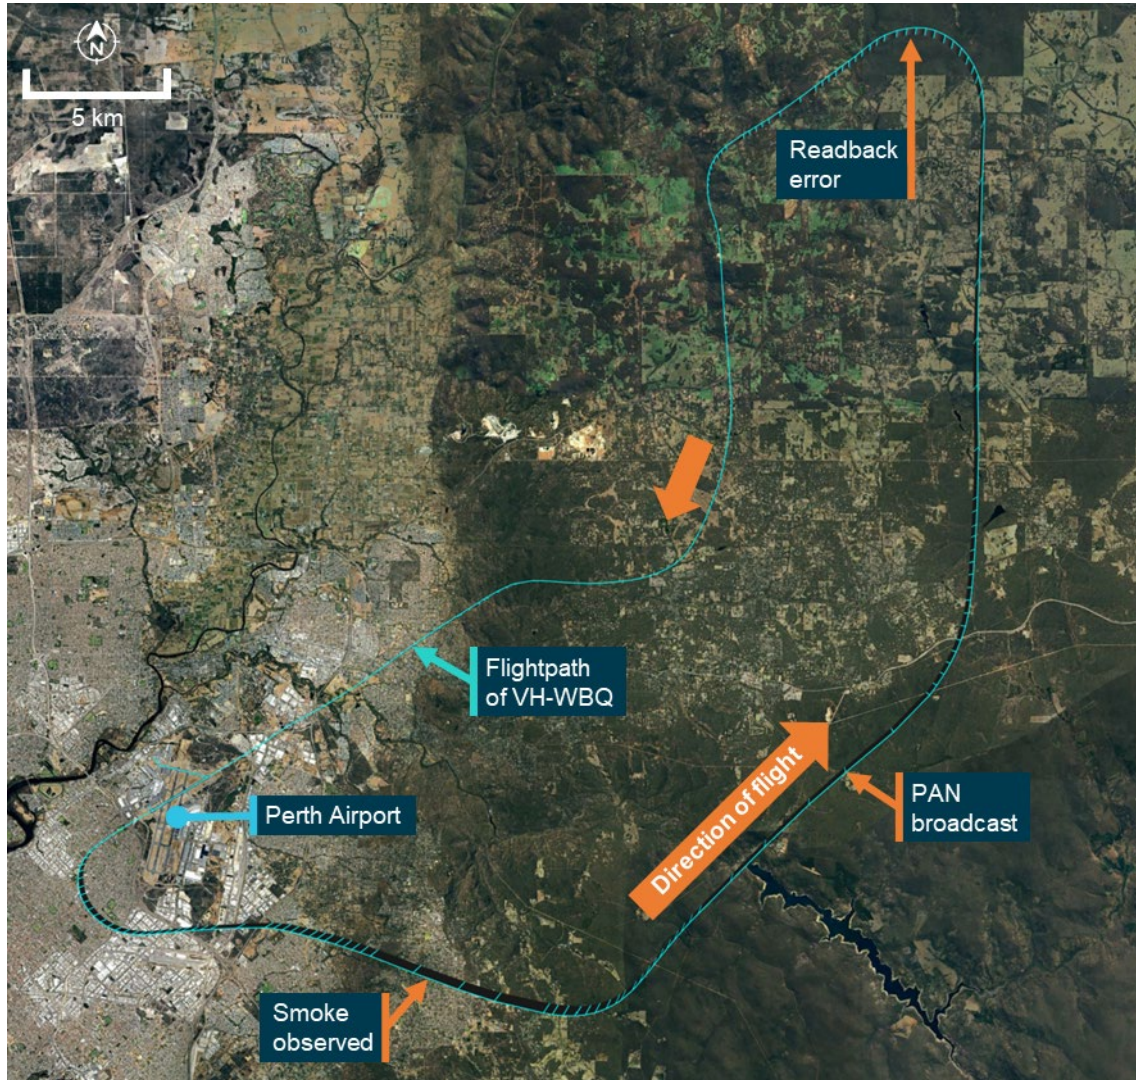
Figure 2: Flight path of VH-WBQ

Shortly after, the controller handed the crew over to the Perth Approach controller. One minute later, the approach controller instructed the crew to turn to a heading of 240° and descend to the lowest safe altitude of 2,800 ft AMSL. The first officer incorrectly read back the descent altitude as 2,000 ft AMSL, however the controller did not identify the error (Figure 2). The crew subsequently began descending the aircraft.

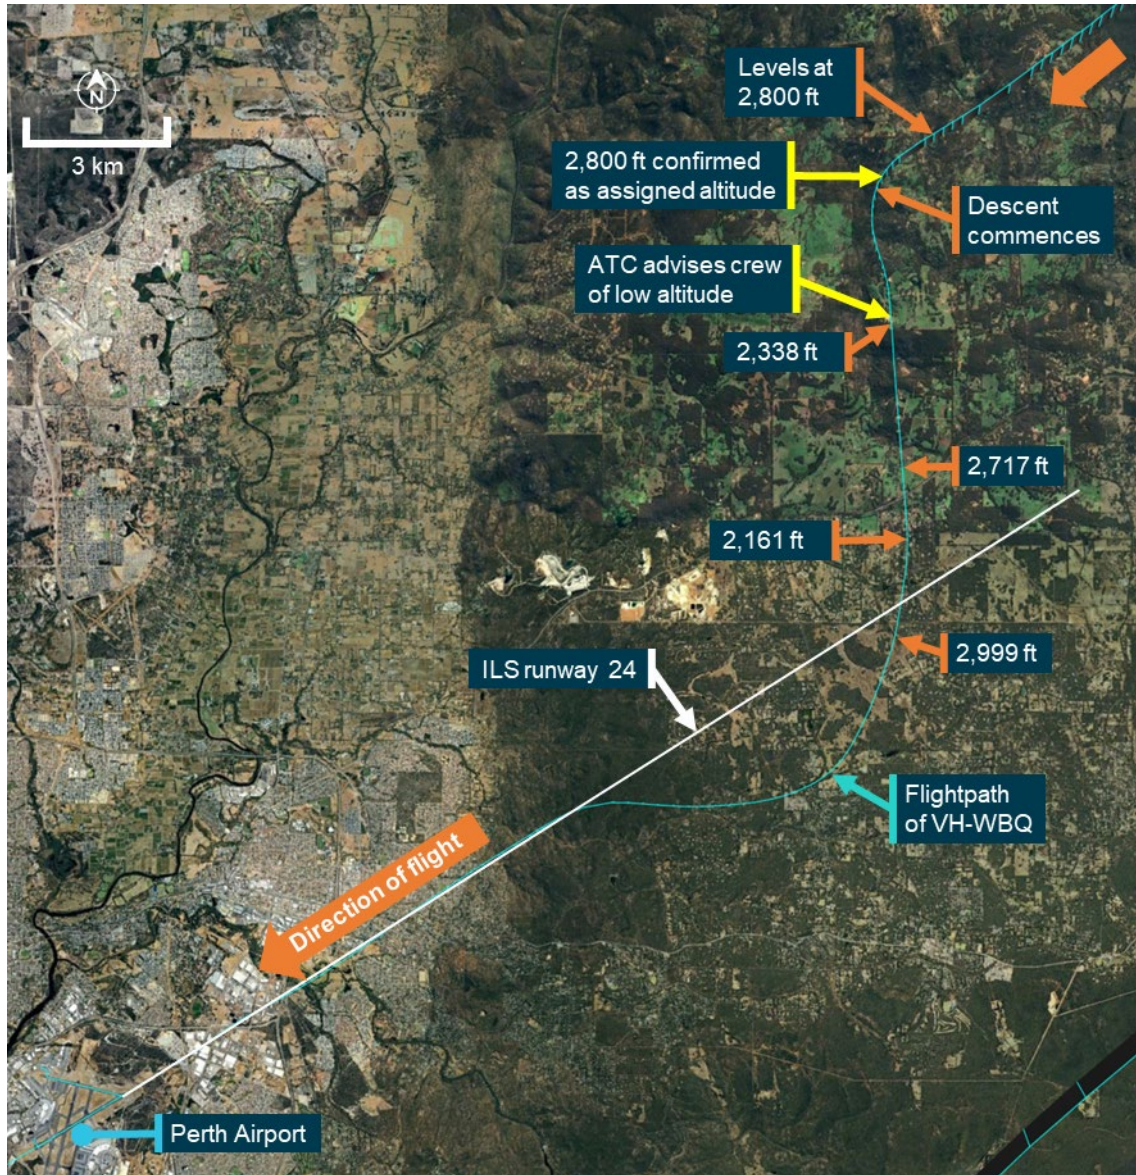
Figure 3: Flightpath of VH-WBQ after the incorrect readback

At 0756, as the aircraft turned to the assigned heading, a descent commenced from 2,800 ft AMSL (Figure 3). About 50 seconds later, having observed the descent, the air traffic controller advised the crew to maintain 2,800 ft AMSL and that 2,800 ft AMSL was the lowest safe altitude. The crew immediately commenced climbing the aircraft, having descended to 2,338 ft AMSL (about 1,600 ft above ground level (AGL)).

The clearance to descend to 2,800 ft was incorrectly readback as 2,000 ft by the first officer (who was not wearing the oxygen mask at that time), but this error was not identified by the air traffic controller. The purpose of a clearance readback is to ensure that the clearance has been correctly received and provides the controller an opportunity to correct any errors. As this error was not identified, there was increased risk of the crew descending the aircraft below the minimum safe altitude while still operating in instrument meteorological conditions. However, despite reading back the clearance incorrectly, the crew initially levelled the aircraft at 2,800 ft before querying and confirming the assigned altitude as 2,800 ft. Therefore, the non-identification of the readback error did not contribute to the aircraft descending below the lowest safe altitude.

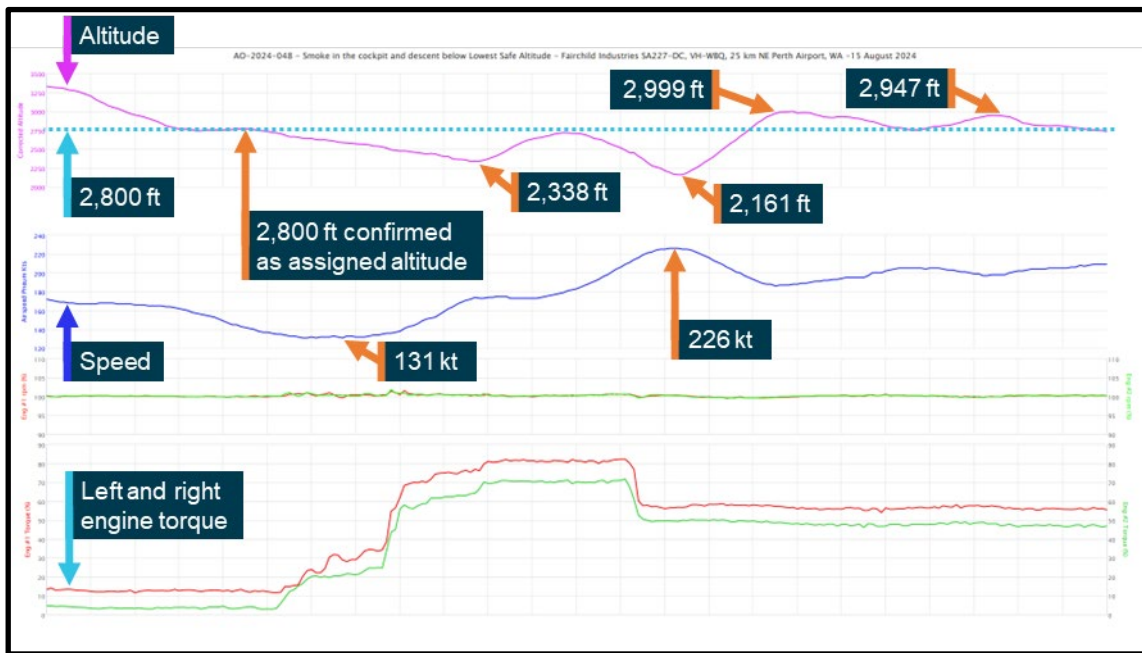
Figure 7: Recorded flight data from 0756 to 0800

As the crew prepared the aircraft for the return to Perth, it descended below the 2,800 ft altitude assigned by the air traffic controller. The controller identified the aircraft descending below the assigned altitude and contacted the crew stating, ‘maintain 2,800, 2,800 lowest safe’, but the broadcast was not prefixed by the required statement ‘safety alert’.

Flight data recorded by the aircraft’s flight data recorder, combined with recorded surveillance and audio data is presented in Figure 7.
