# Loss of control and collision with terrain involving Aérospatiale (Airbus Helicopters) AS332L1, N368EV

41 km north-north-west of Hay aerodrome, New South Wales, on 22 November 2024

**ATSB Transport Safety Report**  
Aviation Occurrence Investigation (Short)  
AO-2024-060  
Preliminary – 28 January 2025

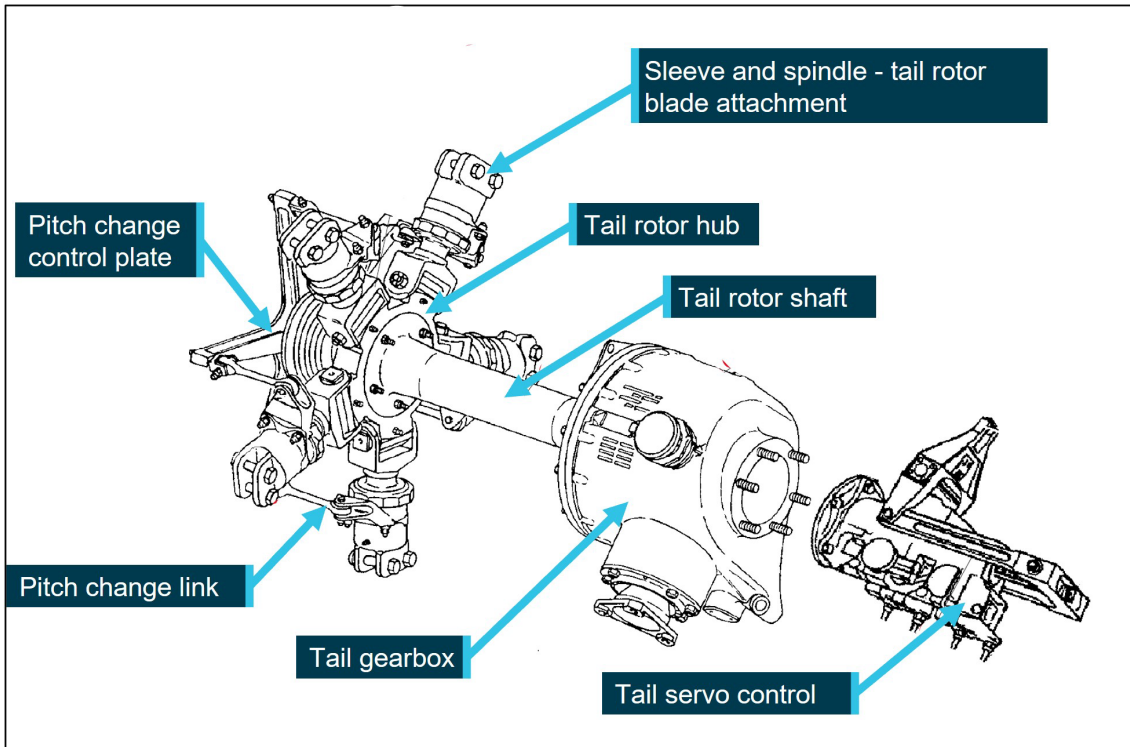
**Figure 1: Tail rotor gearbox and related components**

Tail rotor blade pitch control occurs in response to the pilot's tail rotor pedal inputs via mechanical connection to the servo control. The servo control actuates a pitch change control rod located within the hollow tail rotor shaft and is connected to the pitch change control plate. The pitch change control plate is mounted to and supported by a splined sleeve that slides laterally in a guide located within the tail rotor shaft (Figure 1 and Figure 2).

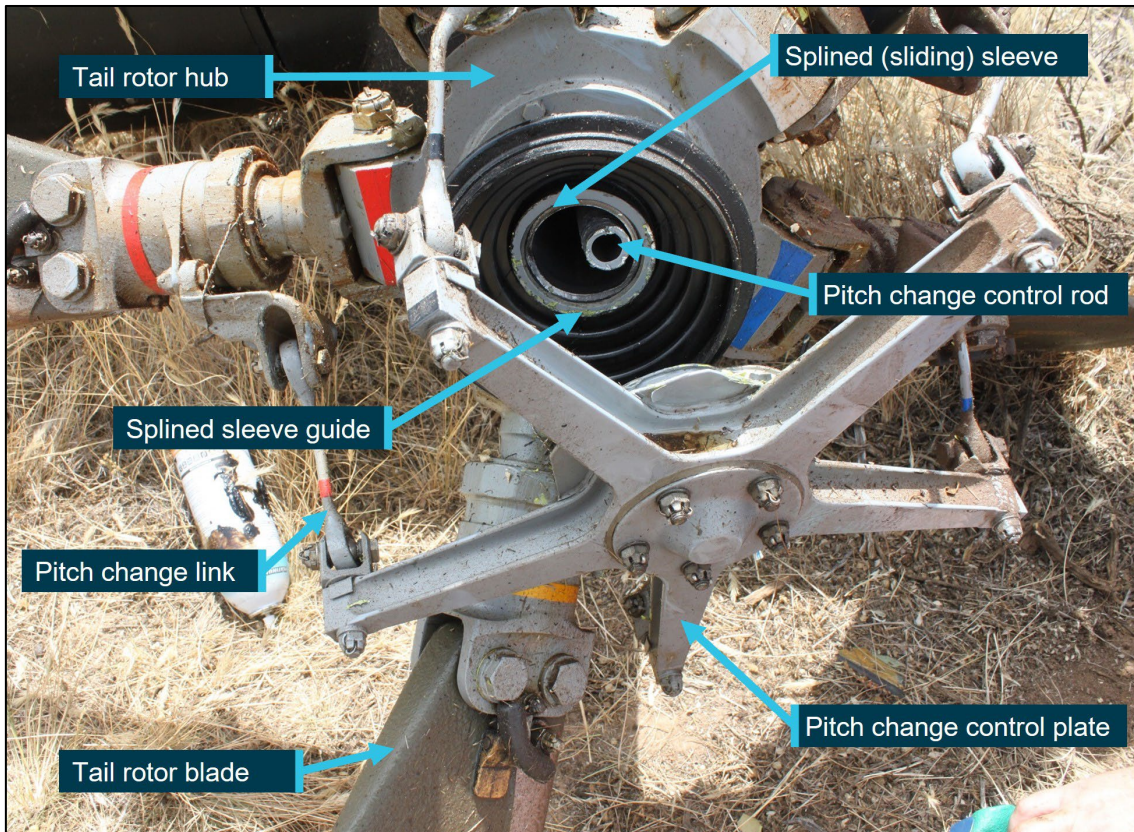
**Figure 2: Tail rotor assembly with separation of pitch change control plate from gearbox**

Examination of the wreckage found that the tail rotor pitch change control plate was detached from the tail rotor gearbox assembly and was the likely reason for the uncommanded yaw. Closer examination showed that the splined sleeve supporting the pitch change control plate had fractured at the mounting flange and the pitch change control rod was also fractured (Figure 2).

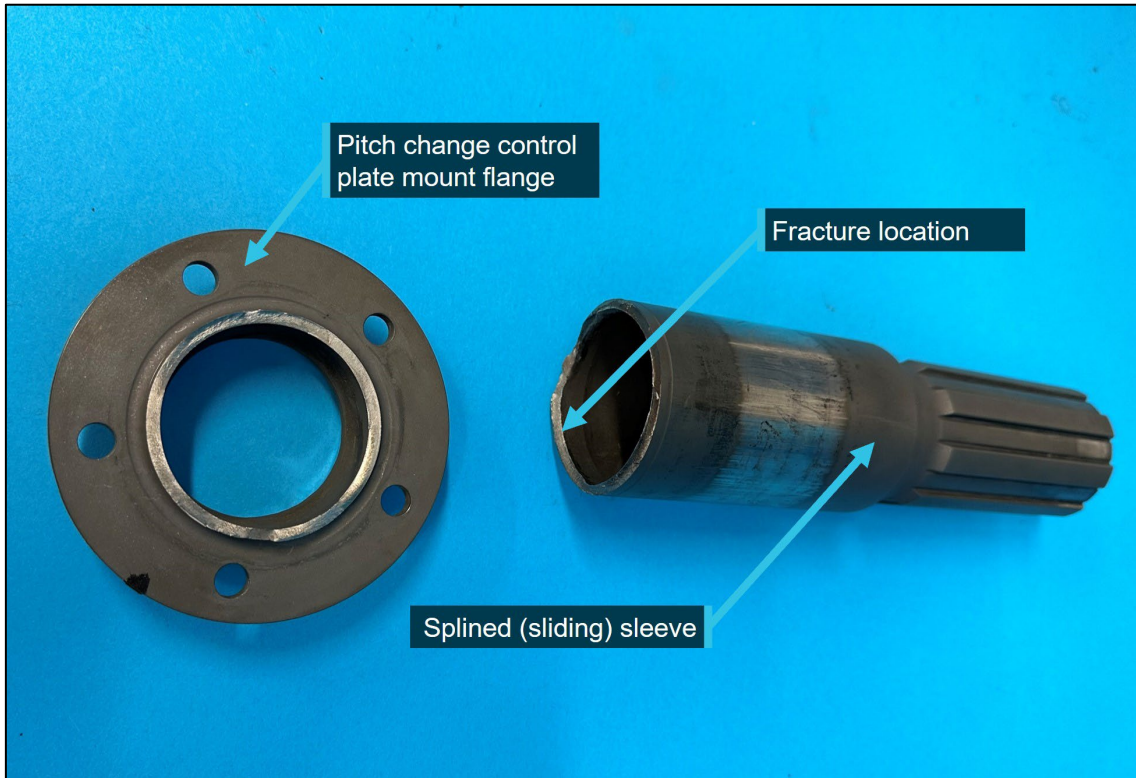
**Figure 3: Separation of the pitch change control plate mount flange from the splined sleeve**

Initial examinations of the fracture surface found that a fatigue crack had propagated around the majority of the splined sleeve’s circumference, leading to fracture of the sleeve in the section adjacent to the pitch change control plate mount flange. Further examination is to be conducted to determine the crack origin and identify the factors contributing to the cracking (Figure 3).

- Safety Information Notice 4082-S-64 on 29 November 2024 that highlighted tail rotor assembly maintenance tasks, specific to inspection and lubrication requirements.
- Alert Service Bulletin ASB AS332-64-20-003 on 23 December 2024 that specified an inspection for defects of the splined sleeve radius area of the control plate mount flange.
