Breakaway occurrences involving *OOCL Brisbane* and *CMA CGM Bellini*

Port of Brisbane, Queensland, on 16 May and 20 May 2022, respectively

ATSB Transport Safety Report

MO-2022-004

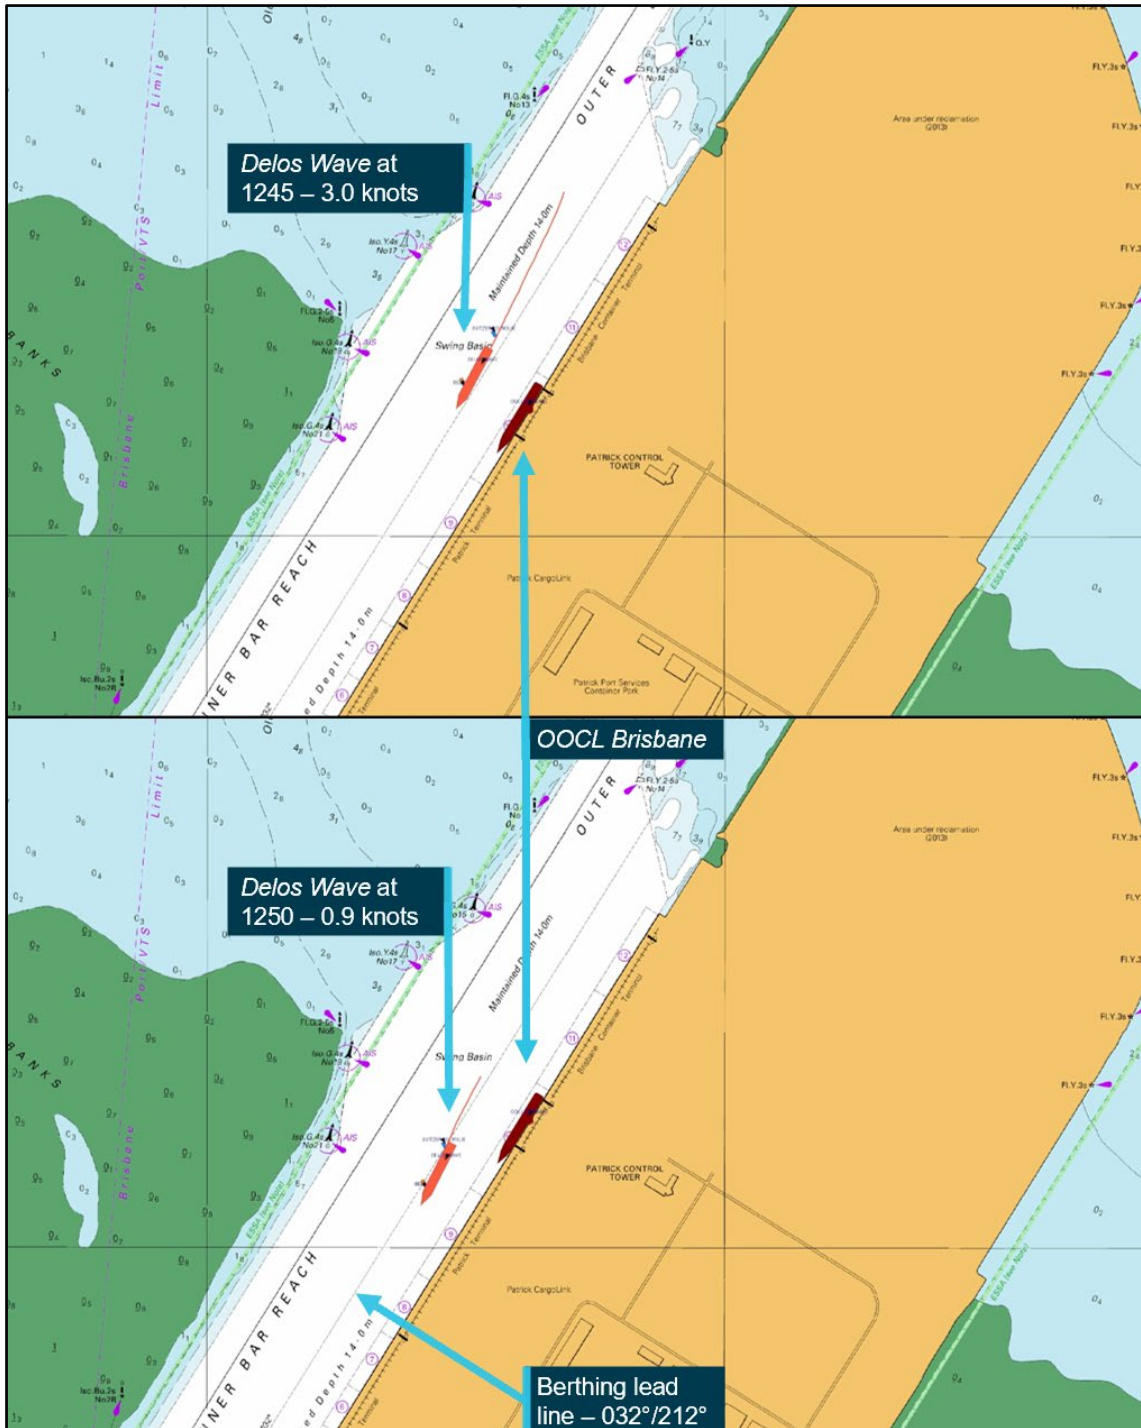
Figure 4: *Delos Wave* passing *OOCL Brisbane*

At 1245, *Delos Wave* was passing *OOCL Brisbane* at a distance of about 113 m at 3 knots (Figure 4, Top). Five minutes later, *Delos Wave*'s speed was 0.9 knots as its stern passed the bow of *OOCL Brisbane*. The distance between the ships was about 100 m.

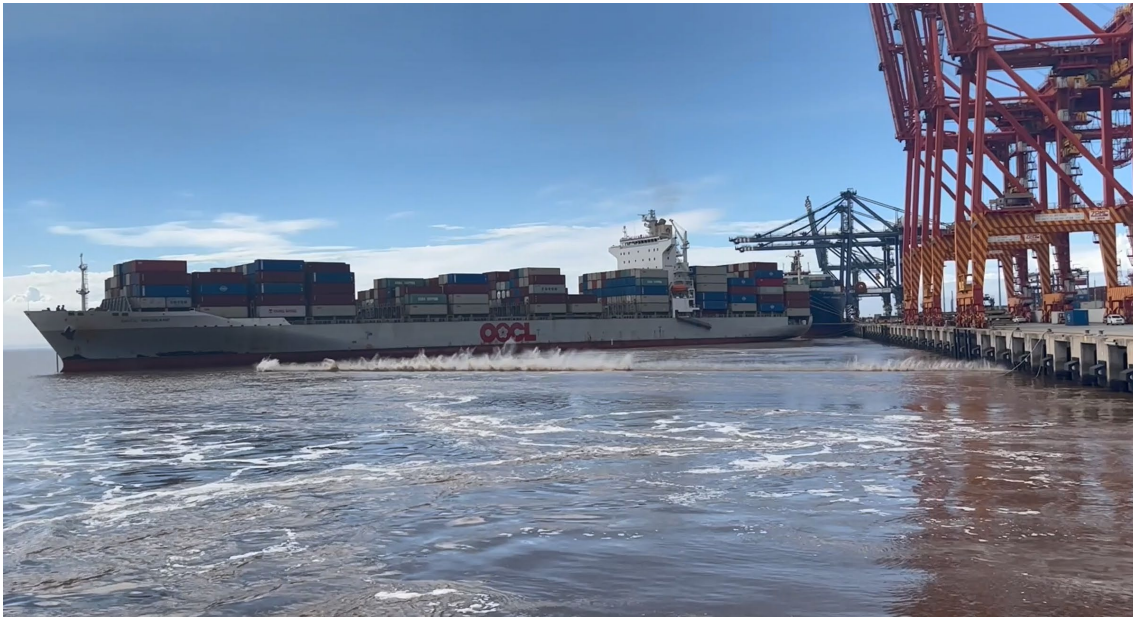
Figure 5: *OOCL Brisbane* breaking away (image shows the last headline parting)

By 1308, all forward lines had parted or fully paid-out (Figure 5). All the aft mooring winches had also begun to pay out and the 2 inboard stern lines turned up on the bits parted at about this time.

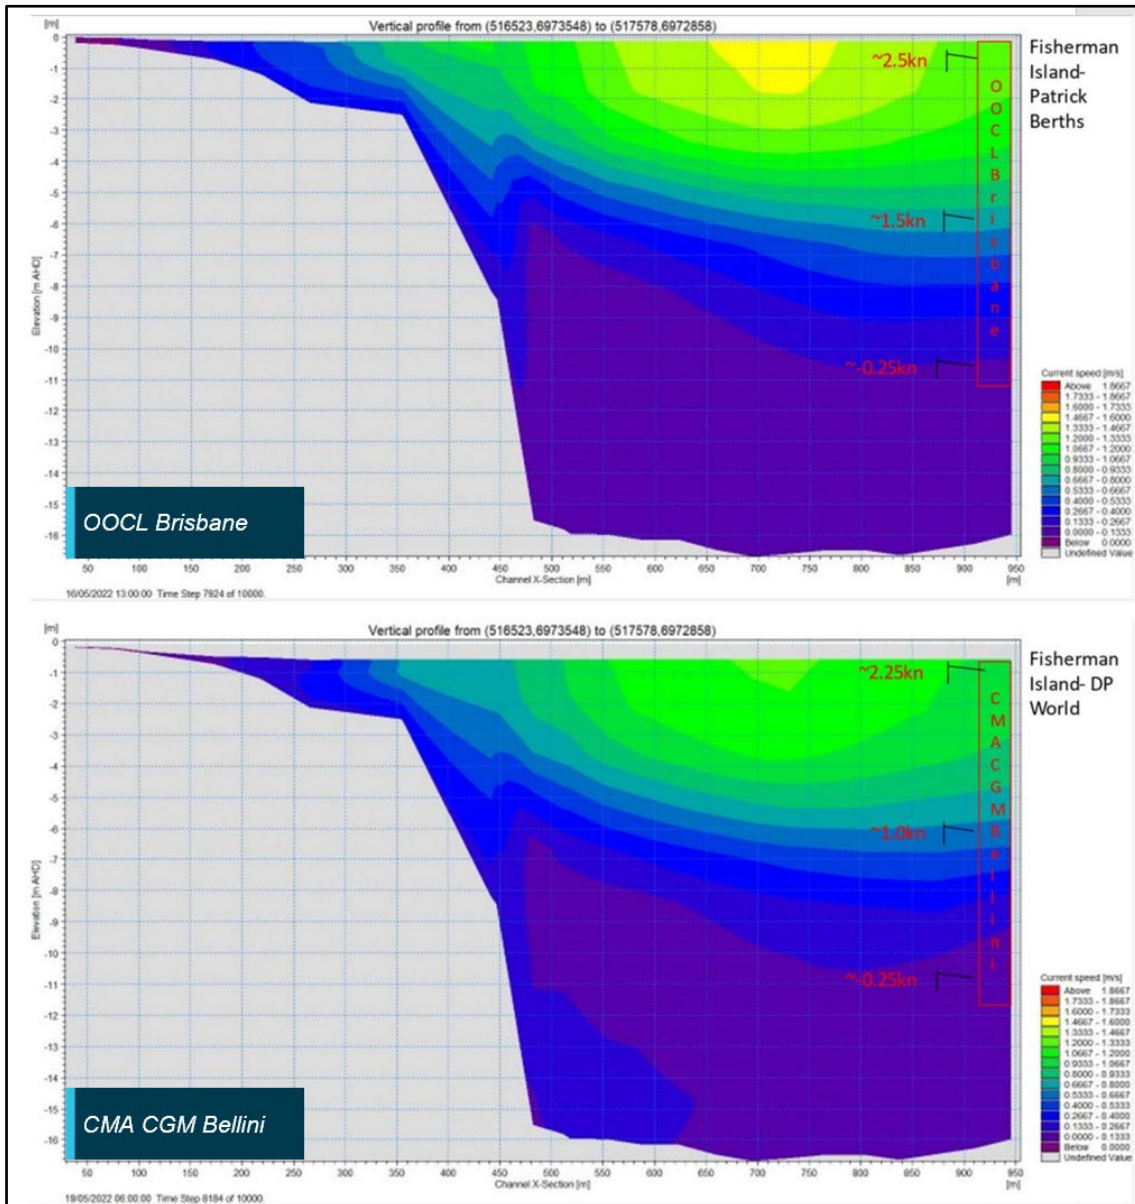
Figure 15: Cross-section of simulated current speeds

The current meter at 2F beacon was installed at a minimum water depth of approximately 5 m. Simulation results produced by Seaport OPX for the time of the breakaways indicated that maximum surface current at the Fisherman Islands berths was greater than that recorded by the meter and estimated the ebb flows to be 1.5 to 2 knots higher than a normal spring ebb tide. Current speed was also found to vary across the channel, with lower speeds closer to the wharf.

The report stated that hydrodynamic conditions ‘were complicated by the likely presence of a strong density-driven stratification of the flows over the draught of the moored vessels, with higher speeds and lower water density near the surface compared to at the bottom of the draught of the vessel’ (Figure 15). According to modelling, the vertical stratification of the flows over the draught of the moored ships meant that denser saline water could flow slowly upriver even while the freshwater surface layers were flowing seaward at up to 3 knots.
