Ditching involving Cessna 421C, VH-VPY

53 km east of Sunshine Coast Airport, Queensland, on 10 November 2023

ATSB Transport Safety Report

AO-2023-055

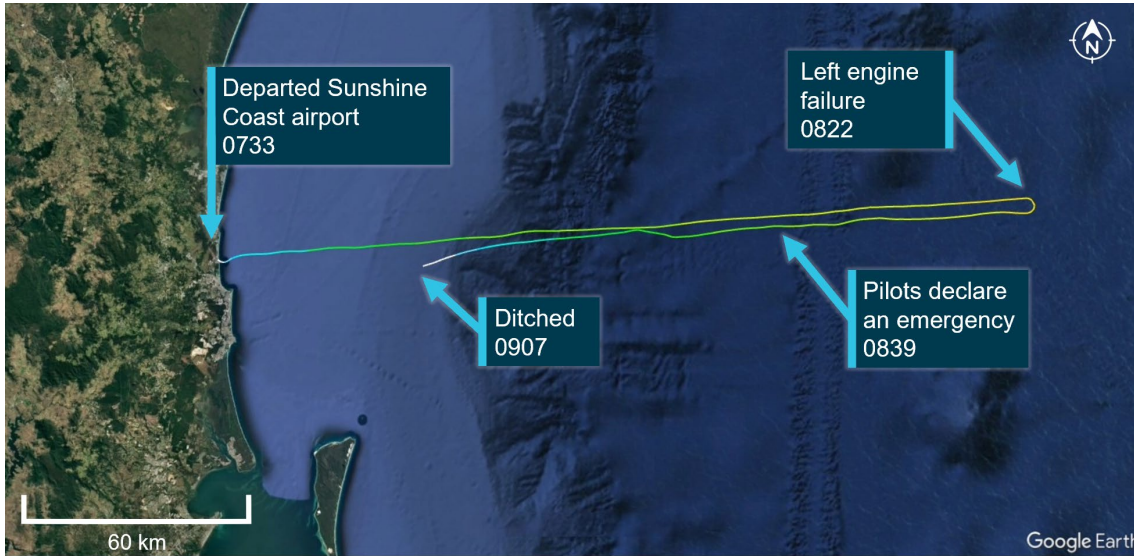
Figure 1: VH-VPY flight path and key moments during the flight

The pilot flying recalled that their priority was to maintain control by keeping the aircraft tracking straight with wings level and to complete the ditching at low speed. To assist with this, they shut down the functional right engine in the final phase of the descent and glided the aircraft from approximately 200 ft above the surface of the water. The ditching occurred at 0907 and approximately 53 km from Sunshine Coast Airport (Figure 1).

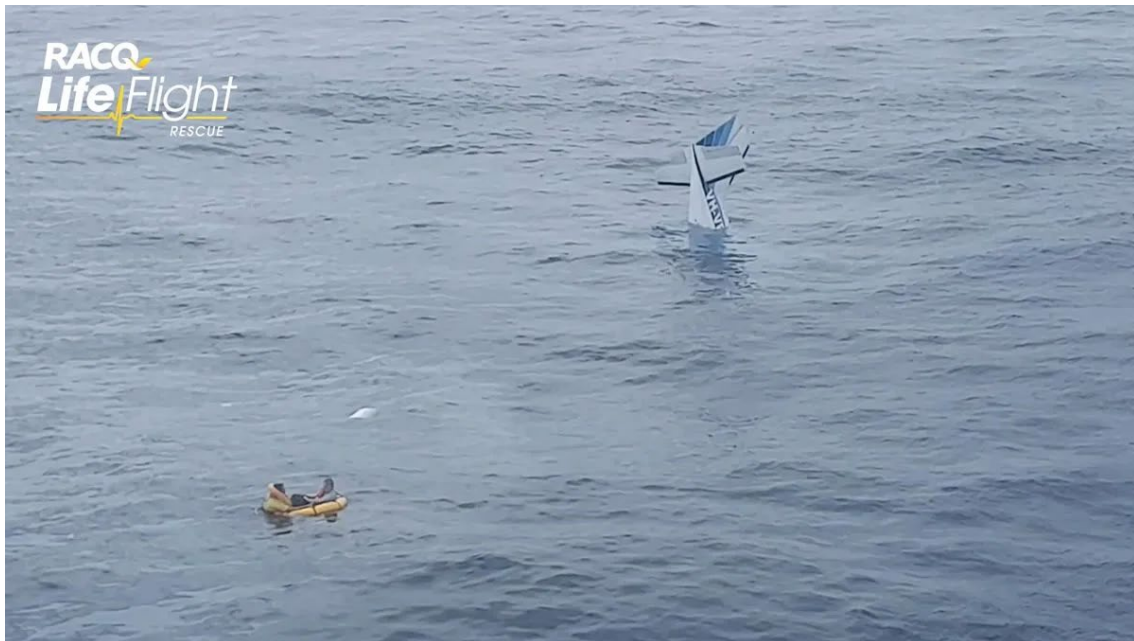
The pilots reported that on contact with the water the aircraft initially skimmed the crest of a wave, followed by very rapid deceleration when the nose pitched into the water. Water washed over the windscreen and the aircraft settled upright in a slight nose down attitude. The crew quickly made their way back through the cabin and over the partially emptied ferry bladder fuel tank to the rear door. There they deployed the life raft before exiting into the water.

Figure 2: VH-VPY remained partially afloat after the ditching and the pilots are nearby using the inflated life raft

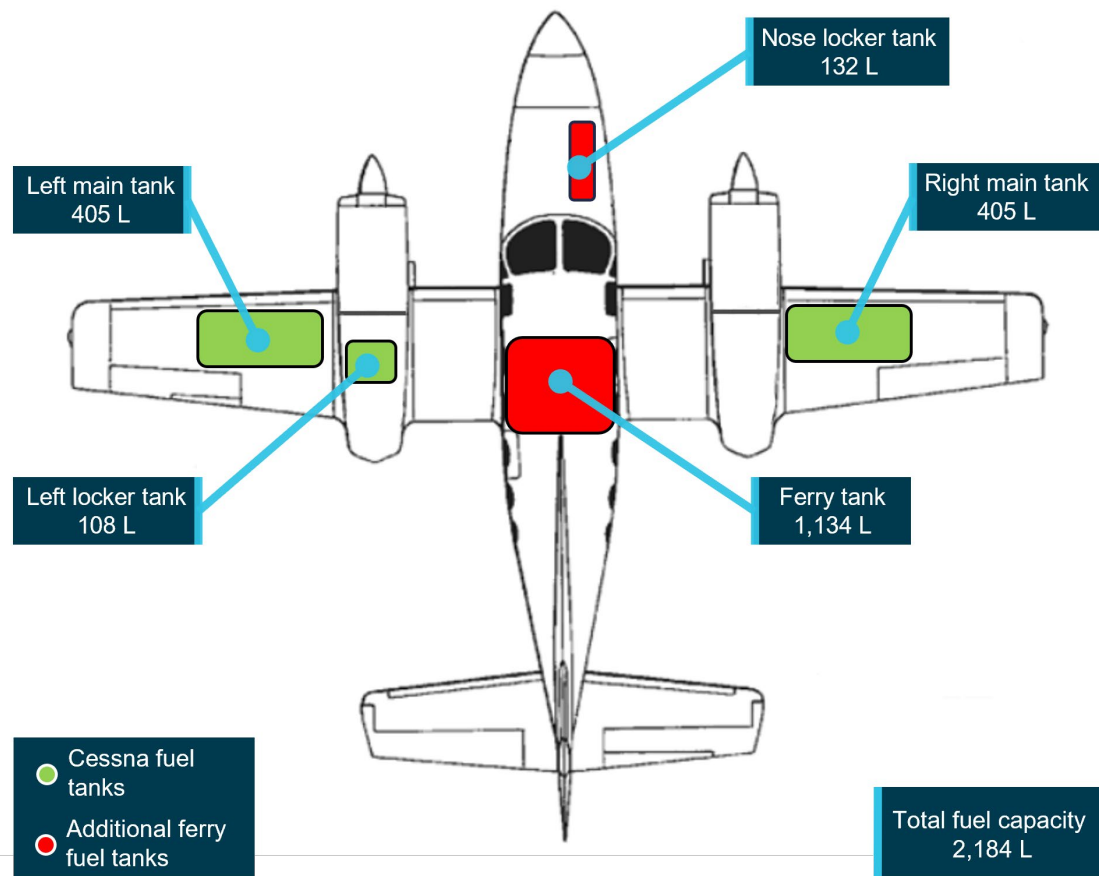
In addition to the ferry tank bladder located in the cabin, the aircraft was configured with a 35 USG (132 L) bladder tank stored in the nose locker. This bladder tank was connected to the ferry fuel control panel. This tank and its connection was an unspecified modification to the approved ferry tank system.

Figure 3: Fuel tanks in VPY included the main wing tanks, a left locker tank, a nose locker tank (unapproved) and the ferry tank (approved)

By using a reputable engineering organisation familiar with the aircraft to design the ferry fuel installation, the likelihood of a technical failure related to the fuel system was reduced. However, the additional bladder tank in the nose locker was not part of the engineering organisation's design and was therefore not compliant with the exemption to use the temporary approved modification for the purpose of ferrying the aircraft under the special flight permit. The unapproved modification did not contribute to the need for the ditching or the outcome of the ditching, however.

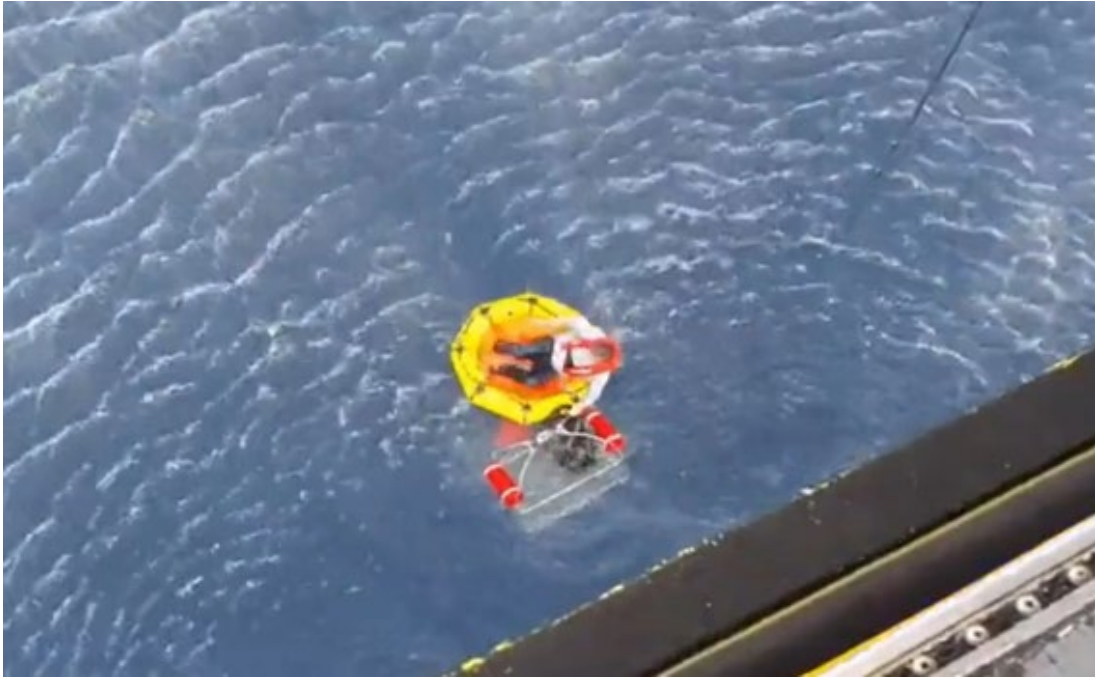
Figure 5: A pilot in the life raft being retrieved by a helicopter rescue crewman
