Near collision involving Beechcraft A36, VH-CKX, and Fairchild SA226-TC, VH-KGX

Geraldton Airport, Western Australia, on 19 March 2024

ATSB Transport Safety Report

AO-2024-009

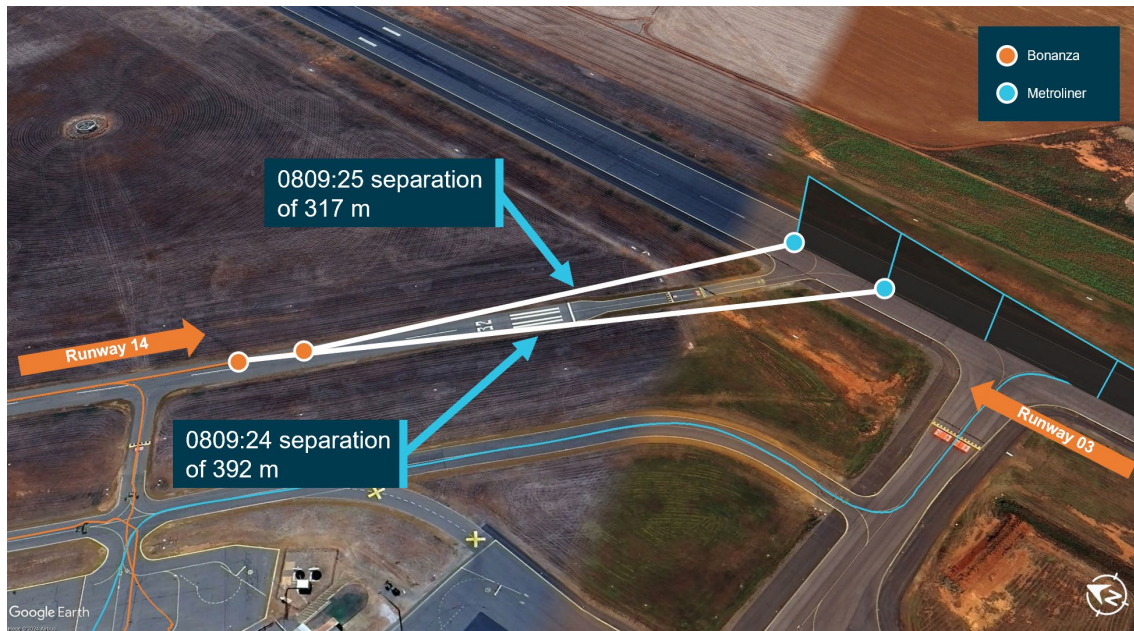
Figure 1: Closest position of VH-CKX (Bonanza) and VH-KGX (Metroliner)

The Metroliner entered the runway 14 strip just before 0809:24, about 400 m ahead of the Bonanza, with a vertical separation of 250–300 ft. The Metroliner cleared runway 14 one second later (Figure 1). Once both the Bonanza and Metroliner were airborne, the pilots were able to establish and maintain effective 2-way radio communications with each other.

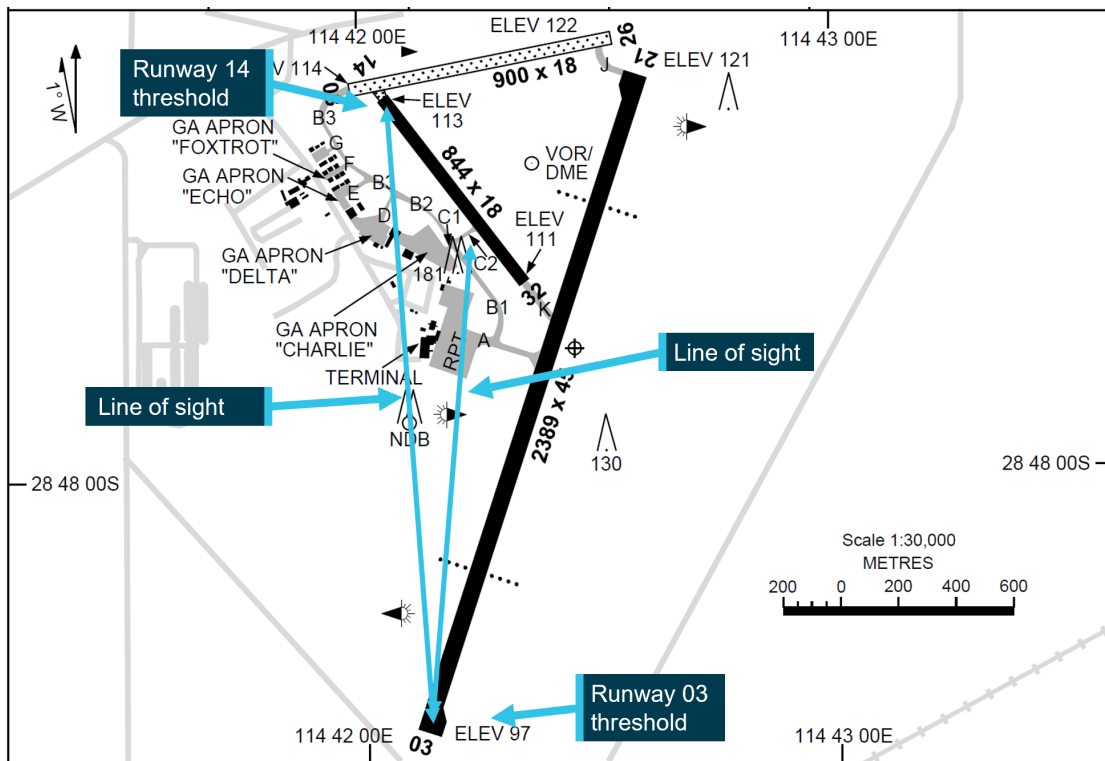
Figure 2: Geraldton Airport chart extract

The thresholds of runways 03 and 14 were separated by a distance of 2,168 m and the majority of airport infrastructure such as the terminal, hangars and aprons were situated between those thresholds (Figure 2).

Geraldton Airport conducted informal radio checks and identified that, when operating at opposite ends of the aerodrome, VHF shielding was possible. It has submitted an amendment to the En Route Supplement Australia to highlight this possibility.

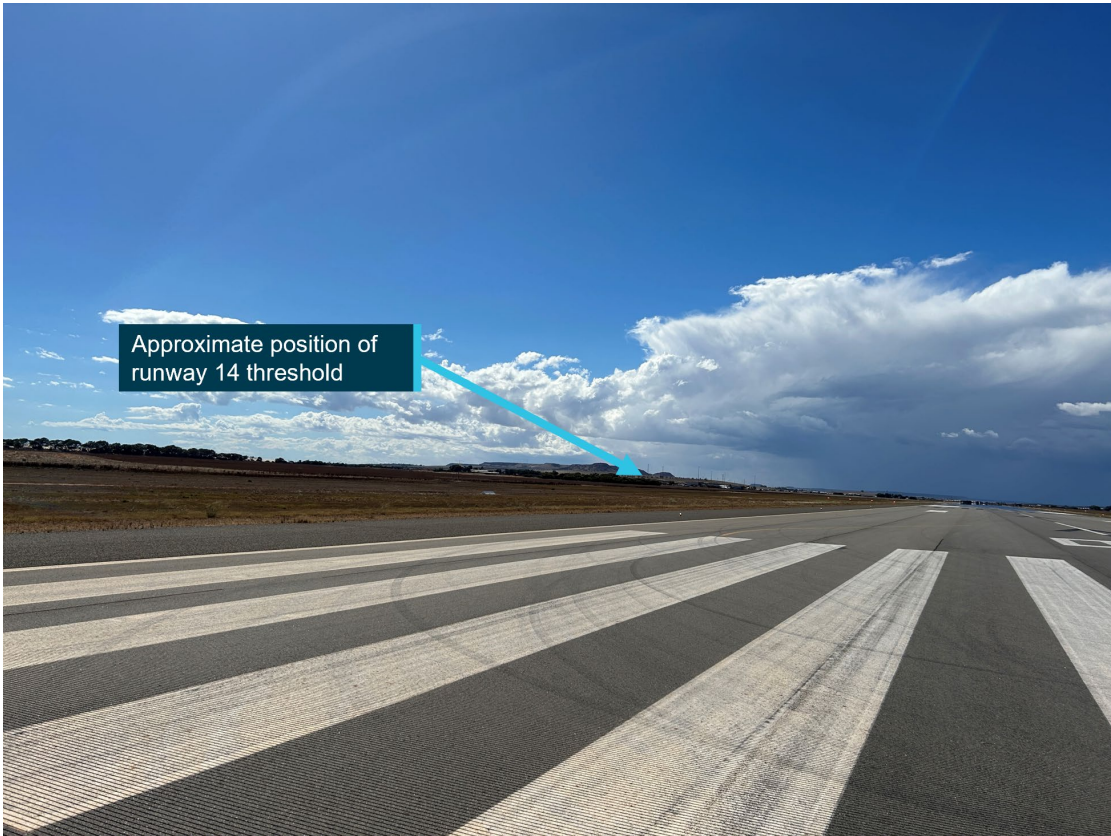
Figure 3: View of runway 14 threshold from runway 03 threshold

The pilots involved in this incident reported not being able to see each other from the thresholds of their respective runways and photographs obtained from Geraldton Airport (Figure 3, Figure 4) showed the visibility from the 03 and 14 runway thresholds.

The configuration of Geraldton Airport meant that when aircraft are operating simultaneously from the runway 03 and 14 (or 08) thresholds, they are likely not visible to each other, obstructed by the airport buildings situated between them. This was consistent with the photographs later taken from the runway thresholds. In this situation, pilots are solely reliant on VHF radio communications for maintaining situational awareness with other aircraft. However, from the informal testing conducted by Geraldton Airport and as shown in a previous ATSB investigation at a different airport, the location of infrastructure may also result in shielding of VHF transmissions, potentially rendering them weak and/or unreadable.

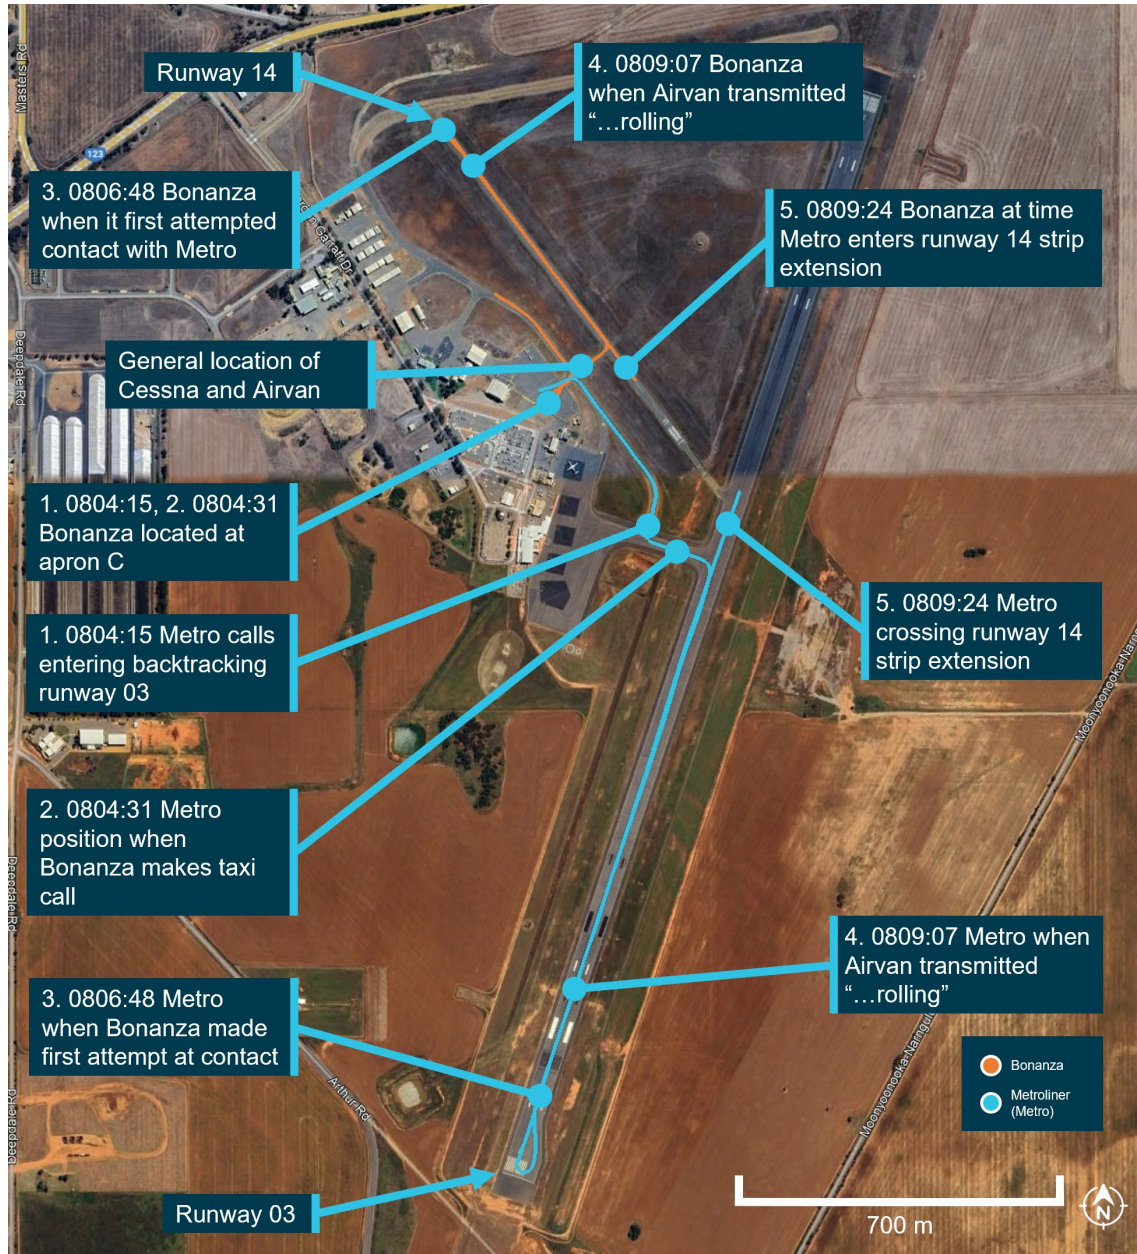
Figure 5: Flight tracking data overlay

Flight tracking data was retrieved from both the Bonanza and Metroliner. Key locations and associated transmissions/events are shown in Figure 5.

At the time the pilot of the Metroliner transmitted their entering/backtracking call (Figure 5, Label 1), the tracking data showed their position as approaching taxiway A, with the Bonanza located at apron C. When the Bonanza pilot made their taxi call the Metroliner was just entering runway 03 and both aircraft were still within line of sight (Figure 5, Label 2).

At 0806:48 (Figure 5, Label 3), the Bonanza was lined up and holding on runway 14 when the pilot made their first attempt to contact the Metroliner. The Metroliner had not yet reached the threshold of runway 03 and lined up on runway 03 at 0807:30.

At 0808:52, the Metroliner commenced its take-off roll, followed by the Bonanza rolling at 0808:55. When the Airvan pilot attempted to alert the Bonanza at 0809:07, the Bonanza had progressed about 100 m along runway 14. The Metroliner had progressed about 400 m (Figure 5, Label 4).

The Metroliner entered the runway strip of runway 14 just prior to 0809:24, about 400 m in front of the Bonanza, with about 250–300 ft vertical separation (Figure 5, Label 5). It was clear of runway 14 just after 0809:25. The Bonanza reached the centreline of runway 03 at 0809:33 by which time the Metroliner was at a distance of 560 m and climbing away from the Bonanza.
