# Hydraulics system failure involving Fairchild SA227-DC, VH-WAJ

Perth Airport, Western Australia, on 12 August 2024

**ATSB Transport Safety Report**

AO-2024-047

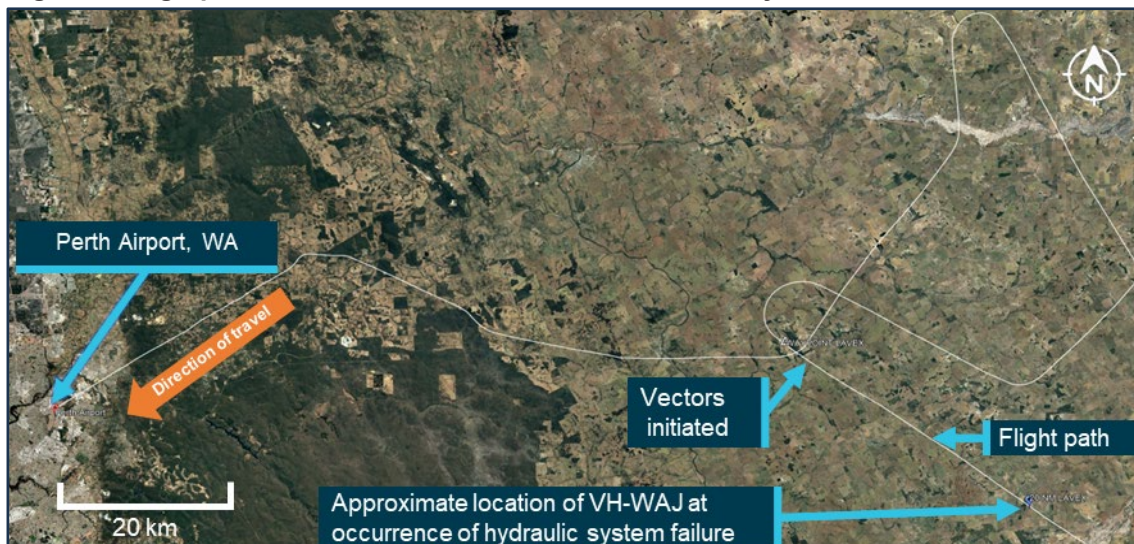
**Figure 1: Flightpath and location of VH-WAJ at the time of hydraulic failure**

At about 1000, the aircraft was close to the top of descent into Perth (Figure 1), when the right hydraulic system low-pressure annunciator light flickered and then subsequently remained solid, which indicated a system failure.

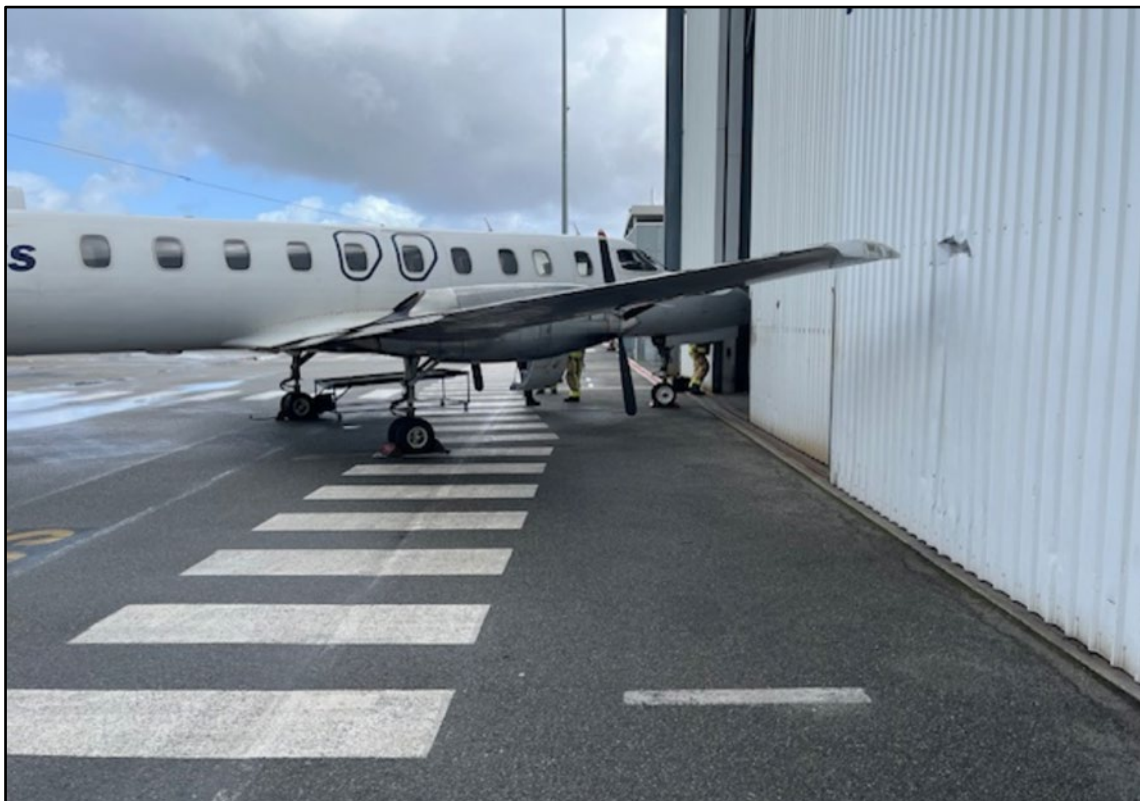
**Figure 2: VH-WAJ shown stationary after collision with operator’s hangar**

In an attempt to avoid collision with the hangar, the captain momentarily used reverse thrust, then shut down the engines and feathered<sup>4</sup> the propellers. However, the aircraft's right wingtip collided with the hangar at low speed, before the right propeller made contact. The impact resulted in minor damage to the right propeller and wingtip (Figure 2). All of the occupants disembarked safely, with no injuries to the crew or passengers.

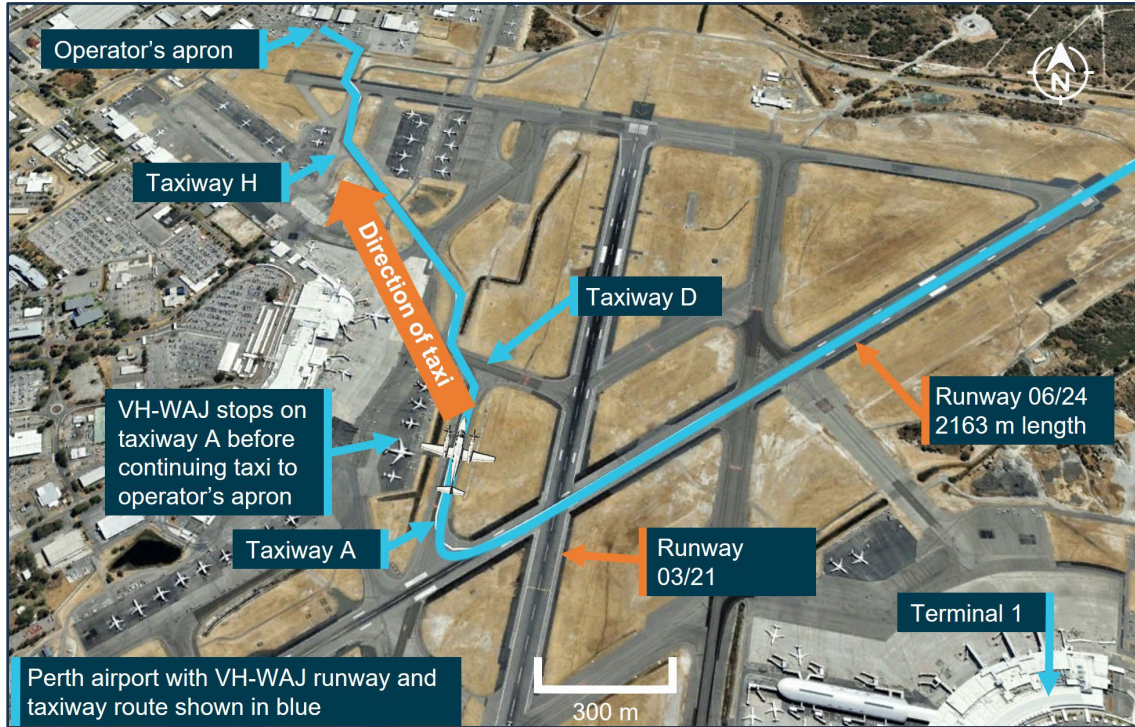
**Figure 3: Aerial view of Perth Airport showing the route used by VH-WAJ after landing**

A system of interconnected taxiways connects runways with terminals, aircraft aprons and hangars. The captain reported using asymmetric power to taxi (as nose wheel steering was not functional due to the hydraulics failure) at walking pace via taxiways D and H to the operator's apron.
