Collision with terrain involving Robinson R44 II, VH-XIX

50 km east of Young Airport, New South Wales, on 4 December 2024

ATSB Transport Safety Report
Aviation Occurrence Investigation
AO-2024-062
Preliminary – 20 February 2025

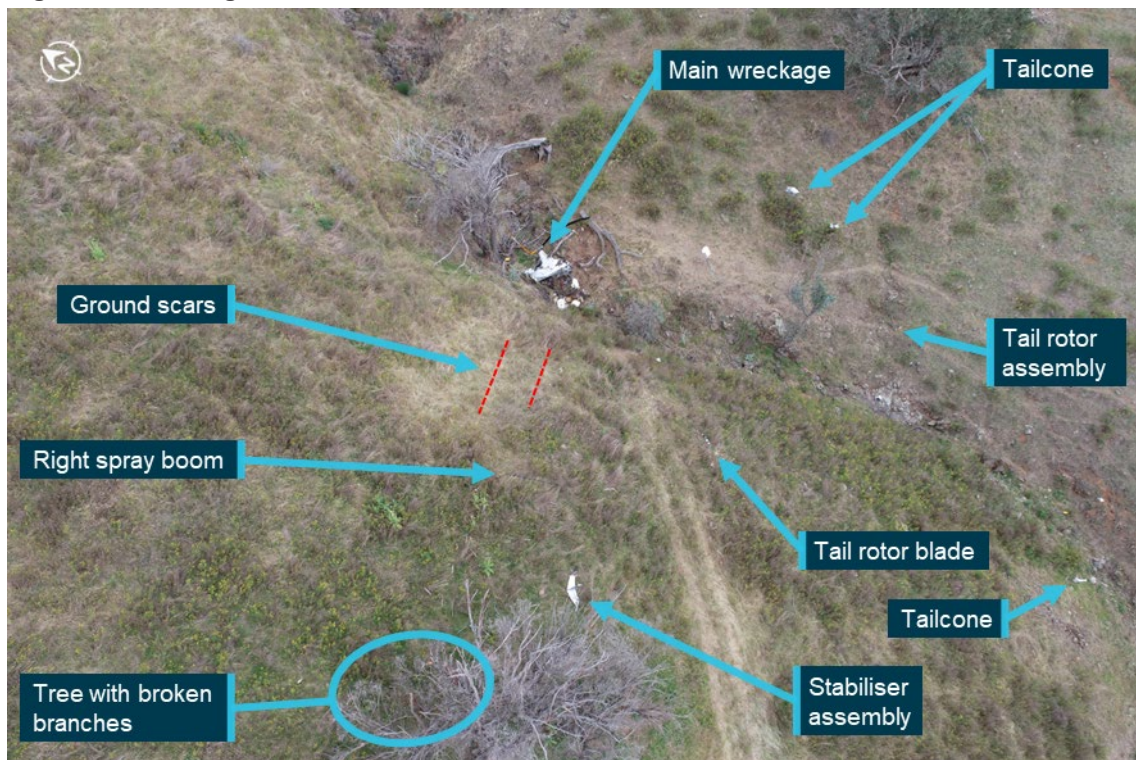
Figure 1: Wreckage site

The first items in the debris trail were the stabiliser assembly, right side carbon fibre spray boom and broken branches. These items were located next to a dead tree, with freshly broken branches on one side, near the top (Figure 1).

Two ground scars, consistent with the landing gear skids, were located between the tree and the wreckage in the gully. The ground marks were indicative of the upright helicopter sliding along the ground, prior to reaching the edge of the gully.

Note: Ground scars from the helicopter skids are highlighted red
Source: ATSB

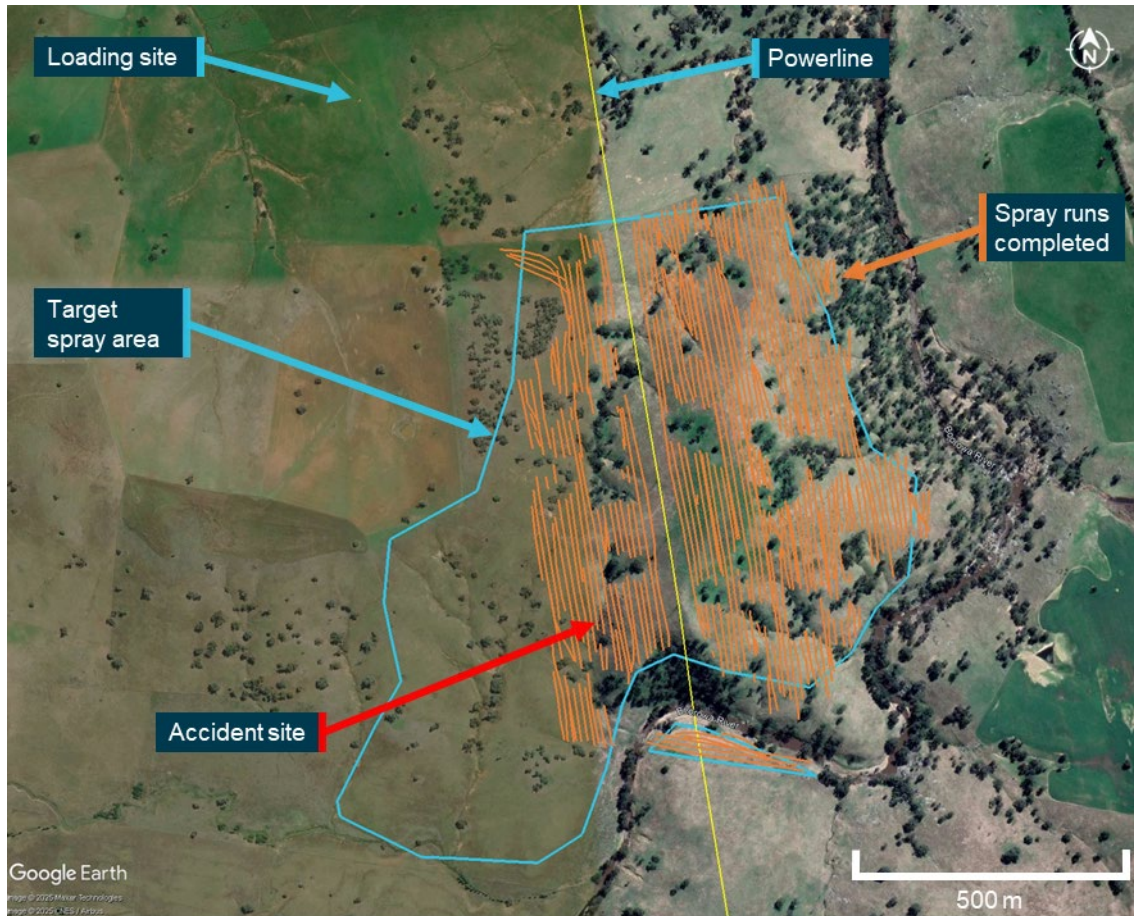
Figure 2: Tracmap spray runs completed

To assist with aerial application tasks, the helicopter was also fitted with a Tracmap GPS guidance device with recording capability. The flight tracks from the day of the accident were recorded and downloaded, including information about when the spray valve was open (Figure 2 in orange), up until a couple of minutes before the accident. Due to the sudden removal of power, some data collected towards the end of the flight was not able to be downloaded. A chip level recovery⁵ was conducted from the device but it contained no further information.

Note: The last few minutes of the flight and spray runs were not recorded.
 Source: Google Earth Pro, annotated by the ATSB using operator and onboard data sources
