Steering failure and contact with navigational beacon involving *CMA CGM Puccini*

Port of Melbourne, Victoria on 25 May 2023

Marine Occurrence Investigation

MO-2023-002

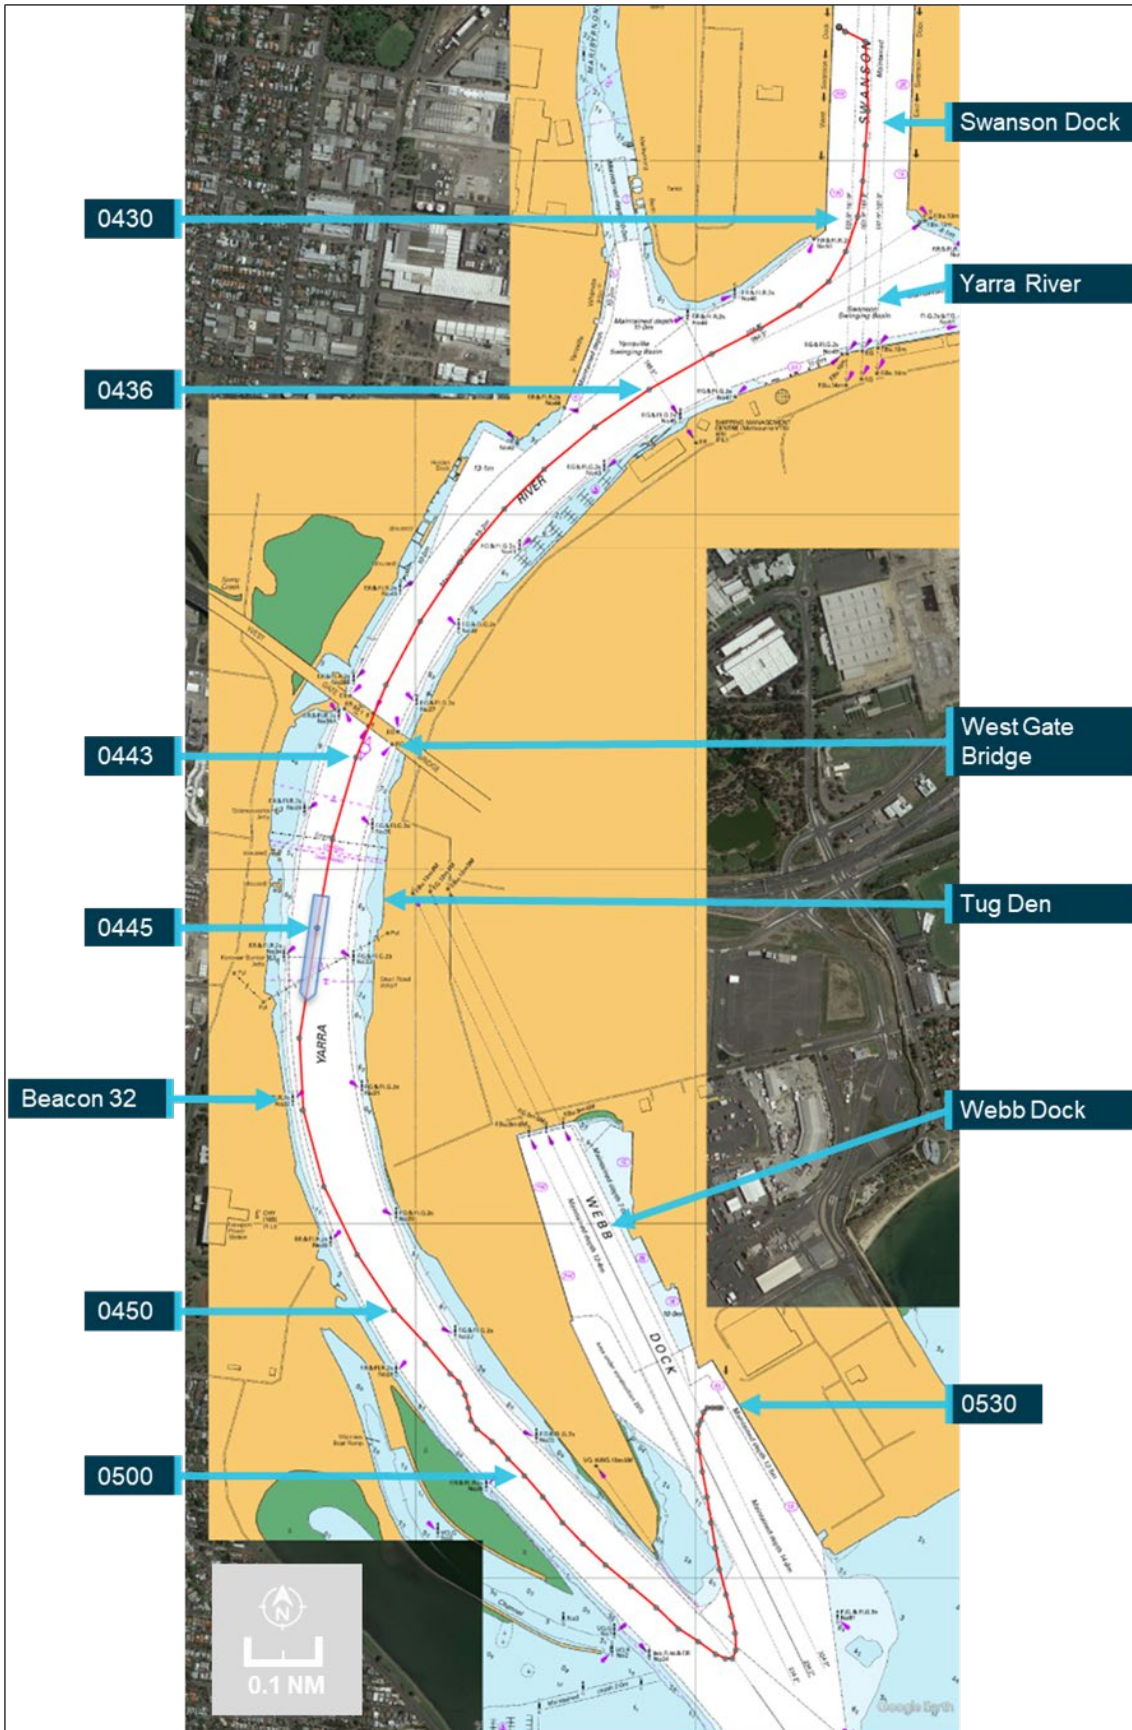
Figure 2: CMA CGM Puccini's track from Swanson Dock to Webb dock

By 0436, the ship was moving along the channel in the river, both tugs had been dismissed and the main engine was increased to slow ahead. At 0442, the ship passed under the Westgate bridge, about 1 mile⁴ downriver of Swanson Dock. The ship's speed was 6.6 knots⁵ with a rate of turn of 4° per minute to port. At 0443, the main engine speed was increased to half ahead⁶ and more rudder ordered (port 10)⁷ to increase the rate of turn. To maintain the turn rate, the pilot then gave helm orders (rudder) of port 5 (0443:34), followed by port 10 (0443:54).

The helmsman informed them that the rudder was not responding to the wheel. By that time, the chief mate had moved to the steering console to investigate and observed that the rudder moved to port 5 and then slowly to starboard 5. The ship, with its speed increasing and rate of turn diminishing, tracked toward the western edge of the channel and beacon 32. At the time, the ship's speed was 7.7 knots, it was turning to port at 3° per minute and was 7 m to starboard of its planned track.⁸

Further helm orders and helm movement indicated that the rudder was not responding. The master remained at the manoeuvring console and, after confirming with the pilot, reduced the main engine speed to slow ahead, and then (0444:50) to dead slow ahead. The master confirmed that the bow thruster was operational and suggested further slowing the ship (to less than 5 knots) to make the thruster effective.

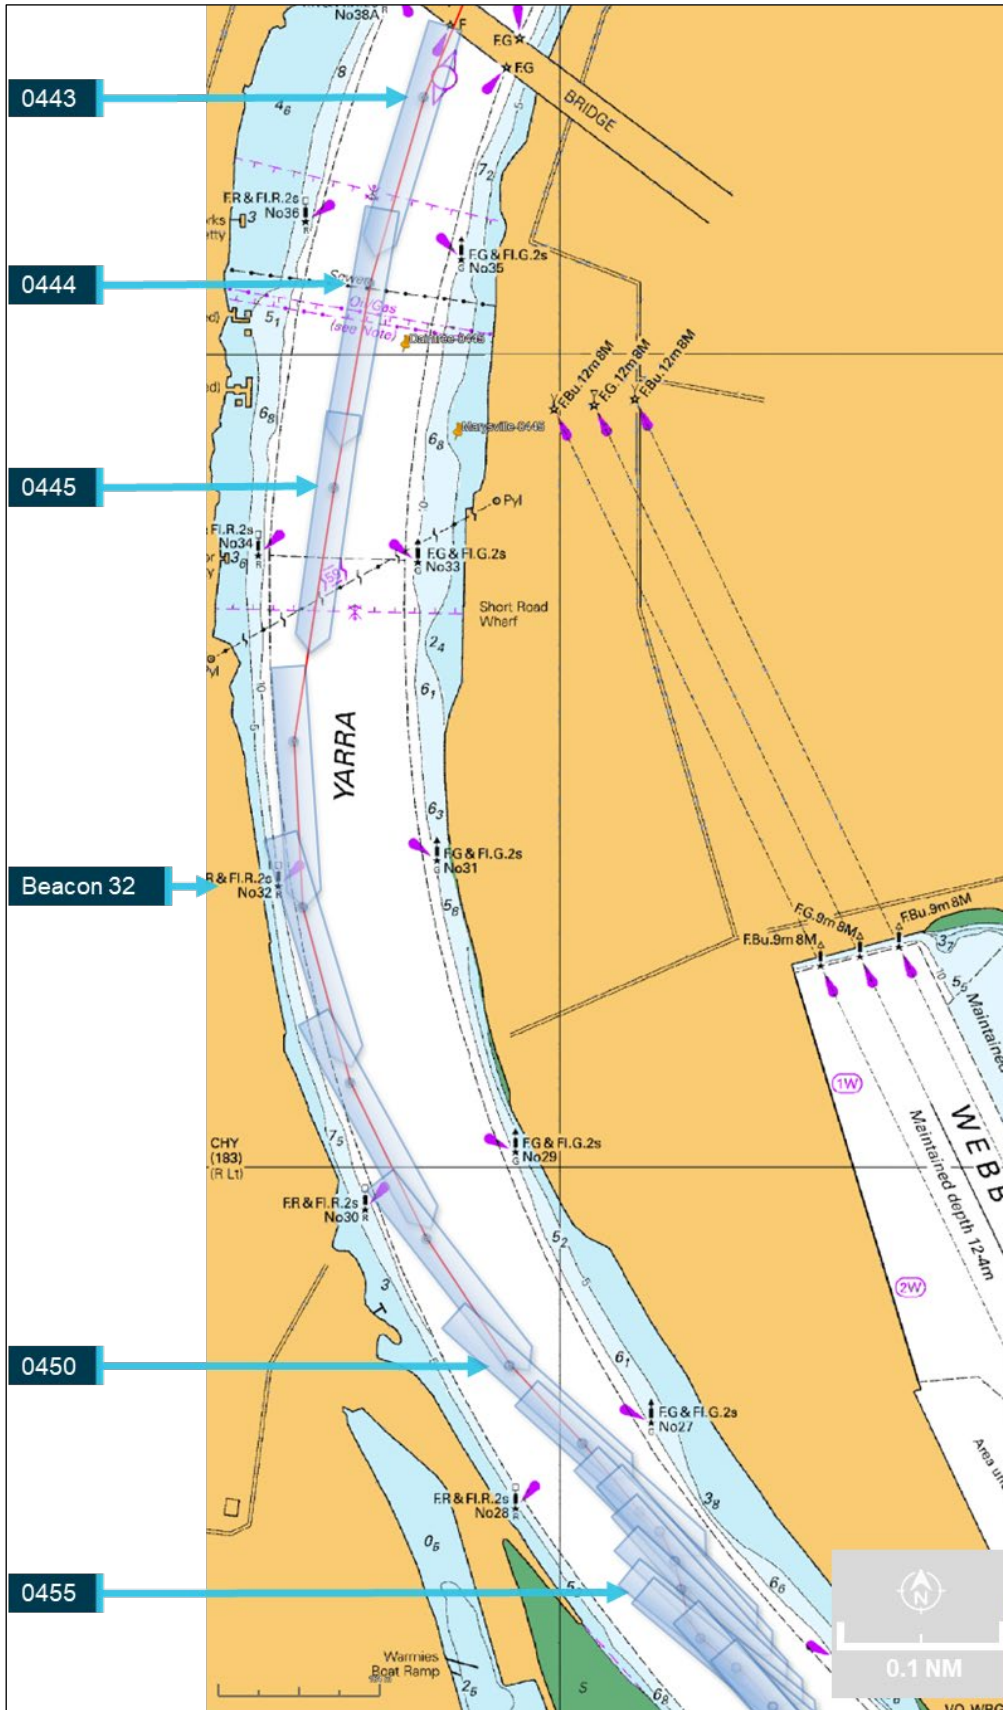
Figure 3: CMA CGM Puccini's track showing contact with Beacon 32

Shortly thereafter, the rudder was observed to move to 35° to port (wheel was hard to port). The main engine was restarted, and the bow thruster set full to port. At 0445:30, the ship's rate of turn to port suddenly increased as its bow closed with the side of the channel. By 0445:44, the ship's speed had reduced marginally (to 7.9 knots) and its swing to port had increased to 13° per minute, with the bow now less than 20 m from channel's edge. The pilot ordered the rudder midships and immediately after to starboard 20 to reduce the increasing swing to port with the aim of avoiding the ship's stern closing and contacting the western bank or shoals (Figure 3).

At 0446:12, the ship was 58 m to starboard of the planned track with significant headway (7.7 knots) and turning rapidly to port (20° per minute) with the bow only about 12 m from the 10 m depth contour and shoal water. Hard starboard rudder and bow thruster full starboard were ordered and the rudder observed to move to about 20° to starboard. However, as *CMA CGM Puccini* was swinging to port, its stern was swinging in the opposite direction (to starboard) and contacted beacon 32. The impact resulted in damage to the beacon, which canted over about 20° from the vertical (cover photo). The ship's side paintwork was scratched due to scraping against the beacon.

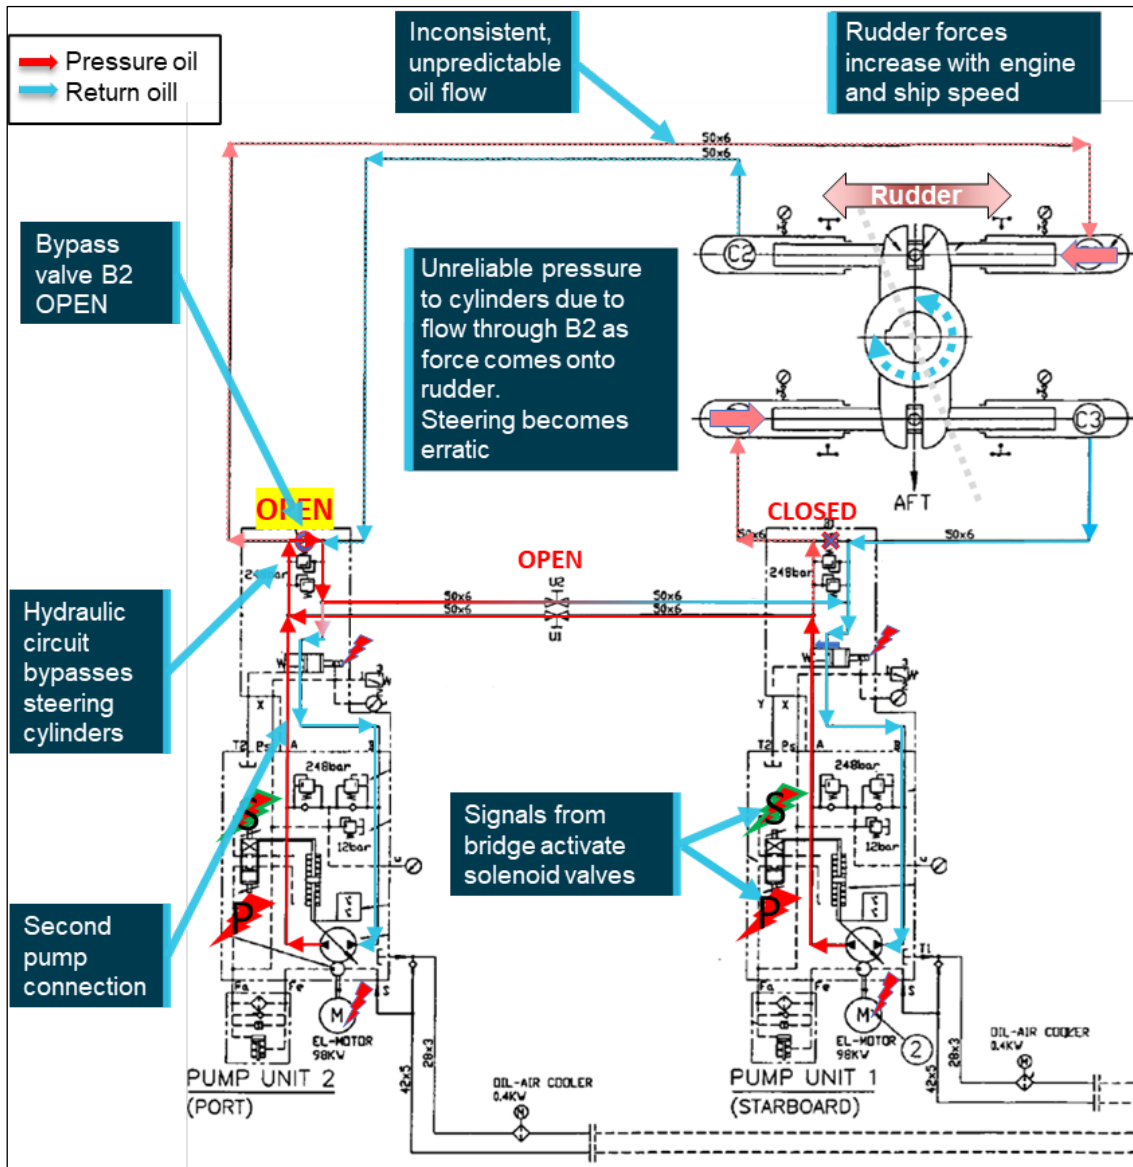
Figure 8: Steering gear hydraulics with both pumps running and one pump bypass valve open

Following steering tests conducted for port State control inspections on the day before the incident, one of the hydraulic pump bypass valves was left open. This resulted in the steering system hydraulics being incorrectly configured for normal operation.

The steering pump bypass lines were about half the diameter of the system flow lines (Figure 9). The difference in pipe diameter allowed the majority of oil flow to pass to the hydraulic cylinders, with leakage through the open valve around the pump. With the ship alongside and with no water flow over the rudder, the load on the rudder was minimal and the hydraulics moved the rudder as expected and sufficiently well to pass the visual observations.

The open bypass valve would have slowed the speed of response but the system, with either, or both pumps running, was still capable of moving the rudder. This was probably the case during the PSC inspection, as well as during pre-departure steering checks.

However, when the ship was underway and the main engine speed was increased, as the rudder was moved and a larger surface area was exposed to the water flow, the load on the rudder increased. At low speeds, the hydraulic system pressure and flow were sufficient to overcome the rudder loads. However, as the main engine was increased to half ahead, and the ship's speed exceeded about 8 knots, the hydraulics were then adversely affected by the flow through the open bypass valve, leading to inconsistent, erratic response of the machinery. Control of the steering was subsequently lost, with the ship turning wide in the channel and making contact with the navigational beacon.
