# Collision with terrain involving Bell 206B-1, VH-ZDI

9.3 km south-south-east of Tumbarumba, New South Wales, on 16 July 2023

## **ATSB Transport Safety Report**

AO-2023-034

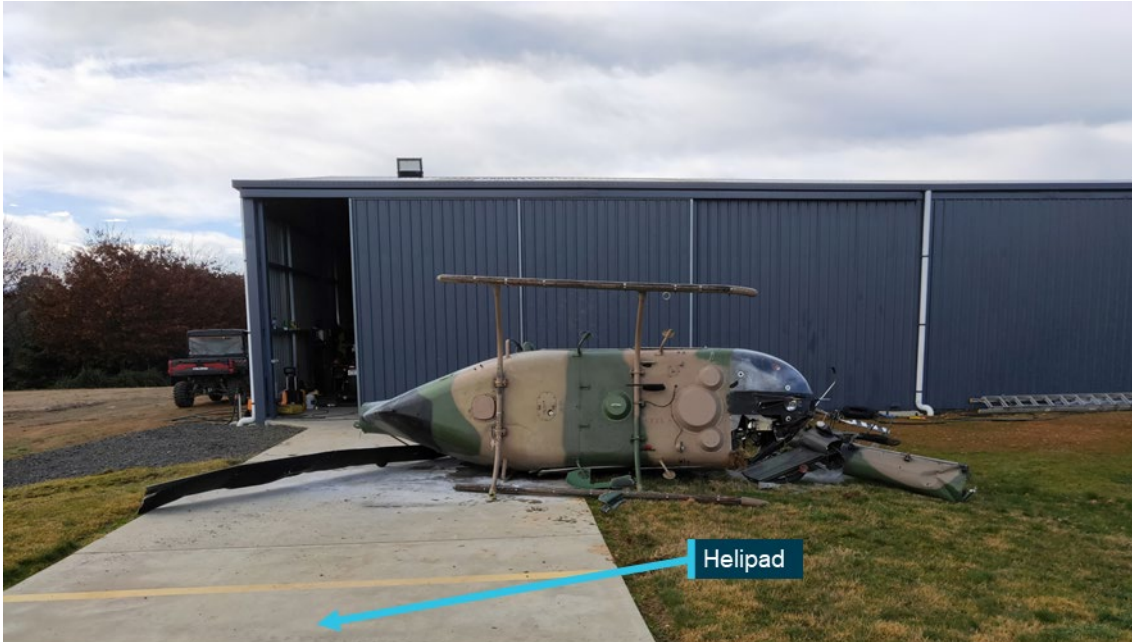
**Figure 1: VH-ZDI in final resting position**

Initially, the left skid contacted the soft earth beside the helipad and broke off. The helicopter then rolled over coming to rest on the left side. The pilot reported that they switched the fuel valve into the 'off' position as the helicopter contacted the ground. The front passenger was able to exit the helicopter with the assistance of the pilot. They then assisted the rear passengers to exit, whereupon all occupants moved away from the helicopter. The pilot collected fire extinguishers

and discharged them into the engine exhaust. There were no injuries. The helicopter was substantially damaged.

The ATSB's examination of the site photographs provided by the pilot and the insurer found that the damage to the helicopter was consistent with a heavy landing and rollover event. The relative locations of the major components were consistent with power being supplied to the main rotor just prior to, or during, impact. The proximity to the ground and integrity of the occupant space contributed to a high probability of occupant survival.

The insurer's assessment reported that they were not able to confirm the pre-event serviceability of the tail boom attachment bolts. The tail boom was attached to the fuselage by 4 bolts. Two of the bolts had fractured and laboratory examination conducted by the ATSB identified that the failure of the bolts was consistent with overstress. There was no evidence of pre-existing flaws or fatigue. Overall, the insurer concluded that the tail boom exhibited damage consistent with impact from a main rotor blade on the left side.

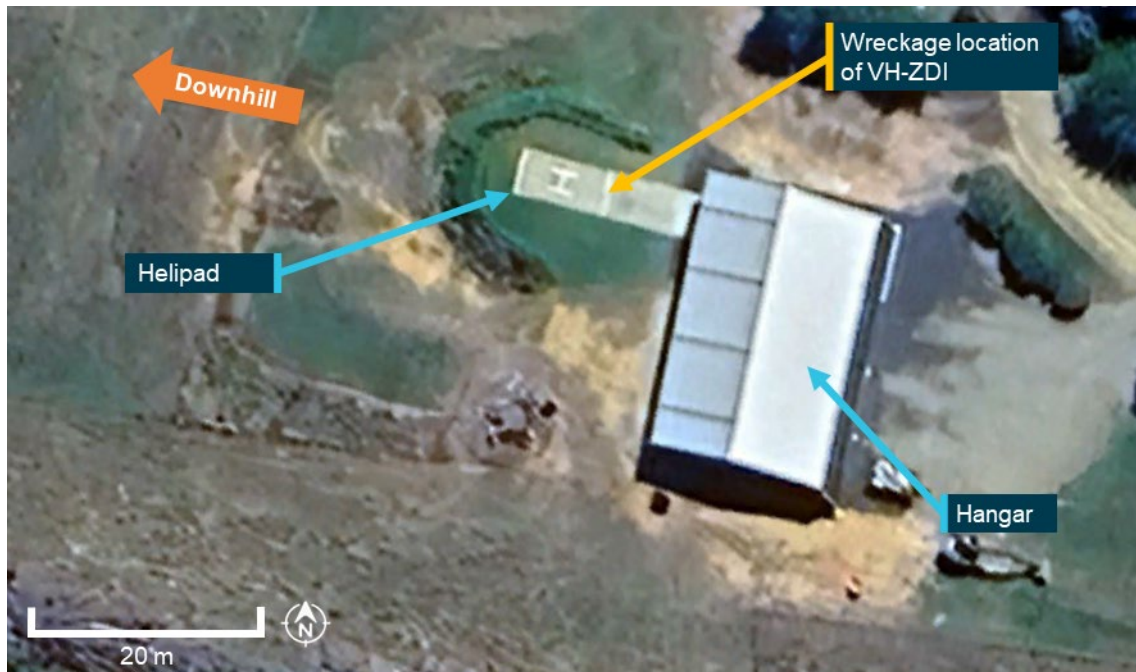
**Figure 2: Helipad location**

The helipad (Figure 2) was a concrete pad, large enough to accommodate the helicopter. It adjoined a hangar, with the terrain sloping downwards to the west, away from it. The centre of the helipad was around 16 m from the hangar. The elevation of the pad was about 1,962 ft.

The method used to conduct a take-off from the helipad was to push the helicopter out of the hangar tail first (towards the west) and position it such that the tail was over the downhill slope, affording the helicopter the greatest possible clearance from the hangar. The pilot would initiate a hover while facing the hangar, rotate left 180°, before commencing forward flight.

The pilot described experiencing helicopter-building interference from the hangar on other occasions. They stated that they had only experienced interference when they came into land and did not position the helicopter on the ground quickly. They likened the experience to rotor-head shake, bad turbulence, and bad air.

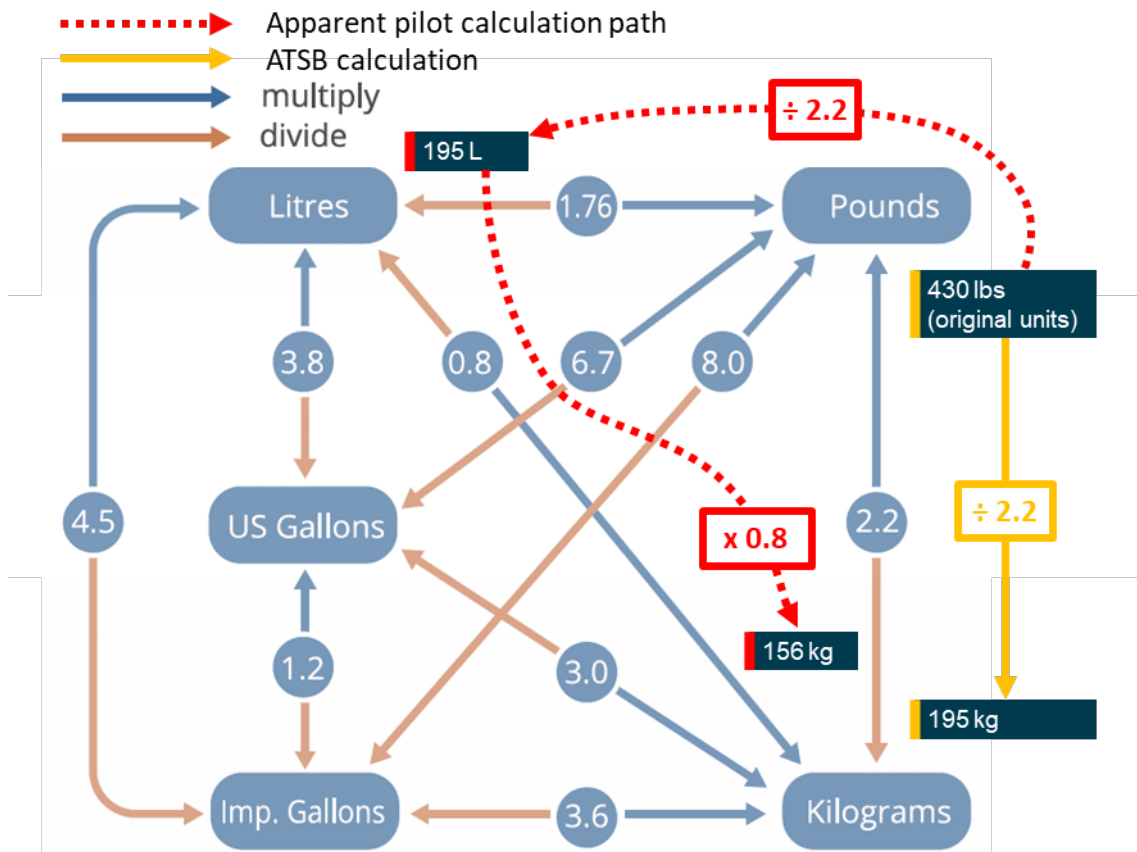
**Figure 3: JetA1 fuel conversion chart**

The pilot performed a weight and balance assessment prior to commencing the flight. In their handwritten calculations, the pilot included the weight and position of the 4 occupants and 430 lbs of JetA1 fuel. Calculation of the weight and centre of gravity required converting the fuel amount from the indicated units of lbs to kg, as all other amounts were measured in kgs. When converting the fuel from lbs to kg, the pilot mistakenly substituted volume, L, for mass, kg, and believed they had converted 430 lbs to 195 L (with the conversion factor of  $\div 2.2$ ) (Figure 3). They subsequently converted 195 L to weight (with the conversion factor  $\times 0.8$ ), arriving at 156 kg of fuel. This resulted in the pilot calculating the weight of the helicopter to be 1,428 kg (Figure 4). The pilot also listed the MTOW for the helicopter as 1,455 kg. This led the pilot to believe the helicopter was 27 kg under its MTOW.

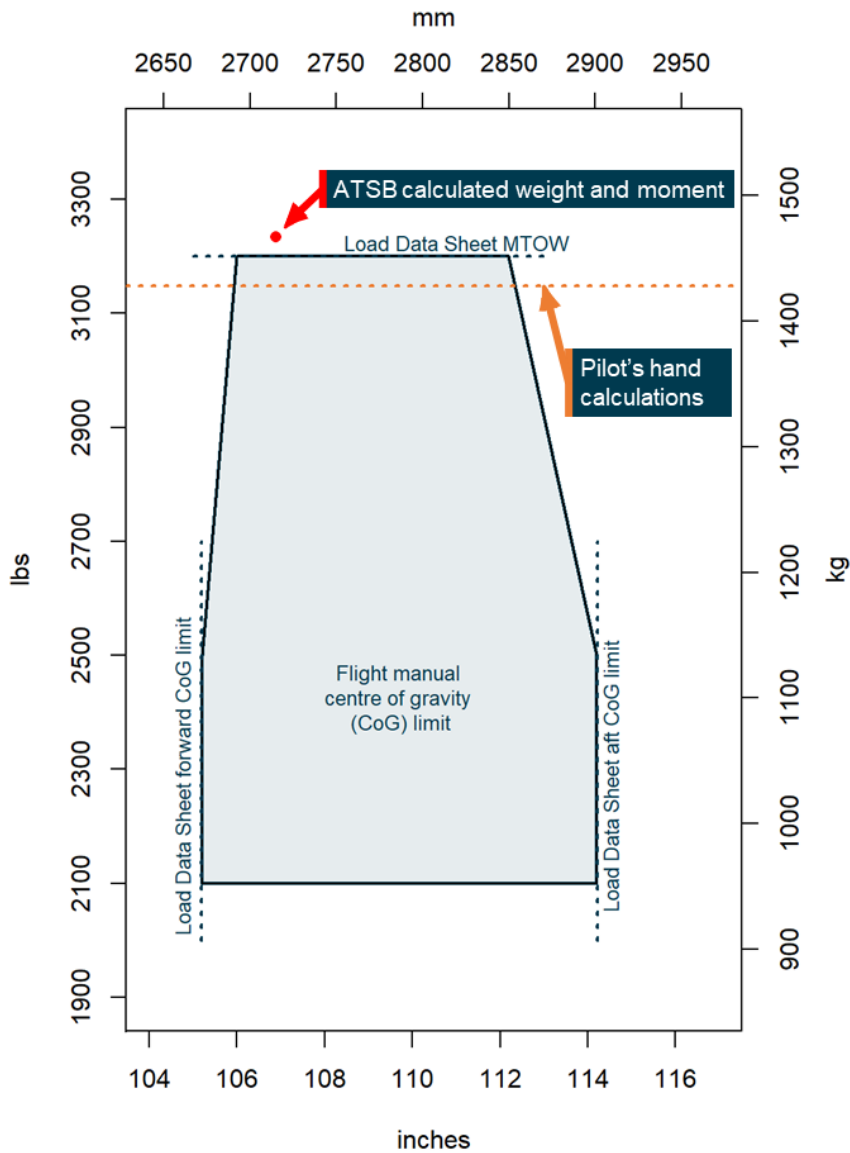
Figure 4: VH-ZDI weight and balance limits and calculations

listed the MTOW as 1,452 kg, the forward centre of gravity limit as 2,672 mm and the aft limit as 2,901 mm (Figure 4).

The ATSB performed a weight and balance calculation with the information provided by the pilot and determined the take-off weight to be 1,467 kg with an associated moment arm of 2,715 mm (Figure 4). This exceeded the MTOW of the helicopter by 15 kg.

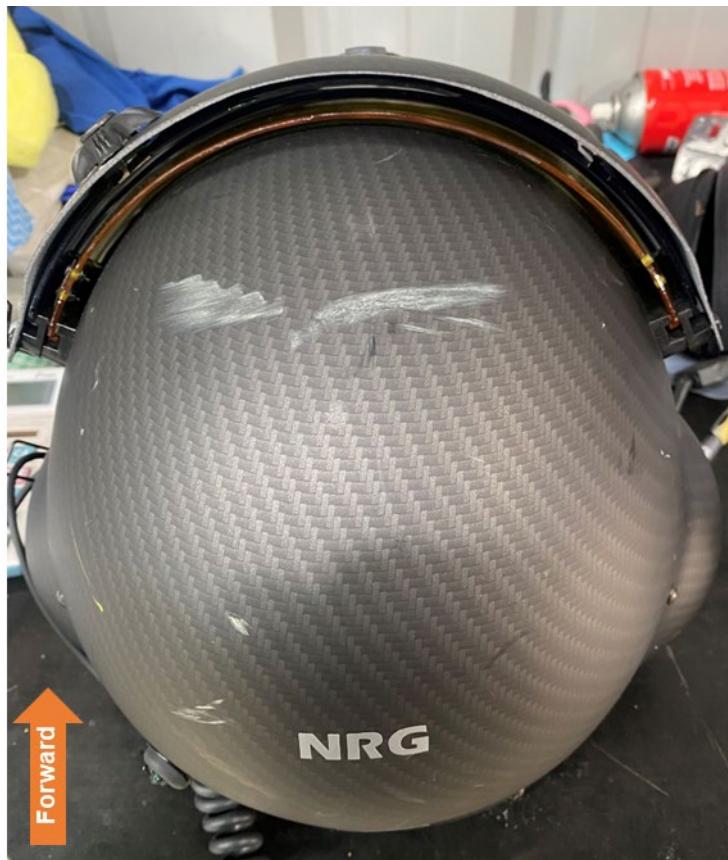
**Figure 7: Top view of helmet worn by the pilot of VH-ZDI showing damage**

The Flight Safety Foundation (2022) stated that the primary purpose of a helmet was to provide impact protection and thereby reduce the risk of head injury in the event of an accident. The helmet worn by the pilot was damaged (Figure 7), indicating that the helmet sustained an impact during the accident sequence.

The front occupants of the helicopter were wearing 5-point turn-to-open restraints, while the rear occupants were wearing 4-point lift-latch-to-open restraints. The pilot was also wearing a helmet, on which only minor damage was observed. There was no comparative evidence, such as, one occupant with a seatbelt and one without to determine whether the severity of the accident was such that the occupants would have sustained greater injury if they were not wearing seatbelts. Nevertheless, the literature indicated that the use of upper and lower torso restraints and helmets reduces the risk of injury.
