# Partial power loss and collision with terrain involving Cessna 208, VH-UMV

near Barwon Heads Airport, Victoria on 20 October 2023

Aviation Occurrence Investigation (Systemic)

AO-2023-049

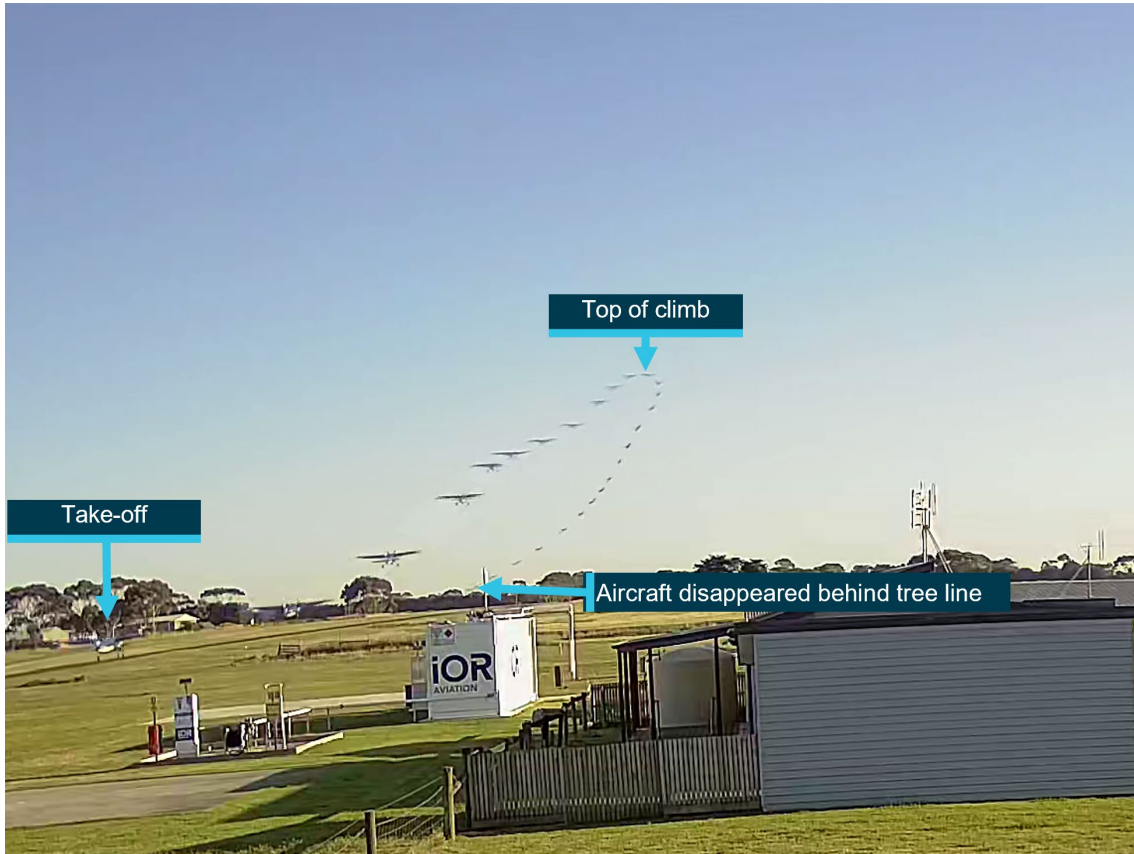
**Figure 1: VH-UMV flight path captured by the airport camera**

*The ATSB combined multiple images together to show the flight path of the aircraft as captured by a local video camera. Source: Airport operator, annotated by the ATSB*

The pilot reported that, as the aircraft descended, they observed the engine torque indication reducing through approximately 30% and attempted to switch off the TTL in accordance with the operator’s Engine Power Loss checklist. Due to the aircraft’s low height above the ground, and the pilot’s assessment that there was an engine issue, the pilot then selected a field in which to conduct a forced landing.

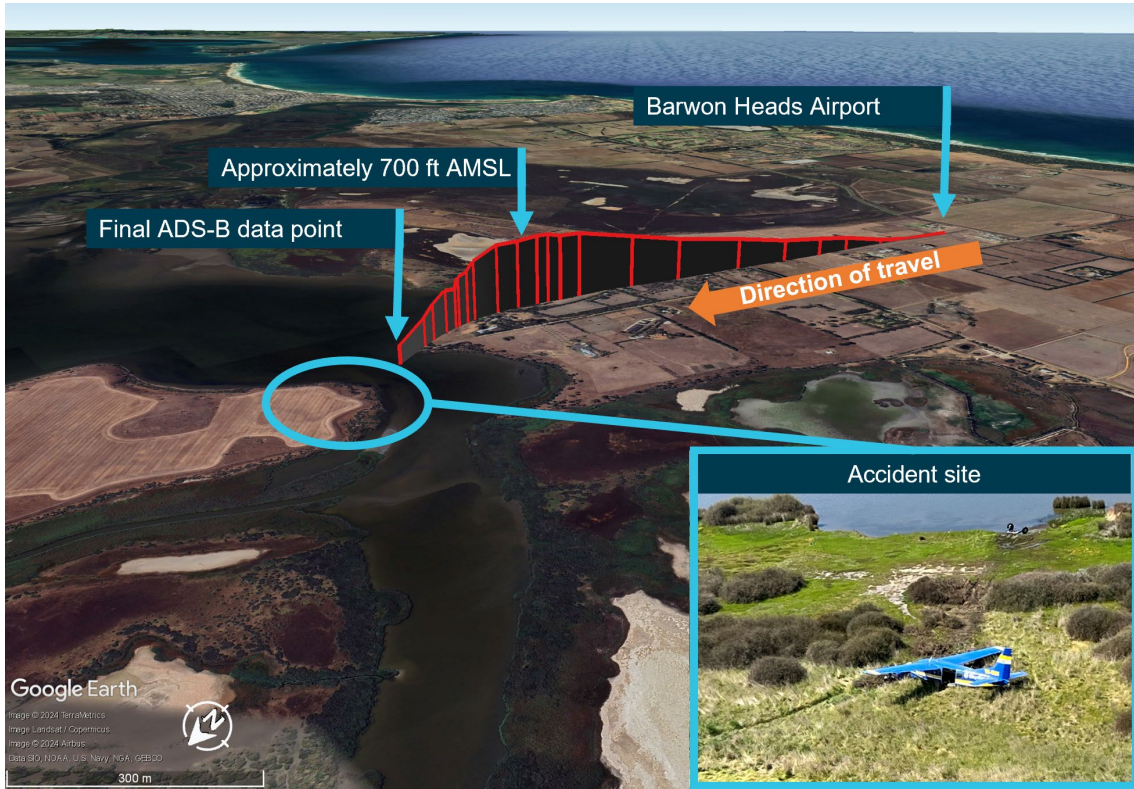
Figure 2: VH-UMV flight path

The pilot sustained minor injuries, 6 parachutists sustained serious injuries, 8 sustained minor injuries and 2 were uninjured. The aircraft was substantially damaged.

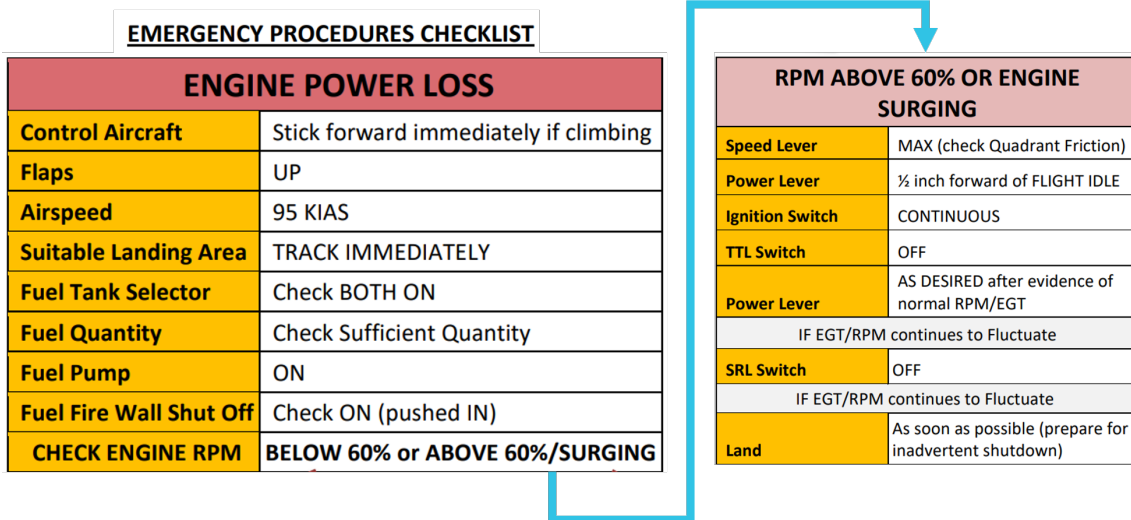
Figure 3: Engine power loss checklist

The Texas Turbine Conversions AFM supplement provided checklists for engine failures, but not for partial engine power loss. The operator’s ‘Engine Power Loss’ checklist for the C208 with the Honeywell engine (Figure 3), required pilots to first control the aircraft by moving the elevator control forward to lower the aircraft’s nose if climbing. After completing initial checks, if the RPM was above 60% or the engine was surging, the pilot was to move the power lever to ½ inch (12.7 mm) forward of the flight idle position, in preparation for turning off the TTL, so as not to produce a transient exceedance of the EGT.

Additionally, in the absence of an aircraft manufacturer’s checklist for partial power loss, the operator had created an engine power loss checklist. The first item was to immediately move the elevator control forward if climbing to prevent airspeed decay. After other initial actions, the checklist then instructed pilots to significantly reduce power if the engine RPM was above 60% or surging, in preparation for switching off the TTL. While that was intended to ensure engine limits would not be exceeded when the pilot subsequently reintroduced power, the operator did not specify a minimum height at which it was appropriate for a power reduction to be made.

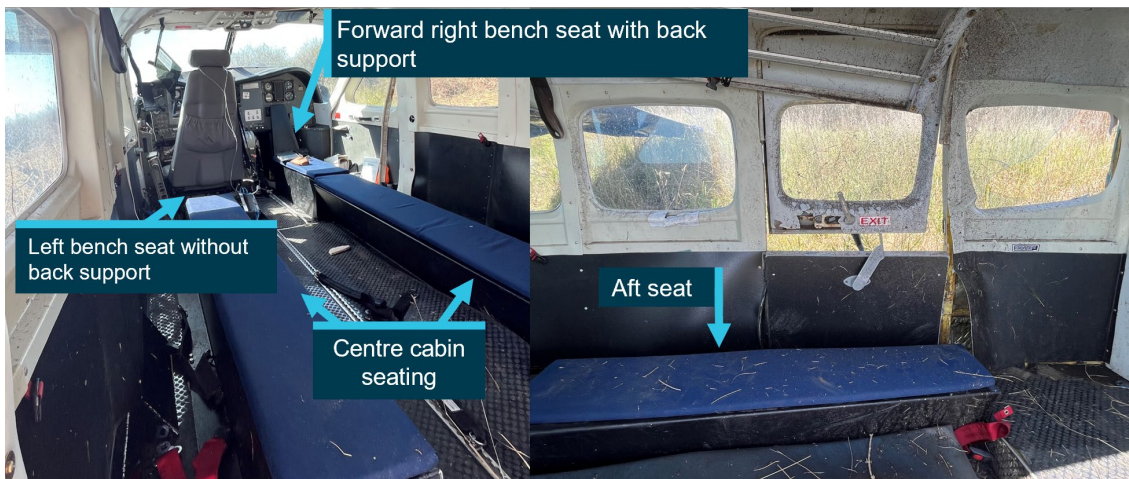
**Figure 6: VH-UMV cabin seating arrangement**

The basic empty weight of the aircraft did not include the flooring, or the 36 kg bench seating installed under engineering order ESE-C208-25-007. The engineering order provided the moment arms and weights shown in Table 3.

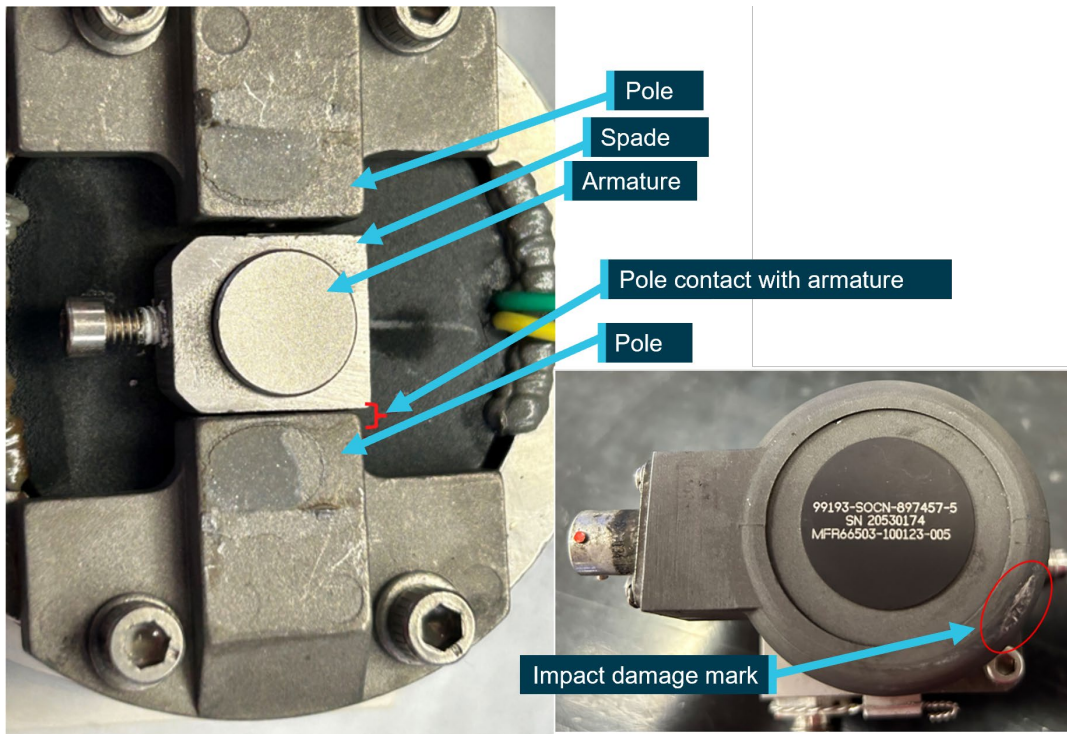
**Figure 7: Fuel bypass valve**

Initial inspection of the fuel bypass valve's outer casing revealed impact markings (Figure 7). When the protective cover plate was removed, the pole associated with the impact side was found in contact with the armature. When a 4.5 kg (10 lb) force was applied to each of the poles, there was no visible movement. The armature was cut away from the spade to determine if the armature screws were loose. The armature screws were found to be suitably tightened, and the armature was not bent.

The findings of the inspection showed the out-of-limit test results were due to impact damage resulting from the accident. As such, the higher fuel bypass identified in the test was not considered to be contributory.

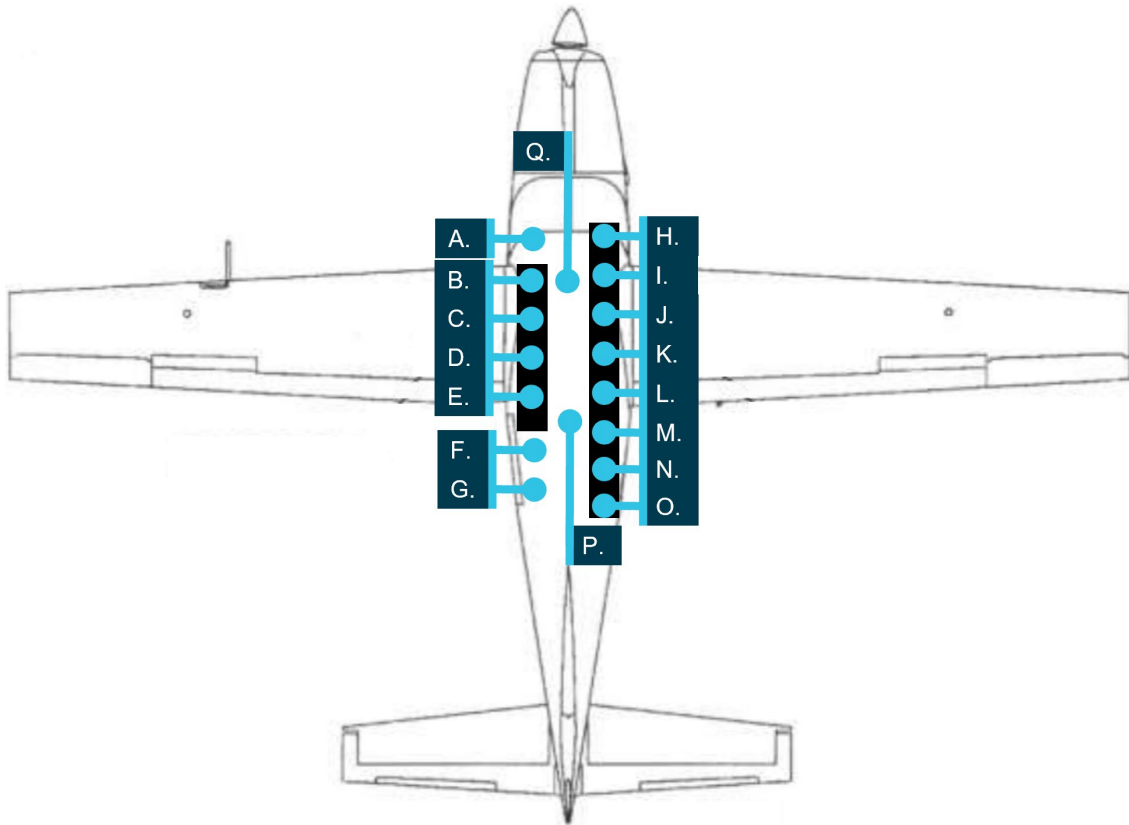
**Figure 9: Seating positions**

B.	Pulmonary contusion, fifth and sixth rib fractures, psychological trauma, and lower back pain	Serious	Slipped off the end of the bench seat and ended up squashed against the ladder or back of the pilot seat due to a loose restraint

C.	No reported injuries	No injuries	
D.	Tears to both rotator cuffs, tear to sternocleidomastoid muscle, and nerve damage to left arm and shoulder	Serious

E.	Broken ribs and internal bleeding to the chest.	Serious	Loose restraint
F.	Whiplash, fractured L4 transverse process, and nerve pain in right shoulder and leg	Serious	Loose restraint, seated on floor; adjacent end of bench seat

Image reference	Injuries sustained	ATSB injury classification	Survivability Comments
J.	Whiplash, cuts, and bruising	Minor	Loose restraint
K.	Whiplash, cuts, and bruising	Minor	Loose restraint
L.	Cuts to head, face, internal chest cuts, and bruising	Minor	Tight restraint
M.	Broken tailbone, bruising	Serious	Tight restraint
N.	Concussion, and bruising	Minor	
O.	Swollen knee, bruised kidney, bruised vertebrae, and strained neck ligaments	Minor	Loose restraint
P.	Internal abdomen bleeding, Internal hematoma inner right leg, cuts, bruising, whiplash, and back pain.	Serious	Loose restraint; inappropriate structures around/in front
Q.	No reported injuries	No injuries

The single point restraints could not be adjusted, but an occupant could potentially position themselves such that the restraint was taut. Nine parachutists provided information about the tightness of their restraint; 7 reported their restraints were loose and 2 reported tight restraints. Of those with loose restraints, 3 sustained minor injuries and 4 sustained serious injuries. Of the 2 parachutists who reported having tight restraints, one sustained minor injuries and the other sustained serious injuries.
