# Partial power loss and collision with terrain involving Cessna 208, VH-UMV

near Barwon Heads Airport, Victoria on 20 October 2023

## **ATSB Transport Safety Report**

AO-2023-049

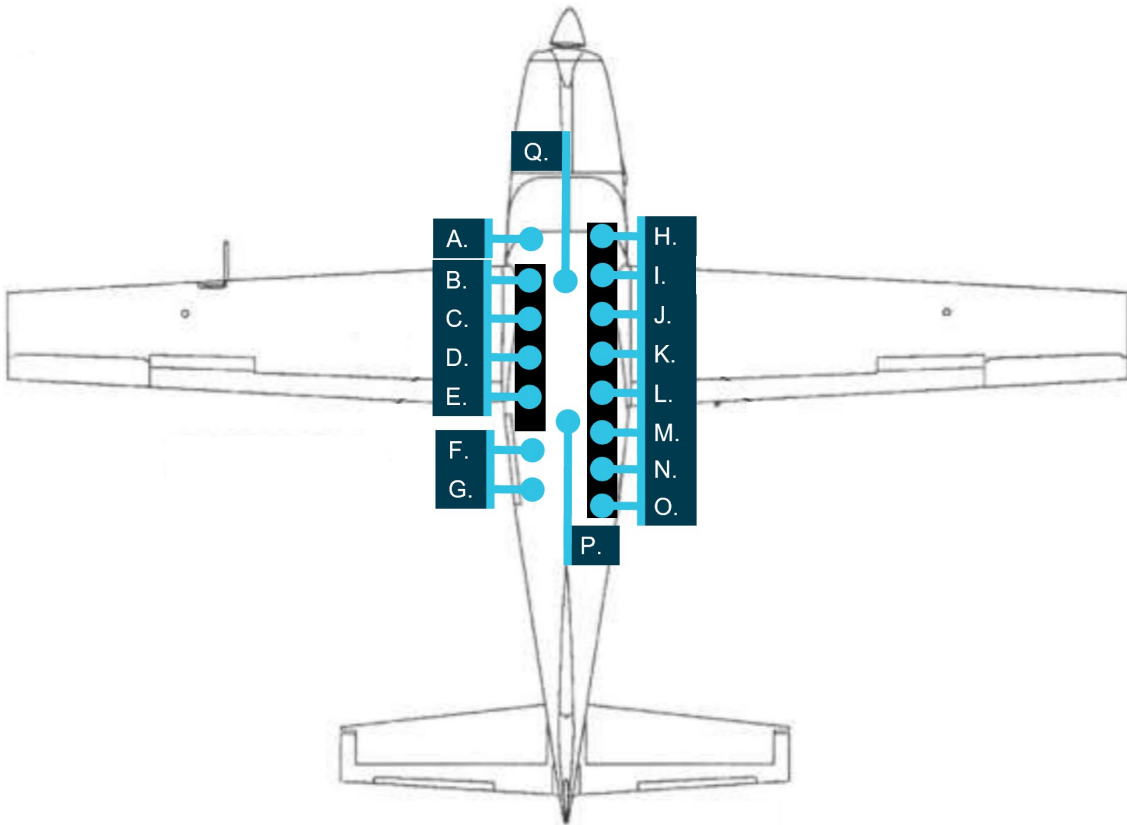
**Figure 9: Seating positions**

B.	Pulmonary contusion, fifth and sixth rib fractures, psychological trauma, and lower back pain	Serious	Slipped off the end of the bench seat and ended up squashed against the ladder or back of the pilot seat due to a loose restraint

C.	No reported injuries	No injuries	
D.	Tears to both rotator cuffs, tear to sternocleidomastoid muscle, and nerve damage to left arm and shoulder	Serious

E.	Broken ribs and internal bleeding to the chest.	Serious	Loose restraint
F.	Whiplash, fractured L4 transverse process, and nerve pain in right shoulder and leg	Serious	Loose restraint, seated on floor; adjacent end of bench seat

Image reference	Injuries sustained	ATSB injury classification	Survivability Comments
J.	Whiplash, cuts, and bruising	Minor	Loose restraint
K.	Whiplash, cuts, and bruising	Minor	Loose restraint
L.	Cuts to head, face, internal chest cuts, and bruising	Minor	Tight restraint
M.	Broken tailbone, bruising	Serious	Tight restraint
N.	Concussion, and bruising	Minor	
O.	Swollen knee, bruised kidney, bruised vertebrae, and strained neck ligaments	Minor	Loose restraint
P.	Internal abdomen bleeding, Internal hematoma inner right leg, cuts, bruising, whiplash, and back pain.	Serious	Loose restraint; inappropriate structures around/in front
Q.	No reported injuries	No injuries
