Collision with terrain involving Oficinas Gerais de Material Aeronautico DHC-1 MK 22 Chipmunk, VH-POR

Jandakot Airport, Western Australia on 26 April 2024

ATSB Transport Safety Report

AO-2024-013

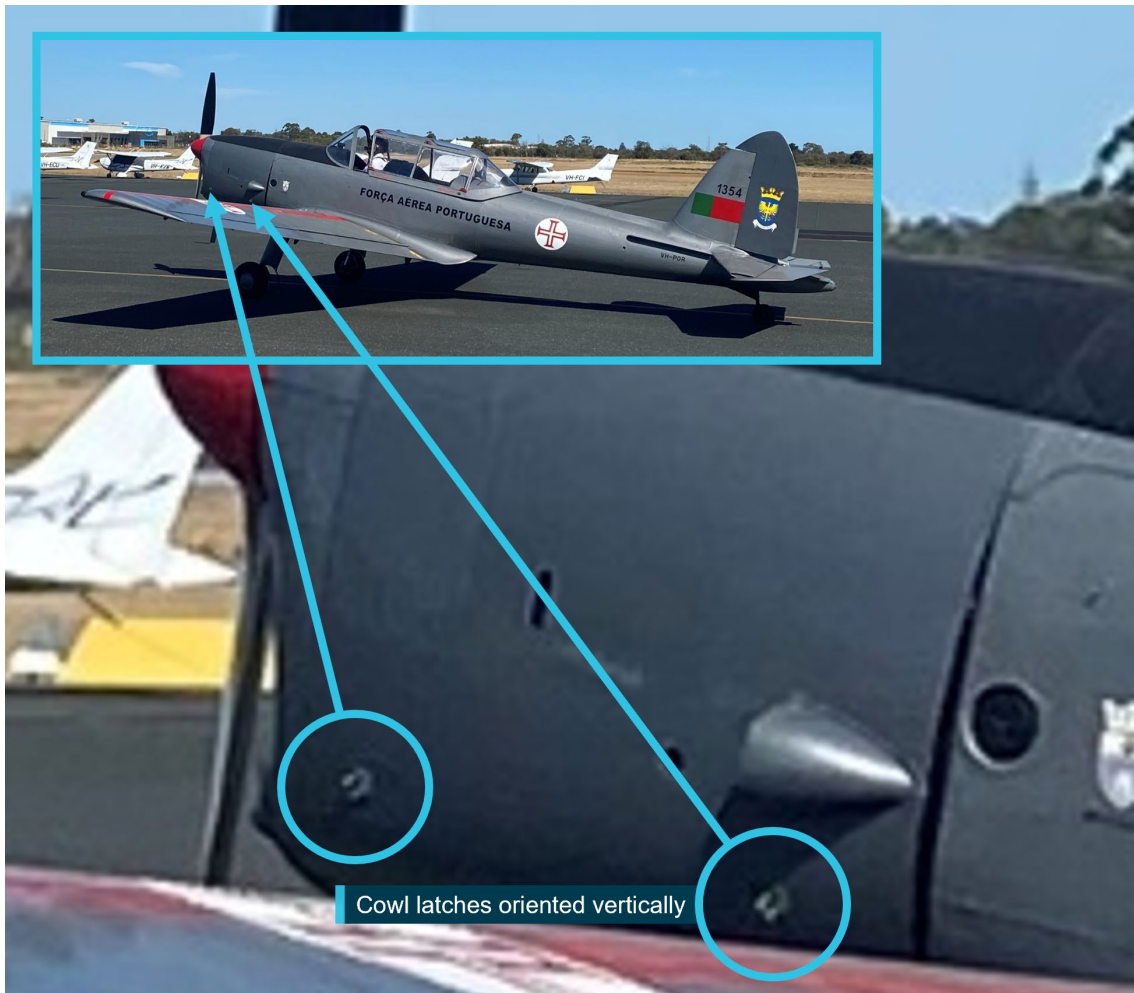
Figure 1: VH-POR taxiing for take-off

A witness on the southern apron took photographs of the aircraft taxiing past, which show the engine cowl latches on the left side were oriented vertically¹ (Figure 1).

The gap at the rear edge of the cowl is normally present when the cowl is closed fully.
Image source: Witness, annotated by the ATSB

In preparing the aircraft for flight, it is possible that the fuel line priming and carburettor flooding functions were carried out by opening the left engine cowl, rather than via the openings on it, and that the cowl was then left unsecured. Alternatively, the cowl might have been opened for another reason or left unfastened from previous activities. In any case, the pilot did not detect that the engine cowl latches on the left side had been left unfastened prior to boarding the aircraft and commencing taxi. After take-off, the cowl was free to open and close in flight.

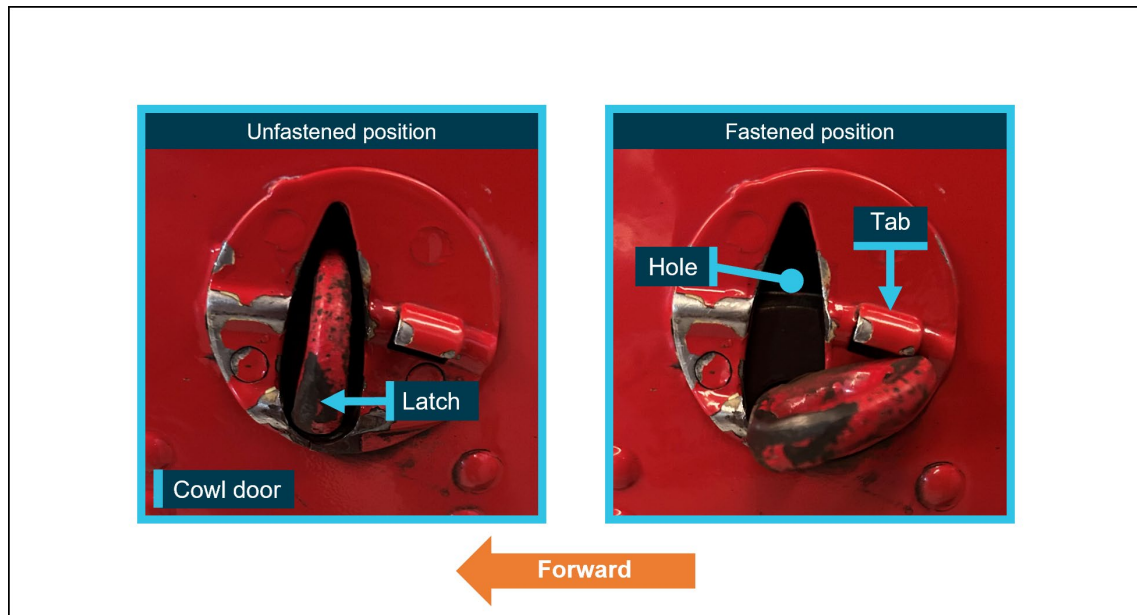
Figure 4: DHC-1 Chipmunk cowl latch detail (exemplar aircraft, left side shown)

Access to the engine is via a cowling door on either side. The cowl doors are hinged at the top and fastened by 2 latches at the bottom of each cowl. The latches are attached to the lower engine cowl and when in the vertical position pass through holes on the cowling doors (Figure 4, left). To fasten the cowl, the latches are pulled outboard, further compressing a pre-compressed spring, and turned aft (1/4 turn) to the horizontal position. Releasing the latch then fastens the cowl. The latches are held in place by the spring and prevented from unfastening by a tab (Figure 4, right). There was no evidence of pre-impact damage to the engine cowl latches fitted to VH-POR (see *Wreckage and impact information*).

Damage to the engine cowl latches was indicative of the latches being correctly fastened on the right side but unfastened on the left at the time of impact. The engine cowls and latches were otherwise undamaged.

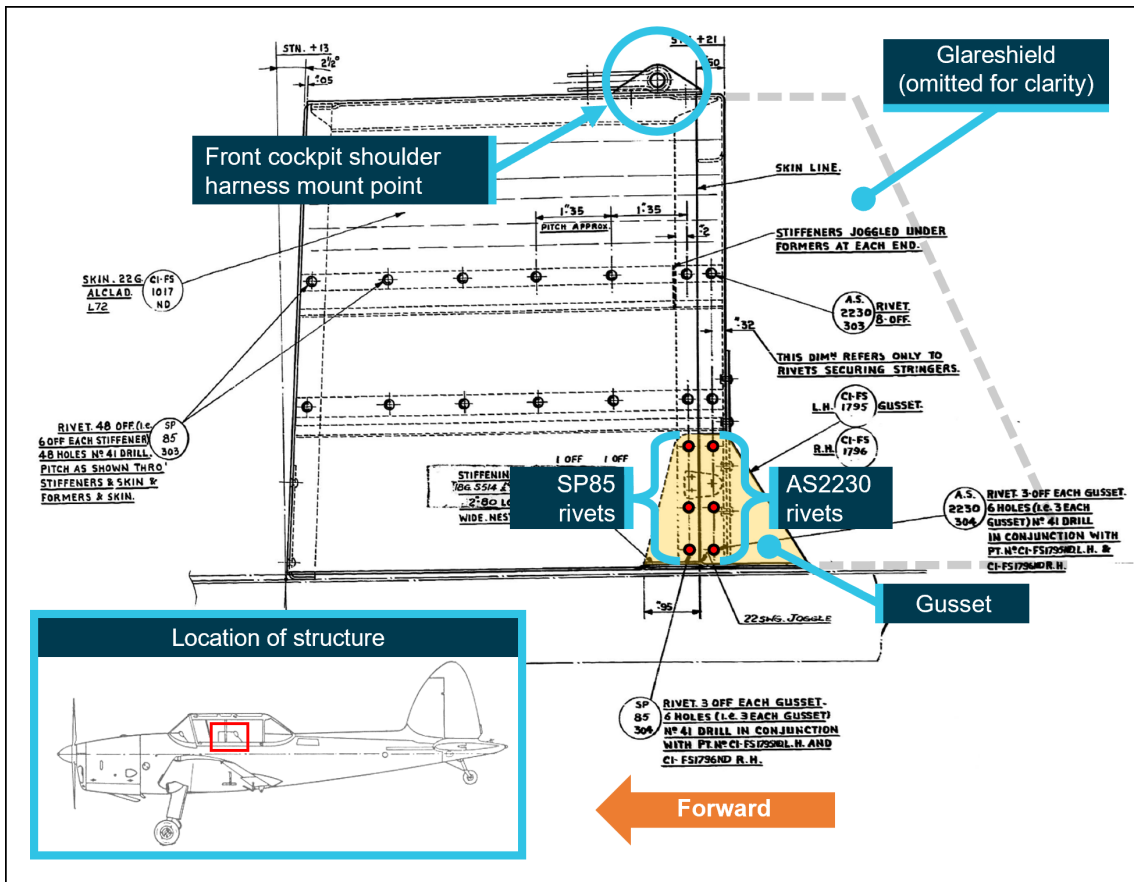
Figure 6: Modification H.268 gusset and rivet location (left side shown)

The gussets fitted to VH-POR were steel, rather than aluminium alloy, which indicated that modification H.268 had been embodied. This modification also required the use of part number SP85 and AS2230 rivets. Both types were required to be manufactured to British standard L.86, which was an aluminium alloy that included copper and magnesium.¹⁰ The standard also specified that the rivets were to be anodised (a surface treatment) and coloured violet.

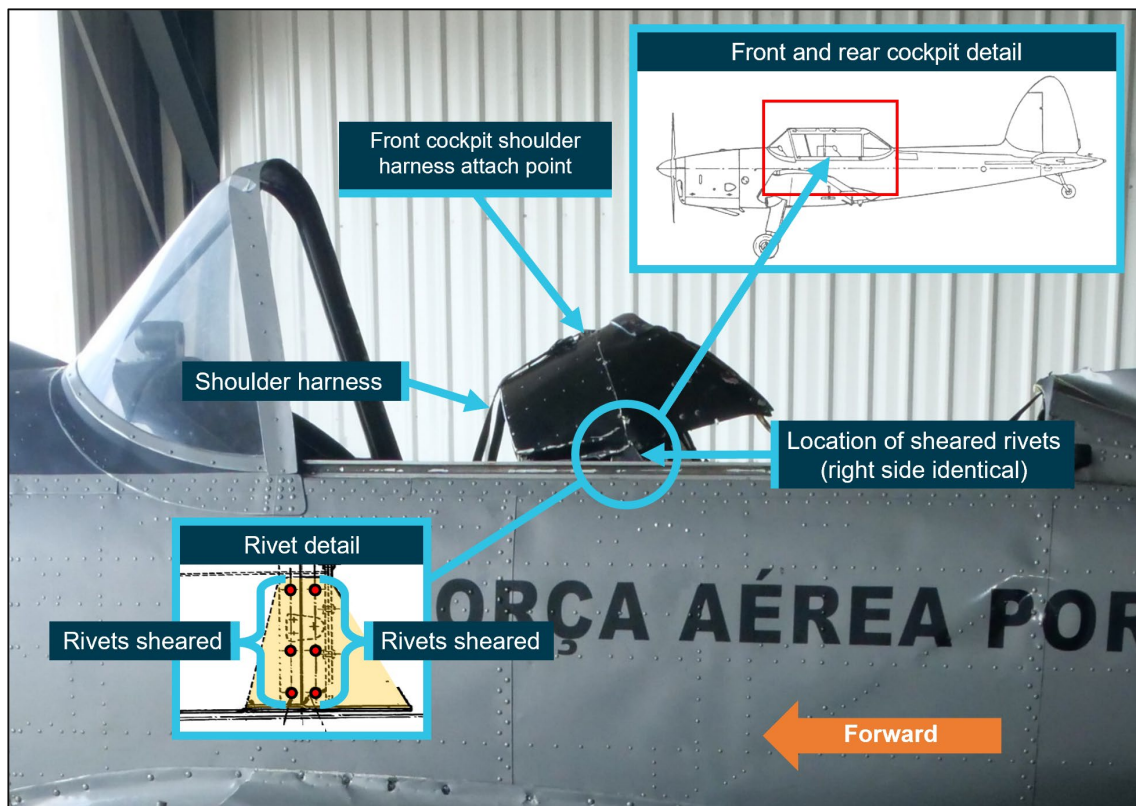
Figure 7: Detached upper structure showing harness attach point and location of sheared rivets

The ATSB found that on impact the upper structure between the front and rear cockpits, corresponding to the attach point for the front cockpit shoulder harness, was torn away from its mountings (Figure 7). All 12 rivets (6 per side) that attached the structure to the mountings had sheared.

Upper structure has been placed in position for the photograph and is representative of its position immediately post-accident. Image source: ATSB, de Havilland Support Ltd (detail), annotated by the ATSB

- The material composition of the rear row of rivets (countersunk) was consistent with pure or near-pure aluminium¹¹ and therefore a non-conforming specification. Testing indicated a significant reduction in strength, estimated to be about one-third of the strength of the specification rivets.
- The material composition of the forward row of rivets (mushroom head) was consistent with an alloy consistent with L.86. The rivets were coated with a gold-coloured chromate conversion coating instead of violet anodising. ATSB testing indicated that the strength of the rivets met or exceeded literature values for L.86 alloy.

The presence of the non-conforming rivets significantly reduced the integrity of the structure retaining the front cockpit restraint, and thereby compromised the crashworthiness of the aircraft. This non-conforming modification may be present in other Chipmunk aircraft, in which case it would likely affect survivability in an accident.

During the accident, all of the rivets securing the structure failed. However, it was not possible to establish whether the correct rivets would also have failed, and the impact deceleration alone may have been above expected human tolerance. Therefore, it was not possible to establish whether the presence of non-conforming rivets affected survivability in this instance. Regardless, the presence of non-conforming rivets was a latent threat to the aircraft's crashworthiness and reduced the likelihood of an accident being survivable.

To advise DHC-1 Chipmunk maintainers and owners of the importance of carrying out this modification to the required specification, the ATSB issued a safety advisory notice ([AO-2024-013-SAN-01](#)) on 11 September 2024.

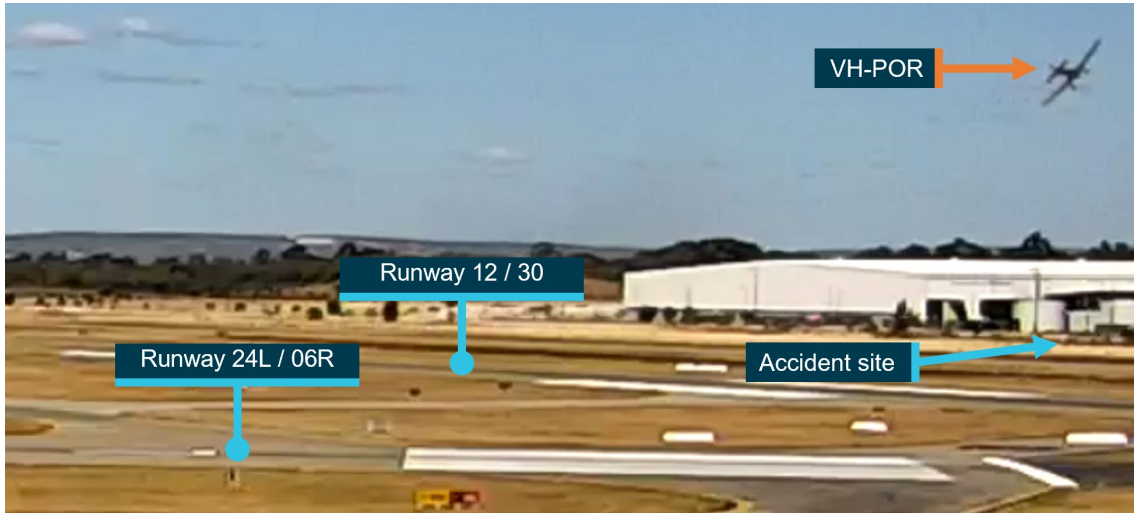
Figure 8: VH-POR angle of bank during left turn after take-off

The camera footage showed the aircraft's angle of bank increasing and the aircraft descending before colliding with terrain.

The aerodynamic stall¹³ speed of aircraft in a steady turn increases appreciably with an angle of bank greater than 30°, and at angles greater than 45° there is a rapid increase in stall speed. At 55° angle of bank, stall speed is increased by about 32%. The Chipmunk’s stall speed in a 55° steady turn while maintaining level flight would have therefore been about 62 kt.
