Flight below minimum sector altitude involving Cessna 310R, VH-ZMB

14 km west-north-west of Alice Springs Airport, Northern Territory, on 1 July 2024

AO-2024-039

Final – 20 March 2025

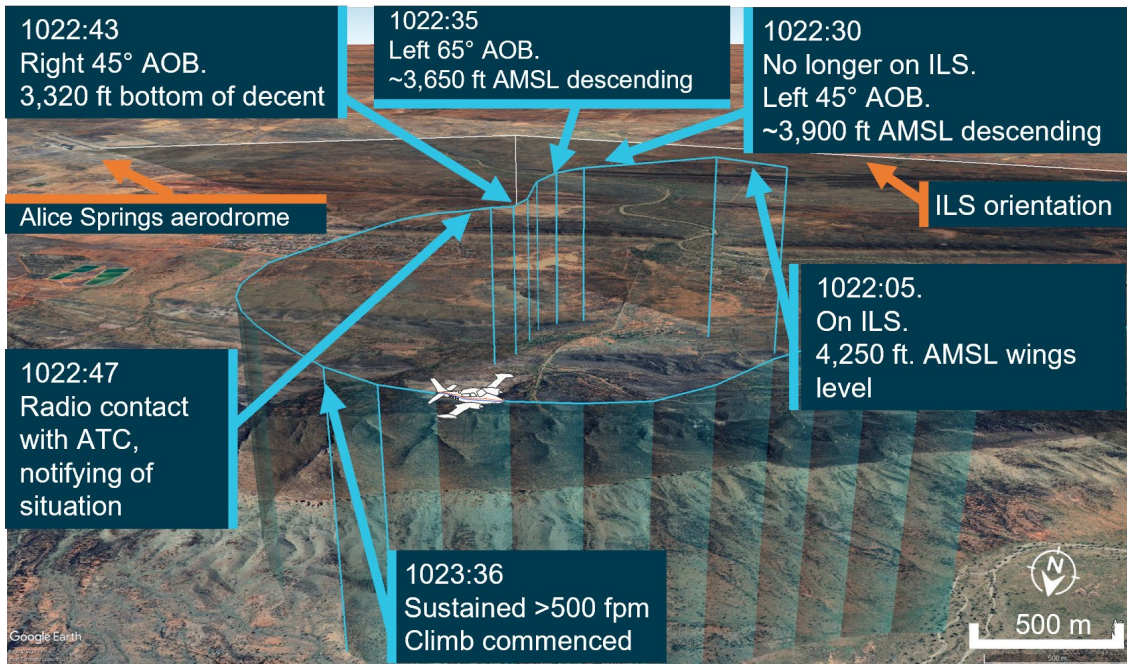
Figure 1: VH-ZMB flight path

At 1022:05, the aircraft was established at 4,250 ft above mean sea level (AMSL) on the approach into Alice Springs Airport on the published ILS approach profile. About 25 seconds later, the pilot recalled receiving erroneous instrument indications from the artificial horizon (AH). At 1022:30, flight data showed the aircraft departing the ILS to the left, and tracking at a perpendicular direction from the approach path with unusual aircraft bank angles (AOB) (Figure 1).

Recorded flight data indicated that during this time, the aircraft was below the minimum sector altitude of 4,300 ft and tracking towards rising terrain. The aircraft came within its closest proximity to terrain as it passed the ridgeline at about 810 ft above ground level.

At 1022:30 the aircraft deviated significantly to the left of the approach path resulting in the aircraft no longer being established on the ILS approach. The aircraft was below the MSA at 3,900 ft and continued to descend to the lowest point of 3,320 ft.

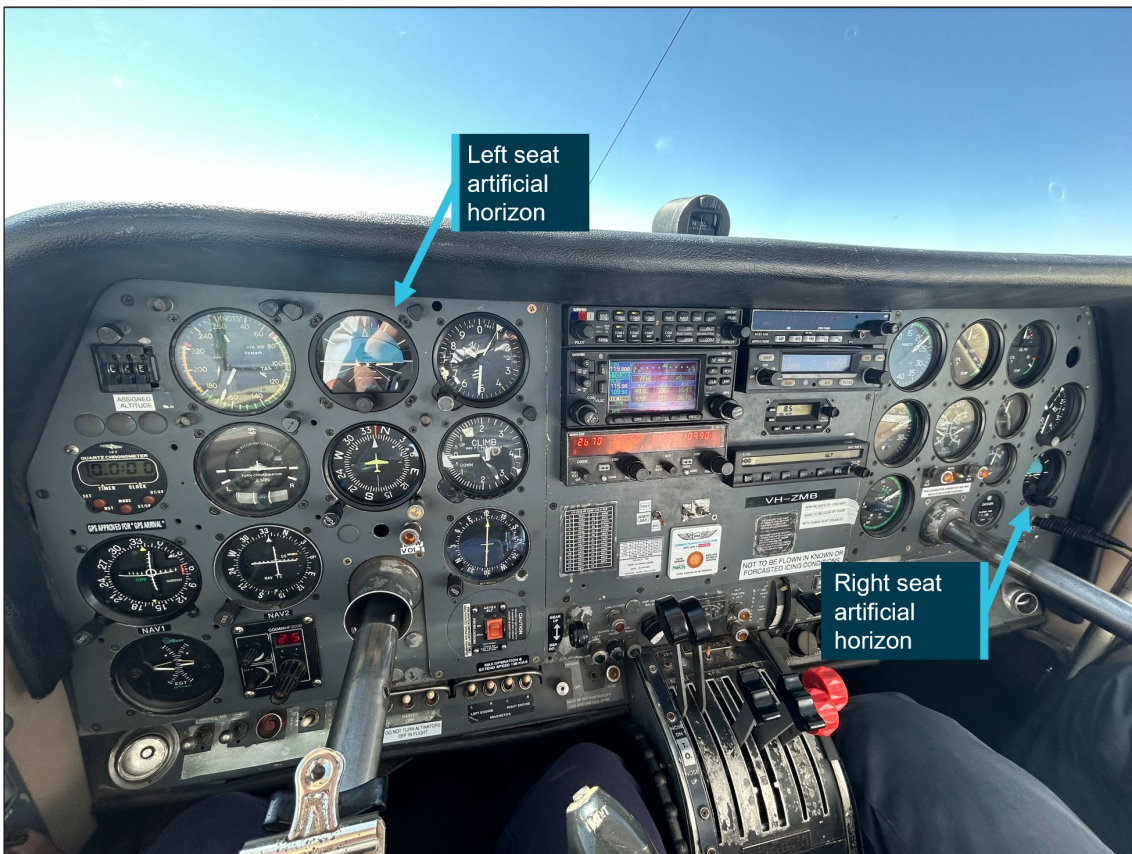
Figure 2: Photo of cockpit instruments from perspective of left (pilot) seat

The pilot reported that placement of the standby artificial horizon on the far right-hand side of the instrument panel (Figure 2) precludes the pilot from observing angles of bank (especially to the left). However, the pilot also reported utilising the standby AH as the primary means of spatial orientation, both during the occurrence and post-occurrence to fly the second approach and identified that recovery to a safe altitude was ultimately slowed by the significant workload of stabilising the aircraft on a limited instrument panel.

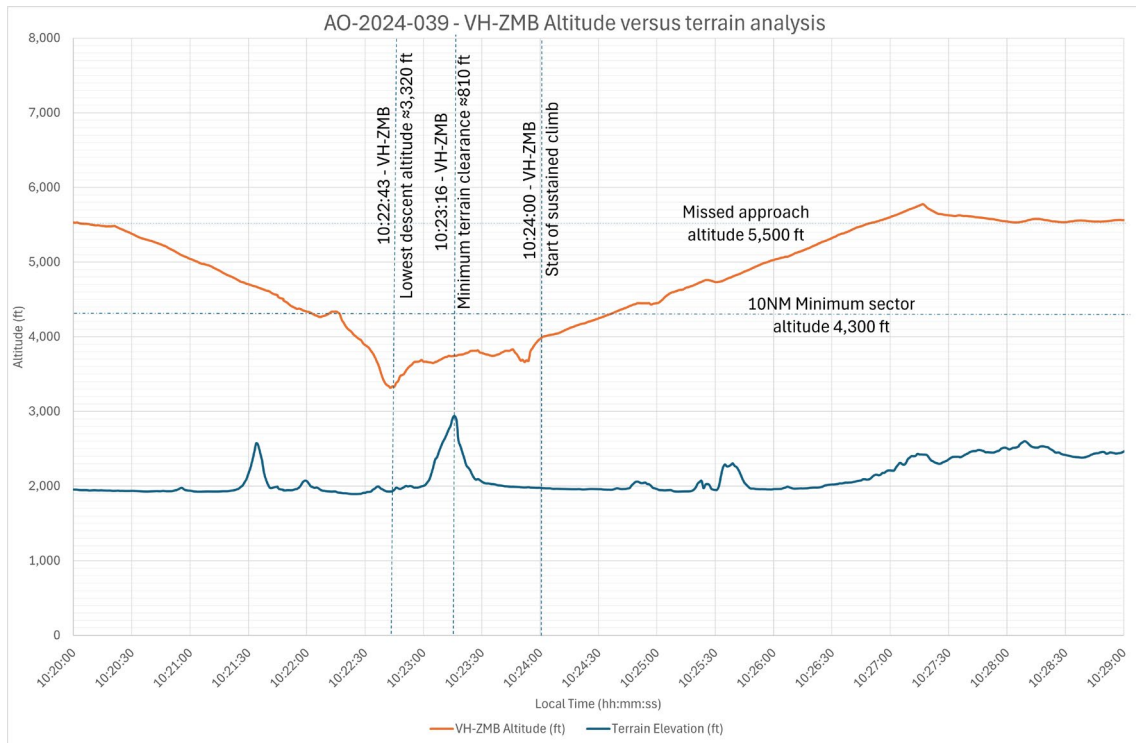
Figure 3: Aircraft vertical profile

About 35 seconds later the aircraft crossed a ridgeline, further reducing the vertical separation with terrain to 810 ft above ground level.

Recorded data indicated (Figure 3) that 30–40 seconds after speaking to ATC and approximately 70 seconds after leaving the ILS approach profile, the pilot commenced a sustained climb and began tracking to the initial approach fix of LISZT. During this time the aircraft was operated below the MSA.

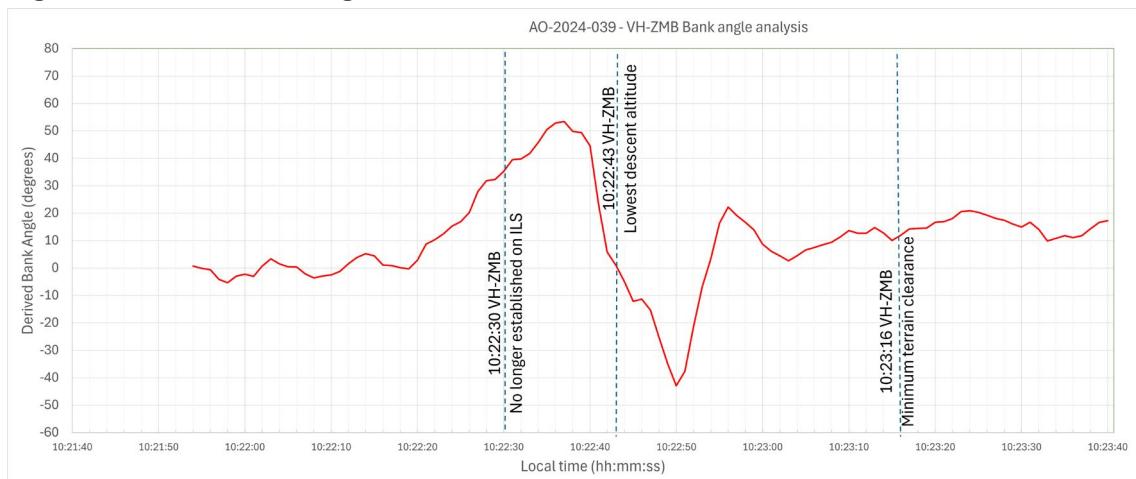
Figure 4: VH-ZMB bank angles

Recorded data identified a significant left turn, greater than 60° AOB, with a subsequent bank to the right of greater than 40° AOB and a further left correction (Figure 4). These occurred while the aircraft was still descending. The descent was arrested, at an altitude of about 3,320 ft. With minimal climb observed for about 30 seconds before approaching rising terrain, the aircraft then passed over the ridgeline at a height of approximately 810 ft (Figure 3). (Note: Graphical figures contain smoothed data profiles that may not precisely reflect the exact data point at an exact period).

- At about 8 NM from Alice Springs whilst established on the ILS approach in instrument meteorological conditions, the pilot likely experienced spatial disorientation that led to directional changes of up to 90° from the approach track as well as left and right angles of bank up to 65°, whilst continuing to descend.

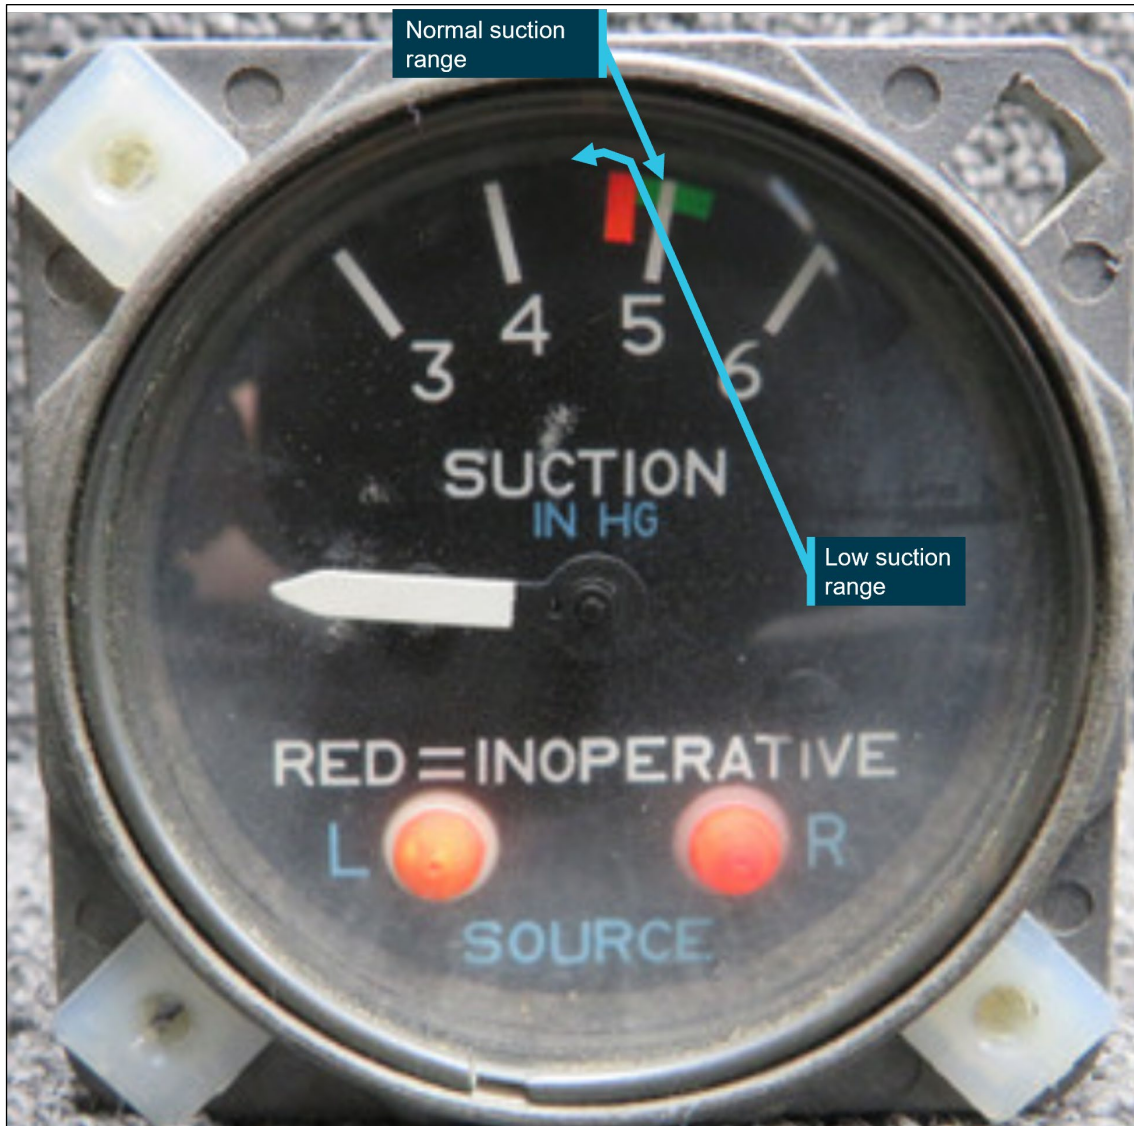
Figure 6: Example of the suction gauge

The pilot reported that during the approach they noticed that the suction gauge was indicating 'low pressure'. A partial blockage or issue in the pilot suction line, immediately after the air filter, could affect the pilot (left-side) AH and the suction gauge, with nil effect on the copilot (right-side) gauges.

However, post-occurrence maintenance inspections and ground runs could not identify any abnormalities in the vacuum system.
