Descent below glideslope involving Fairchild SA227, VH-VEU

About 17 km north-east of Brisbane Airport, Queensland on 2 July 2024

ATSB Transport Safety Report

AO-2024-040

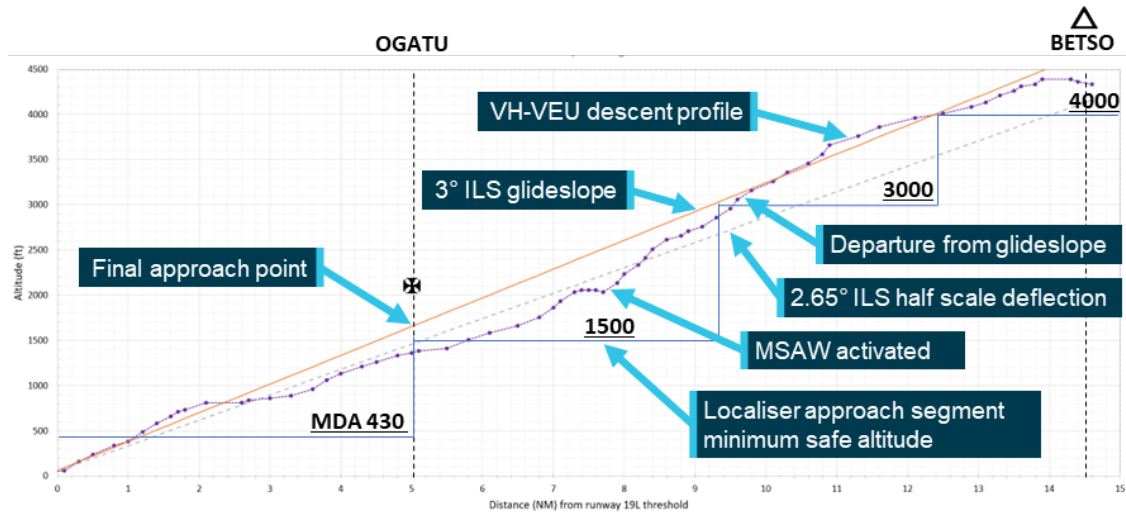
Figure 1: Descent profile of VH-VEU

Passing 3,000 ft and 9.5 NM (17.6 km) from the runway threshold, the aircraft began to descend below the 3° glideslope. The PM recalled that the PF advised that they would stay below the lower patches of cloud to ensure that they remained visual. At 1529:36, ATC radar recorded the aircraft at an altitude of 2,100 ft with a descent rate of 2,068 ft/min, approximately 8 NM (14.8 km) from the runway threshold and 400 ft below the glideslope. This descent rate and low altitude triggered an ATC minimum safe altitude warning (MSAW),⁶ which was visually displayed (Figure 2) and aurally alerted to the approach controller. Upon receipt of the MSAW the controller assessed that the aircraft was above the minimum altitude on the radar terrain clearance chart and not in unsafe proximity to terrain. Therefore, a safety alert was not issued.

The aircraft continued descent and at the final approach point remained more than half scale deflection below the glideslope. At approximately 3 NM (5.6 km) the rate of descent reduced, with the aircraft passing above the glideslope, before increasing again and the glideslope being re-intercepted 1 NM (1.8 km) from the runway at 500 ft. The aircraft then followed a stabilised flight path to landing.

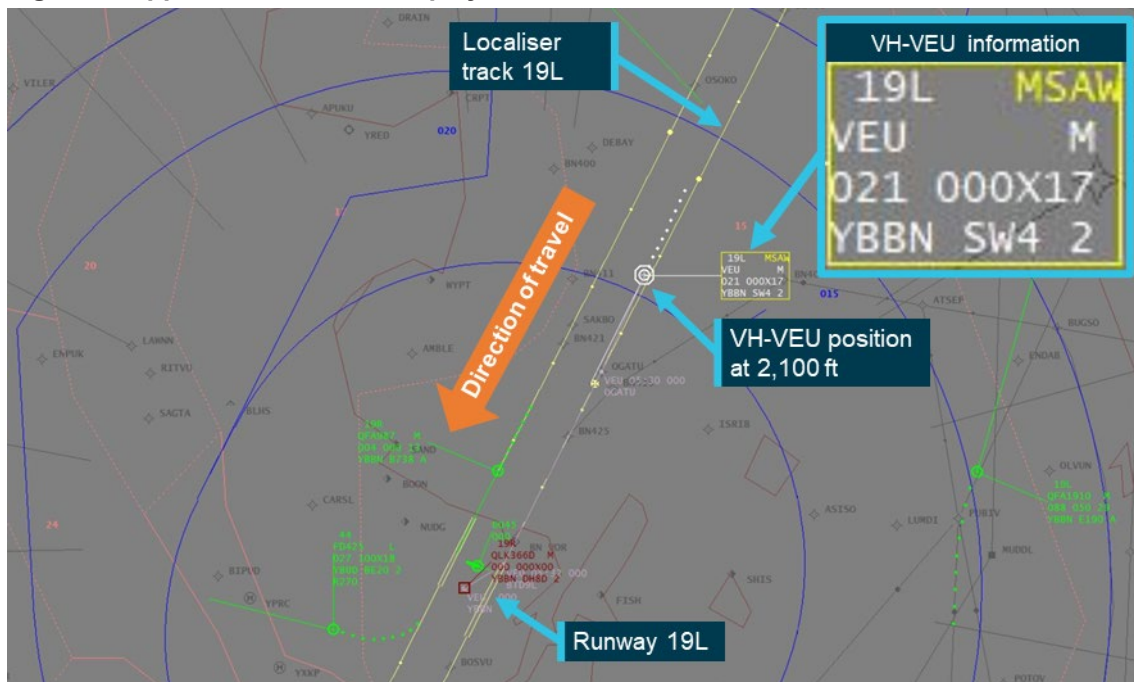
Figure 2: Approach controller display at 1529:46

Instead, as the flight crew had switched the radio to the aerodrome controller’s frequency, the approach controller alerted the aerodrome controller that the aircraft was below the glideslope, which the aerodrome controller then passed on to the crew. In response, the pilot monitoring asked the aerodrome controller if the glideslope was serviceable, to which they responded that it was. During the exchange, the aircraft entered the area surrounding the airport where MSAWs were inhibited, and the alert was no longer presented on the approach controller’s display.

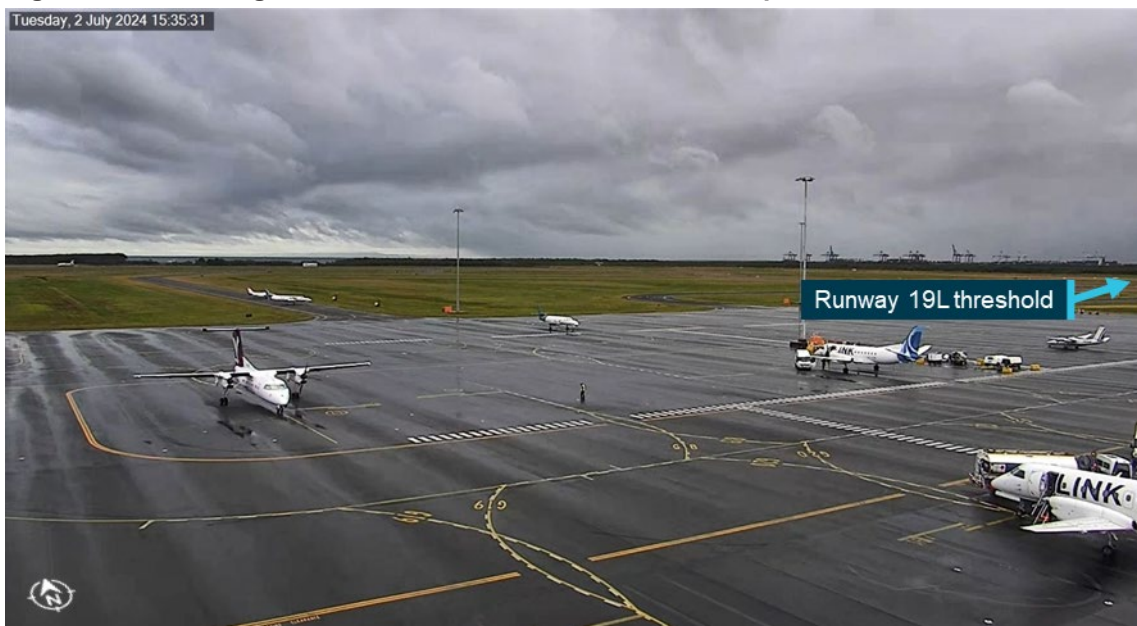
Figure 3: CCTV image of weather conditions at Brisbane Airport at 1535

The ATSB obtained further information regarding the weather conditions that would likely have been encountered during the approach. The automatic METAR,⁹ issued at 1530, reported few clouds at 600 ft, scattered cloud at 1,500 ft and broken cloud at 3,500 ft. Video footage from the airport (Figure 3) and satellite imagery showed cloud coverage consistent with the aerodrome meteorological reports.

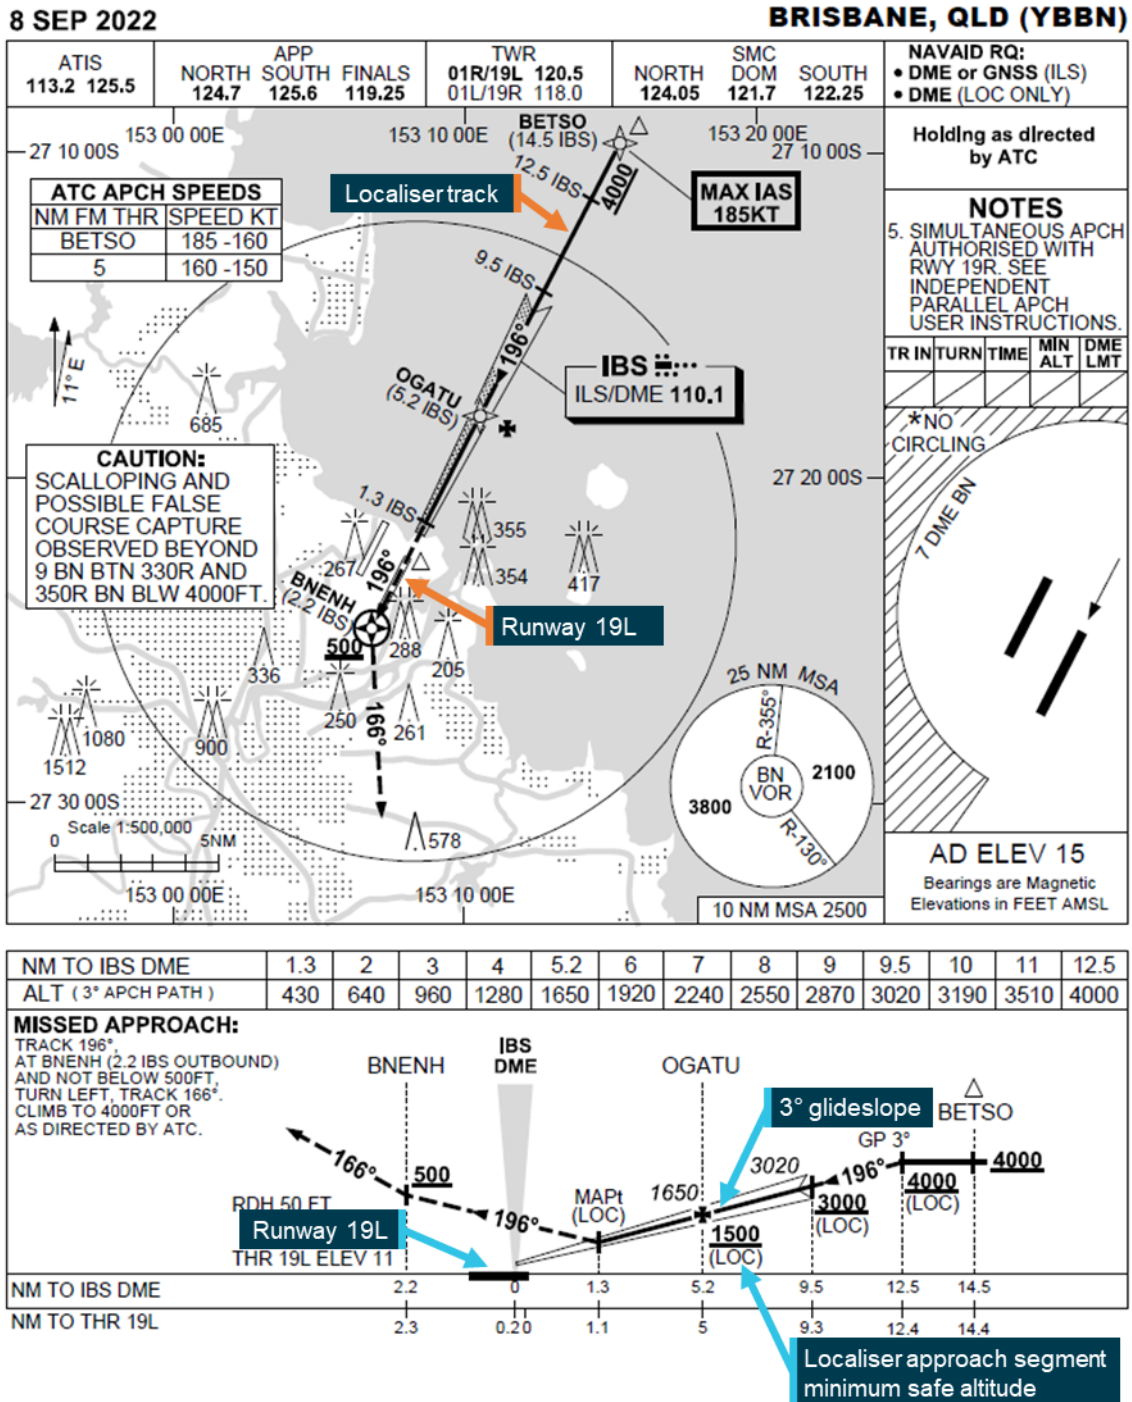
Figure 4: Brisbane runway 19L instrument landing system approach

About 1 minute later the aircraft overflowed the waypoint BETSO⁵ (Figure 4), the initial approach fix for the ILS 19L approach, at approximately 4,400 ft above mean sea level (AMSL) (Figure 1) and commenced the ILS approach. The crew recalled that they became visual with the water and clear of cloud at about that time, but that was not reported to ATC and no request was made to discontinue the ILS approach and conduct a visual approach. The PM also recalled that upon becoming visual, they observed patches of lower cloud, but none that would affect their ability to proceed visually to the runway.

The AIP wording combined the terms 'must' and 'should', making it unclear as to whether this was a requirement or a recommendation. However, Airservices Australia confirmed that aircraft were required to comply with the vertical guidance of the glideslope when conducting an ILS approach, and that descent outside this vertical guidance could be safety critical.

For a 3° ILS approach, half scale deflection below the glideslope was the equivalent to an approach angle of approximately 2.65°. Airservices Australia also confirmed that a clearance to conduct the ILS approach was not a clearance to conduct the localiser approach, despite both approaches using the localiser for lateral guidance and sharing the same instrument approach chart.
