Flight into a thunderstorm involving Beech Aircraft B200, VH-ZMW

108 km west-north-west of Toowoomba, Queensland on 9 October 2024

AO-2024-051

Final – 19 March 2025

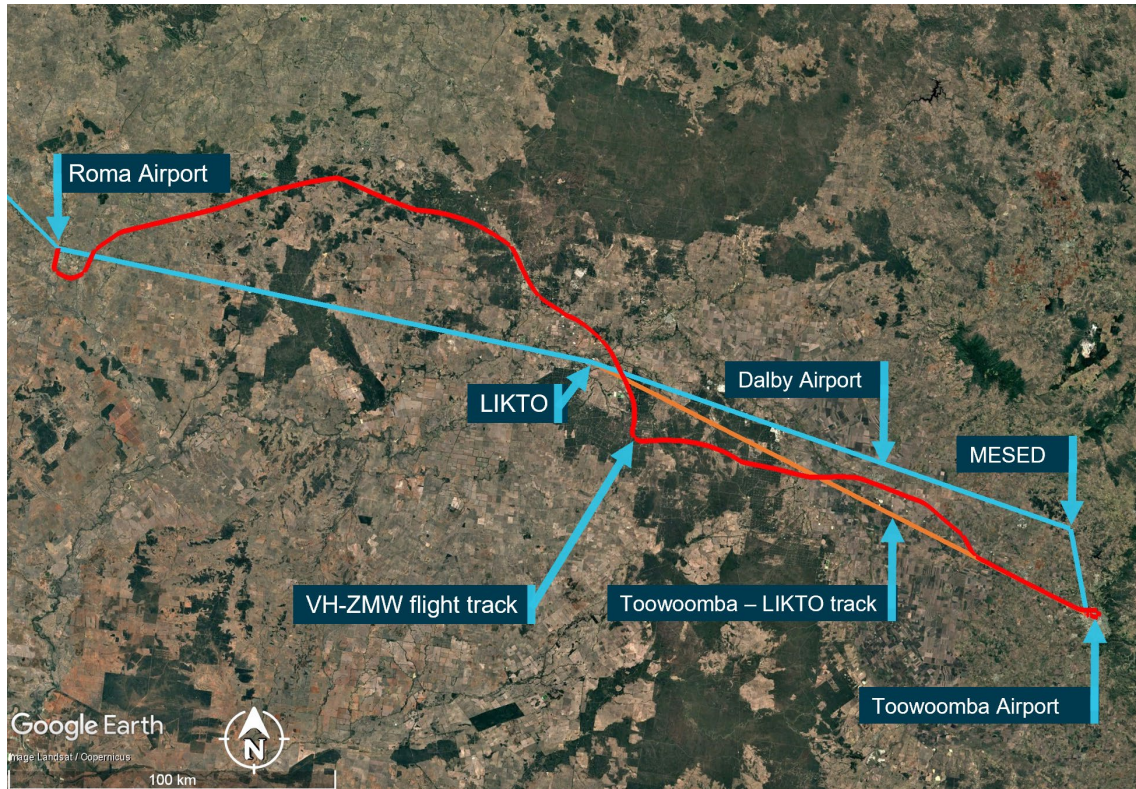
Figure 2: VH-ZMW actual flight track

At 1634, approximately 20 NM (37 km) north-west of Toowoomba, passing 10,900 ft on climb and clear of cloud, the pilot requested and received clearance to deviate 10 NM (18.5 km) right and left of the flight plan track to avoid cloud. They then turned onto a more northerly heading (Figure 2). The pilot later reported that they were able to maintain visual conditions up to the intended cruise level of FL 240.³ Reaching FL 240 at 1645, the pilot observed a return on the weather radar to the right of the aircraft's intended flight path, which they associated with a thunderstorm cell. Consequently, they deviated to the left toward the Toowoomba to LIKTO direct flight track. At this time another Beechcraft B200 departed Dalby Airport and climbed to an altitude of 4,000 ft, tracking for Roma Airport. This aircraft also reported an expected LIKTO arrival of 1654.

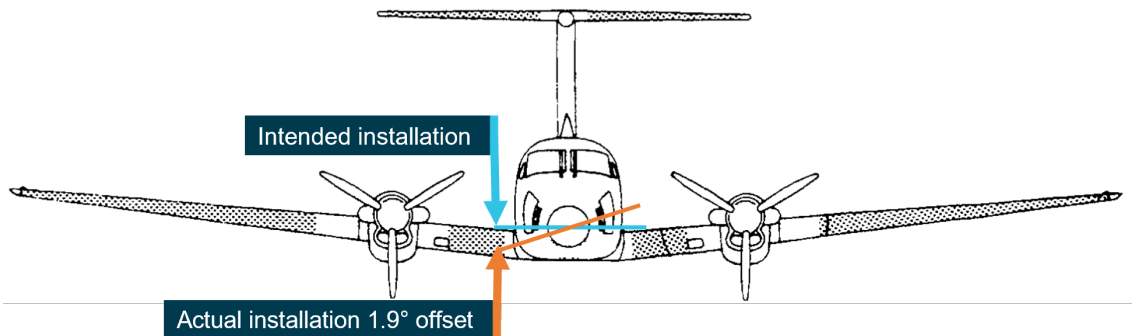
Figure 7: Installation of the weather radar on VH-ZMW

The operator advised that, as part of an aircraft upgrade, the weather radar was installed approximately 3 weeks prior to the occurrence. During the installation, it was inadvertently mounted into position offset from the lateral aircraft axis by approximately 1.9° right side low, rather than level (Figure 7).

This meant that, with the aircraft level, when the radar panned to the maximum left position, it was tilted up 1.9° and at the maximum right position, it was tilted down 1.9°. This resulted in ground clutter appearing on the right side of the radar when the left side was clear (Figure 8).

- the operator identified and implemented an enhanced radar manufacturer training course for its pilots, specific to the installed GWX 70 radar
- the incorrect antenna installation has been rectified
- the flight planning software has been reviewed to ensure that the parameters are as specified in the company exposition
- although fatigue was not considered to be a safety factor in the occurrence, the company has adopted the use of the Samn-Perelli Seven Point Scale fatigue reporting tool, for sign-on and sign-off to improve monitoring of pilot fatigue due to roster patterns.

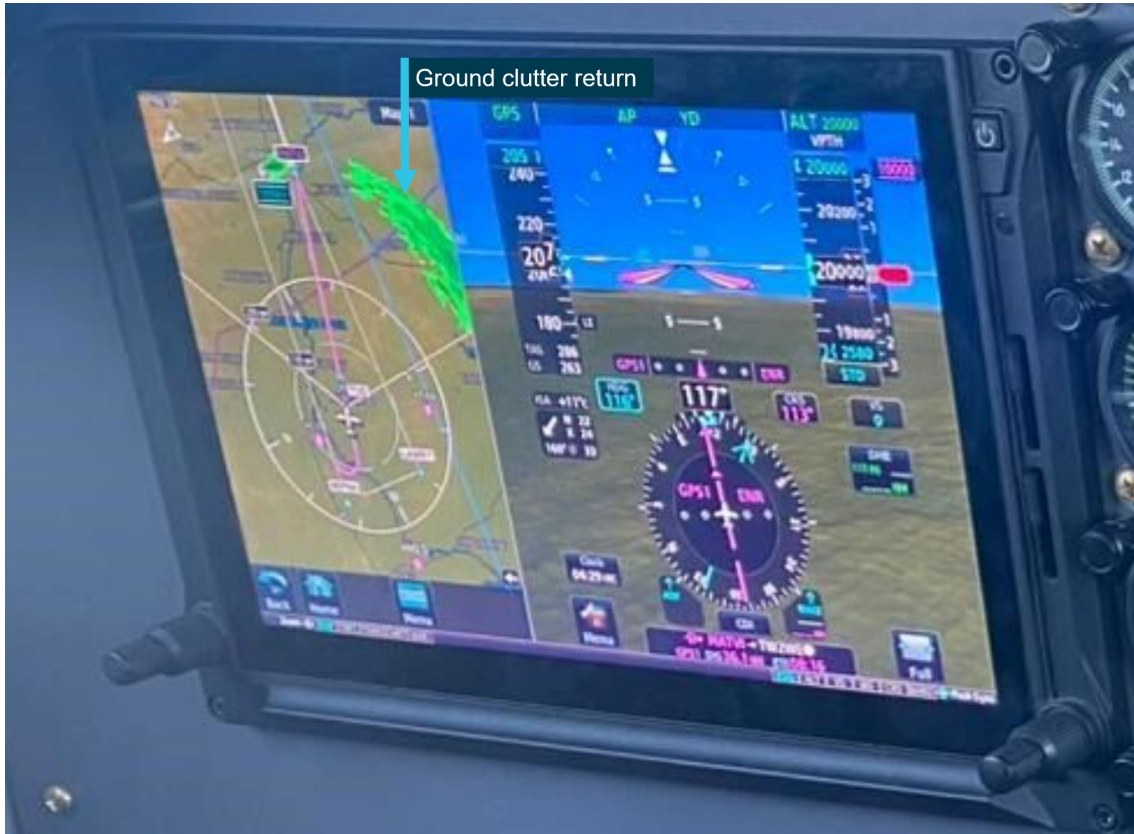
Figure 8: Weather radar ground clutter on VH-ZMW

The incorrect installation resulted in increased ground clutter on the right side of the screen. This meant that using the recommended method for setting the tilt resulted in a higher initial baseline tilt angle. This most likely resulted in the radar beam scanning the tops of the clouds rather than the most reflective areas within a storm. This would have been exacerbated on the left side due to the increased tilt on that side.

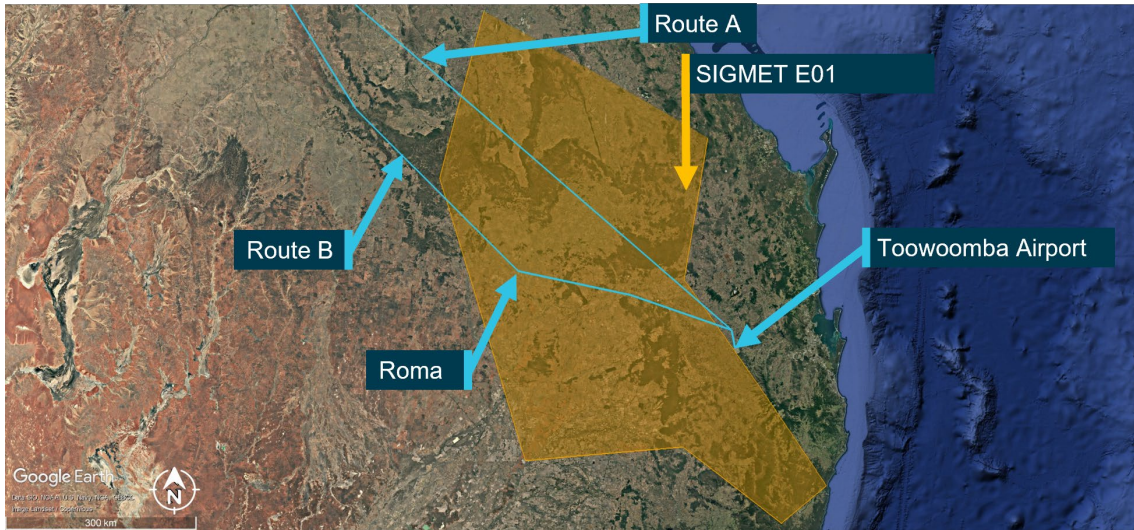
Figure 9: SIGMET area

east-north-east at 15 kt. SIGMET E01 covered the area west of Toowoomba Airport and the intended flight path went through the affected area (Figure 9).

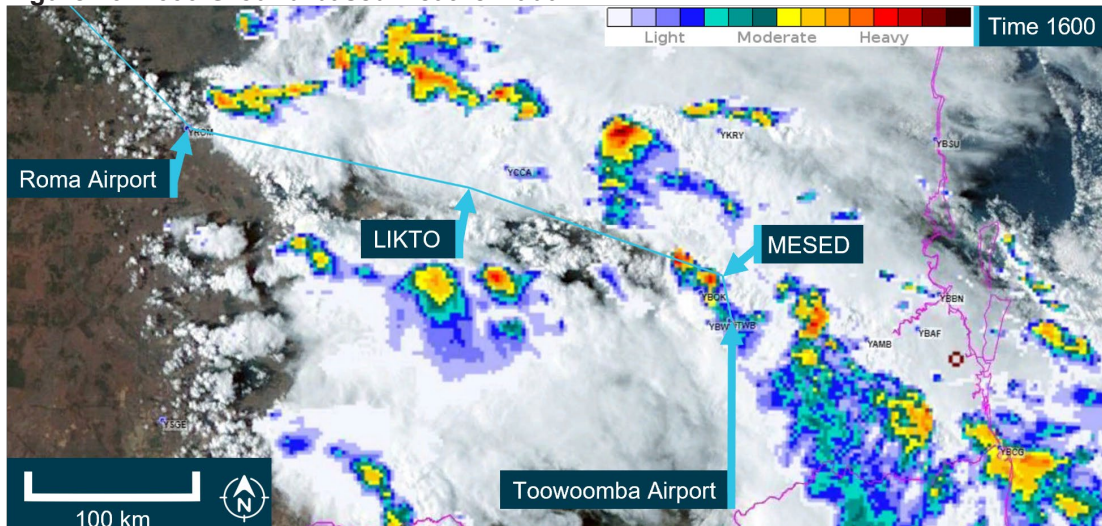
Figure 10: 1600 Ground-based weather radar

The Bureau of Meteorology provided the ATSB with ground-based weather radar images at different intervals throughout the flight. The ground-based weather radar available to the pilot prior to departure, showed that, apart from the storm activity in the vicinity of Toowoomba (that the pilot delayed the departure for), moderate level precipitation could be avoided by 20 NM (37 km) along the planned departure route (Figure 10).

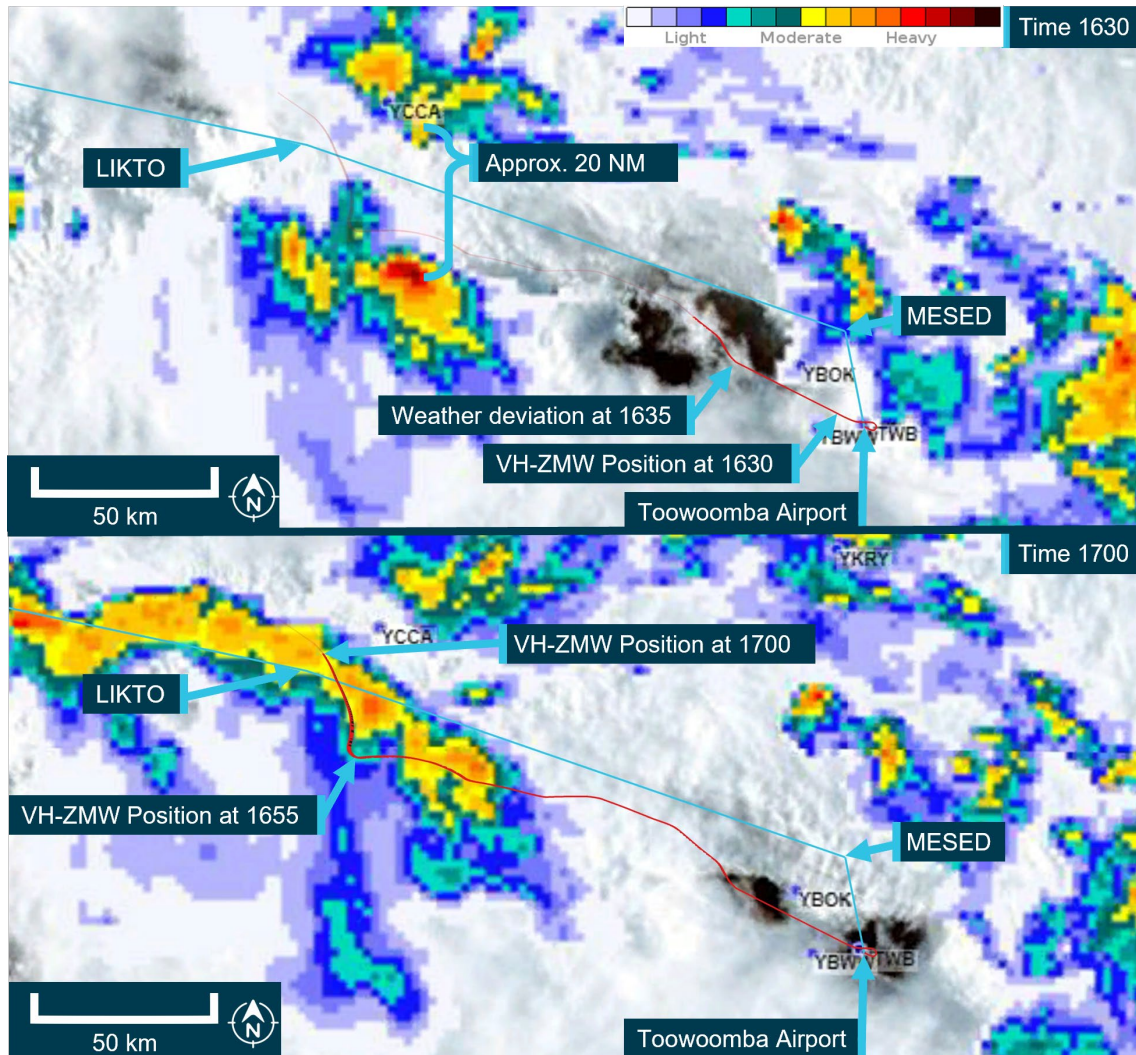
Figure 11: Ground - Based weather radar at 1630 and 1700

It is likely that the pilot's in-flight assessing and planning was influenced by the airborne weather radar information, and they did not remain clear of thunderstorms by the recommended 20 NM (37 km). The ADS-B data overlaid on the ground-based radar along with the pilot's recollection of visible lightning, turbulence, and icing are all consistent with flying into a thunderstorm.
