Level crossing irregularity involving freight train 1MP9 at Torrens Road

Ovingham, South Australia, on 7 December 2020

ATSB Transport Safety Report

RO-2020-021

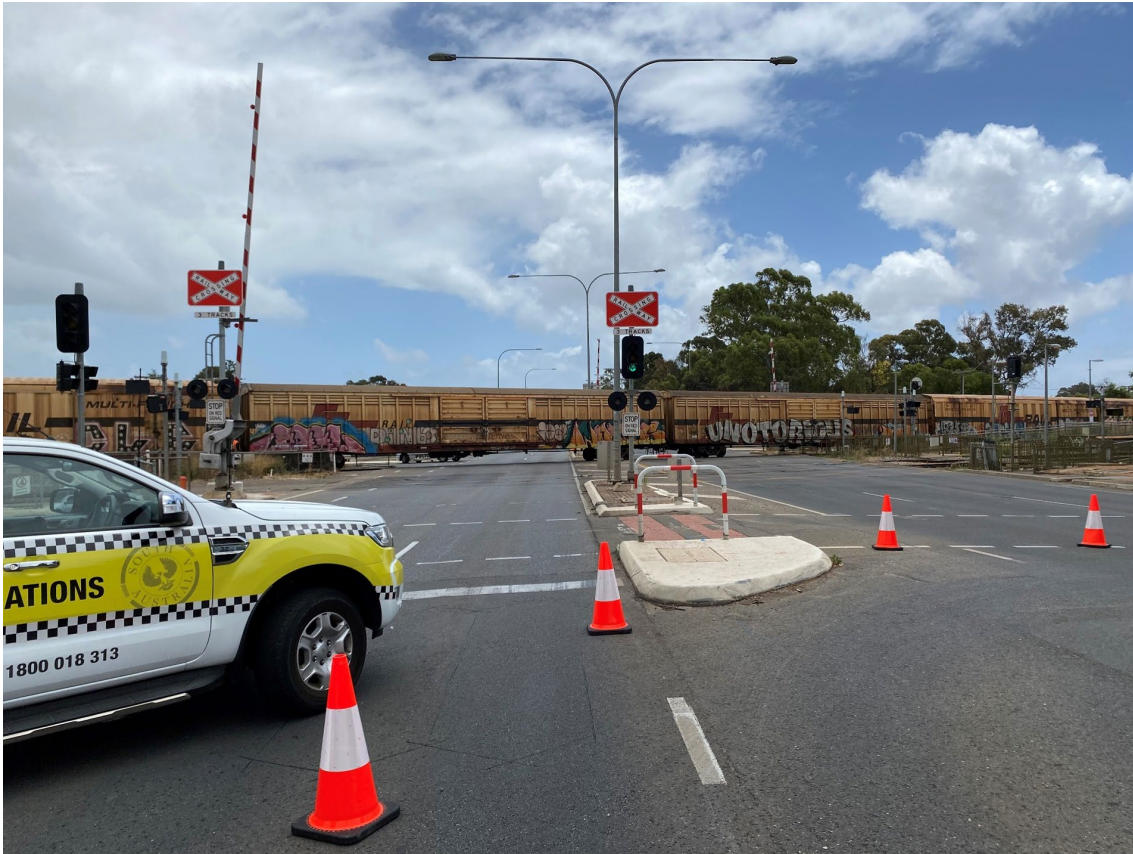
Figure 4: Train 1MP9 at Torrens Road level crossing

At about 1158, the driver of 1MP9 made an emergency radio call to the ARTC network control officer (NCO) notifying the Torrens Road crossing warning equipment had failed to operate for their train and that there were several near misses with road vehicles as the locomotive passed over the level crossing.¹⁰ The NCO instructed the train crew to remain in situ and wait for the arrival of support personnel to manage safety at the site (Figure 4).

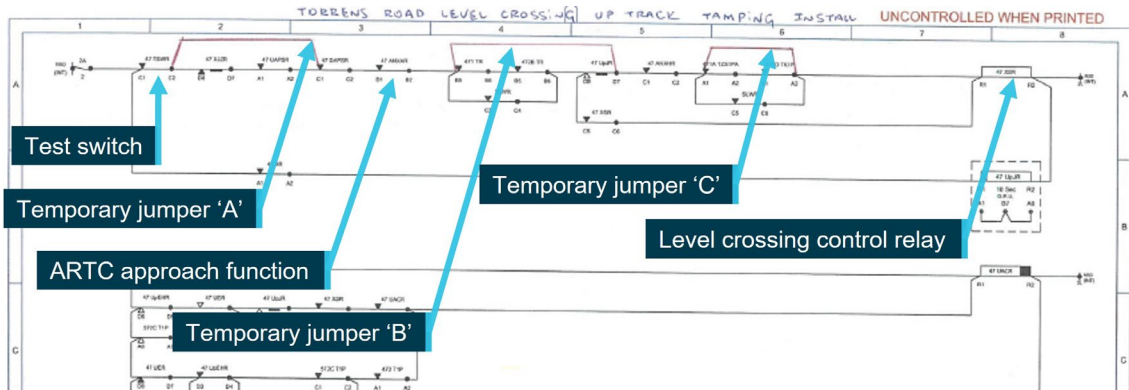
Figure 10: Extract of the SAPTA-approved Torrens Road inspection and test plan showing approved temporary wiring configuration

The TIC stated that, on reflection, only one temporary jumper wire was required. The other 2 jumpers (marked 'B' and 'C' in Figure 10) were superfluous²⁷ as they bypassed the single line working function, which was not planned to be in use on 7 December 2020. The single line working function would only be used where single line bi-directional working was instigated under an alternative method of safe working arrangement. This was not the case on 7 December 2020.

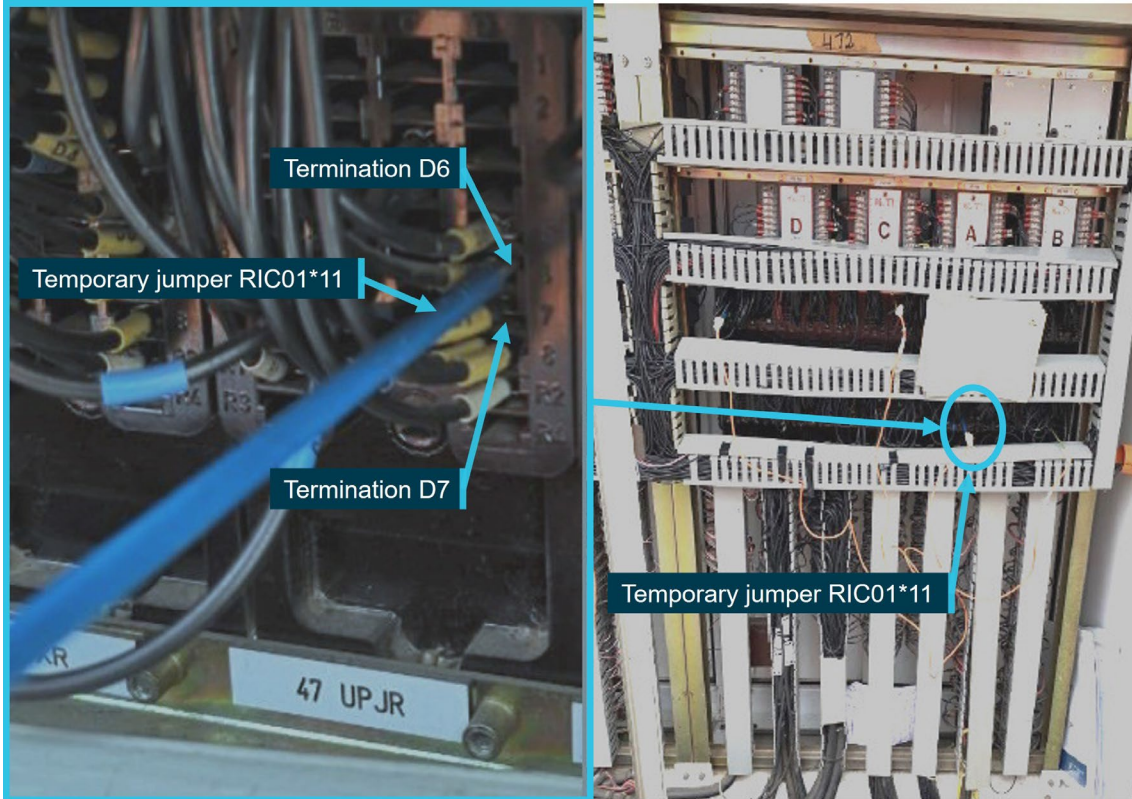
Figure 11: Rear of Torrens Road location case showing 47 UpJR control relay

jumper was inadvertently placed into 47 UpJR - D6. This was located directly above the intended termination point (47 UpJR - D7) detailed in the ITP and positioned on the bottom row of the relays in the equipment rack (Figure 11).

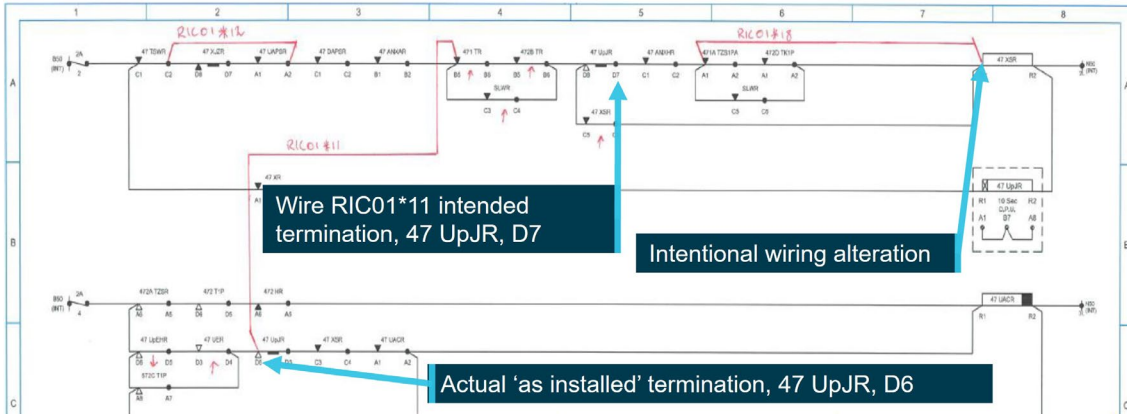
Figure 12: Extract of the Torrens Road level crossing control circuit showing temporary jumper wires in the ‘as installed’ configuration

The unintentional installation of a jumper probe into the 47 UpJR - D6 terminal and intentional termination of a jumper probe into the 47 XSR R1 termination meant the jumper wiring was configured as illustrated in Figure 12. This was inconsistent with the description in the approved plan document and detail shown on the amended circuit diagram.

Note: Configuration of the temporary jumper wiring recorded by SAPTA during the post-incident onsite investigation. Source: South Australian Department for Infrastructure and Transport, annotated by the ATSB

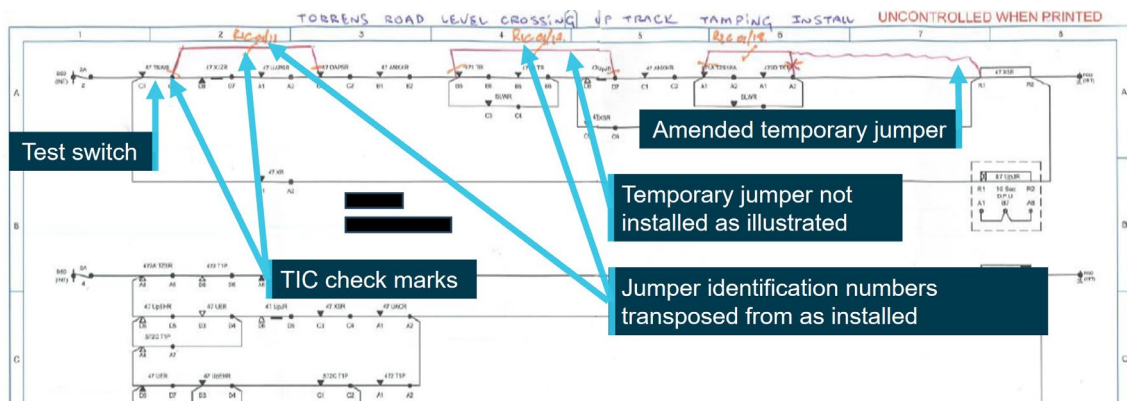
Figure 13: Extract from the Torrens Road inspection and test plan marked up with testing annotations and amended jumper wiring configuration

In the absence of any instruction from SAPTA to specify the testing or methodology required for recording test results, the TIC used their typical method for recording verification testing and marked up the circuit diagram with details to record the installation of each jumper together with its identification number (Figure 13).

The TIC recorded each test activity using a system of symbols to signify the installation and verification of the jumper wire in accordance with the approved circuit diagram. The markings

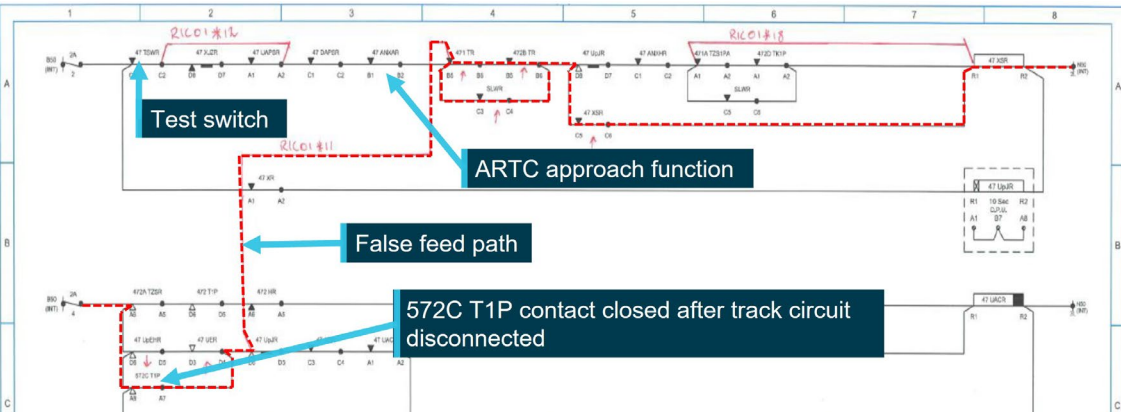
Figure 14: Extract of the Torrens Road level crossing control circuit showing the path of false feed

state of this relay closed contacts A7 and A8. An alternative connection from the control circuit power supply was applied to the 47 XSR function via the incorrectly installed jumper wire RIC01*11 (Figure 14). The false feed subsequently maintained the 47 XSR function in an energised state (level crossing warning equipment inactive), regardless of the configuration of another AMPRN or ARTC control input in the circuit. The level crossing warning equipment would now not operate for train 1MP9 approaching Torrens Road on the ARTC network, or any other AMPRN or ARTC train approaching the level crossing.

Note: Red dashed line shows the path of the false feed applied to the Torrens Road level crossing control relay, after 572C T1P relay was de-energised.

The later disconnection of electrical connections to the rails on the Adelaide metropolitan passenger rail network caused a false feed to the level crossing control relay via the incorrectly installed temporary jumper wire. This false feed prevented the correct operation of the level crossing warning equipment for a train approaching on the Australian Rail Track Corporation network.
