Research and testing required for fitment of constant wear lifejackets with multipoint seatbelts

Safety Advisory Notice

To aviation research and testing organisations

Number: AO-2023-001-SAN-002

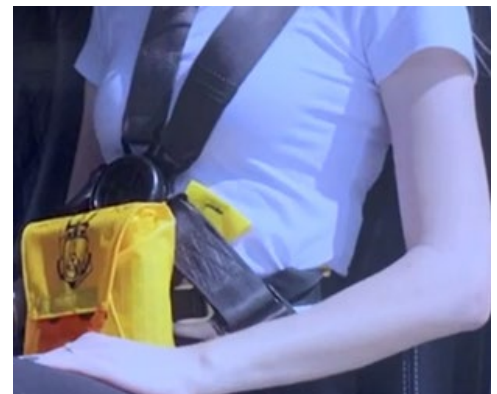
Passengers from both helicopters were found to be inadequately restrained from incorrect fitment of their seatbelt. This was due in part to the placement of constant wear lifejackets that were being worn. The ATSB was unable to determine the level of contribution of incorrect restraint to the injuries sustained by the passengers.

Incorrect fitment of seatbelt with constant wear lifejacket (source: Sea World Helicopters)

Australian regulations for scenic flight operations over water require passengers to be wearing lifejackets in addition to seatbelts in a helicopter. This is to ensure that passengers can access this piece of equipment in a timely manner. To comply with the regulation most operators provide their passengers with pouch style constant wear lifejackets. While these 2 pieces of equipment were commonly used together there was no available guidance about how to integrate them while maintaining their functionality. Manufacturer instructions for fitment of all pouch style constant wear lifejackets requires them to be worn around the waist and positioned at the middle of the body. However, this interferes with the correct fitment of a multipoint seatbelt.

The correct fitment of any seatbelt requires the lap portion to be worn low and tight across the hips. The operator's ground and flight crew were not aware of how to integrate the constant wear lifejacket with seatbelts without affecting correct fitment of the seatbelt. This led to inadvertent incorrect fitment of passenger seatbelts.

AO-2023-001-SAN-002: The ATSB encourages those organisations capable of research to determine a correct method of wearing a constant wear lifejacket with a multipoint seatbelt, while ensuring the correct function of each.
