Collision with terrain involving Extra EA 300-LT, VH-XKW

about 10 km west-south-west of Bathurst Airport, New South Wales on
13 October 2024

Aviation Occurrence Investigation (Short)

AO-2024-052

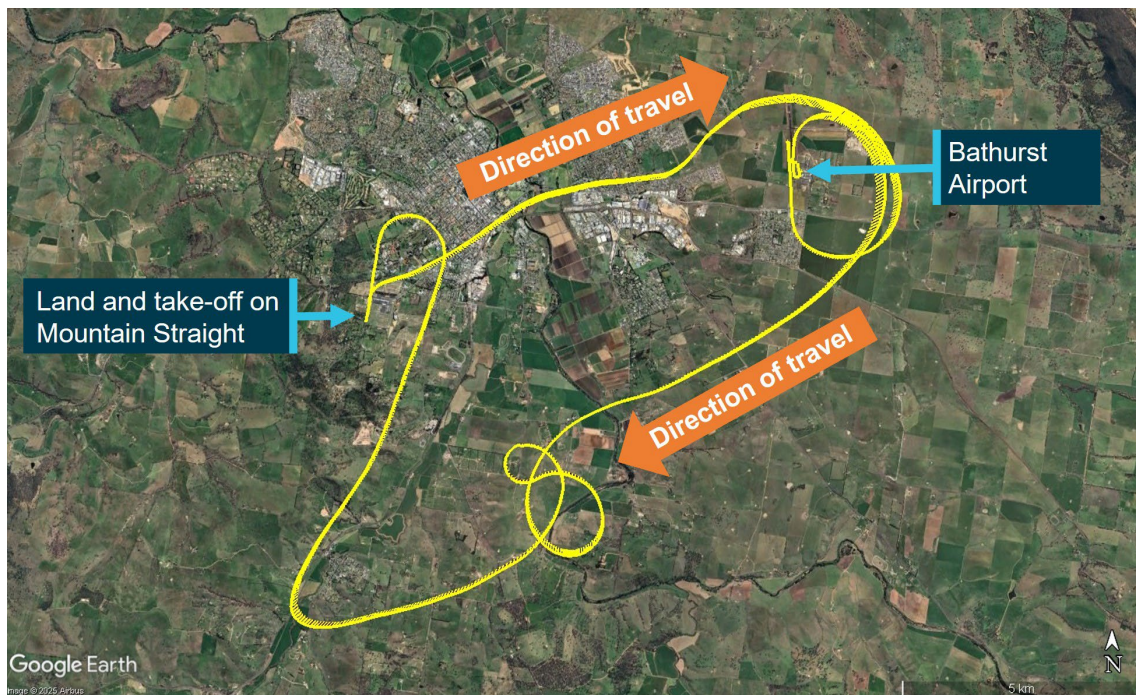
Figure 1: Landing and take-off of incident flight between Bathurst Airport and Mount Panorama

At 0953 local time on 13 October 2024, an Extra EA 300-LT aircraft, registered VH-XKW, with a single pilot on board, departed from Bathurst Airport to conduct a trophy delivery at the annual Bathurst 1000 car race. Recorded data indicated that after take-off, the aircraft proceeded to a holding area where it arrived at 0956. After completing a left and right orbit, the aircraft left the holding area in the company of a media helicopter filming the trophy delivery event. The aircraft then commenced a left hand circuit to line-up for a landing in the southerly direction on the Mountain Straight section of the Mount Panorama motor racing circuit, about 10 km west-south-west of the airport, where the trophy was to be delivered (Figure 1).

At 1003, the aircraft lined up on a 1 NM final approach at an altitude of about 2,900 ft. At this time, Bathurst Airport recorded a wind velocity of 7 kt from 071° True (T) after a peak of 13 kt from 048° T at 0959. The pilot reported there was a crosswind from the left and a small tailwind component on final, but that they were within the aircraft limits and there were no wind gusts. The aircraft arrived overhead the start of Mountain Straight at an altitude of about 2,402 ft (50 ft above ground level) with a groundspeed of 89 kt, after passing overhead spectators on short final, before landing on the grass to the left of the bitumen. The pilot then manoeuvred the aircraft to the right from the grass onto the bitumen as it continued to slow while travelling uphill along the straight.

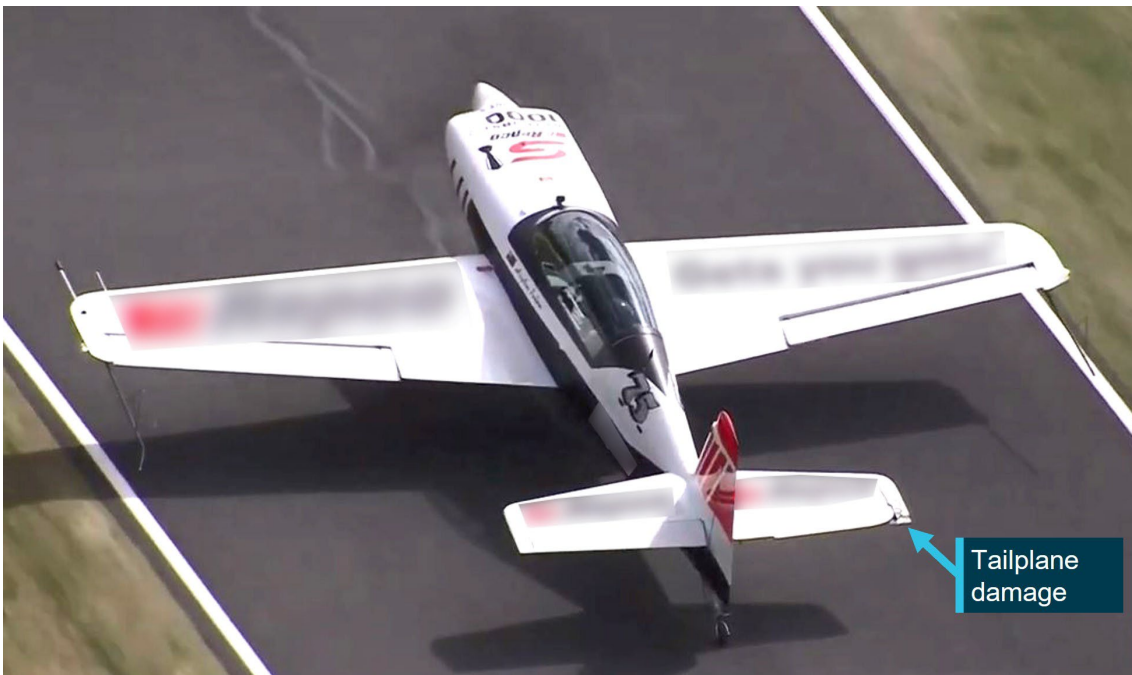
Figure 2: Tailplane damage after collision

Footage and recorded data of the landing indicated that the left wheel moved off the left edge of the bitumen at a groundspeed of about 27 kt just before the aircraft veered right and traversed the bitumen track from left to right. The aircraft slowed to about 13 kt groundspeed when the right wheel exited the bitumen onto the grass on the right side of the track. The aircraft then spun around about 90° to the left before the right rear corner of the tailplane impacted the concrete track barrier and stopped the aircraft. At the time, the aircraft was about 530 m along the straight from the 50 ft threshold height. Engine power then increased, and the aircraft moved away from the barricade, completed the left reversal turn and taxied down the straight, in the opposite direction to the landing, to the location of the trophy delivery, with damage to the right rear corner of the tailplane (Figure 2).

The camera operator in the media helicopter saw the aircraft’s tail impact the barrier during the turn and immediately reported this to the media helicopter pilot. The media helicopter pilot in turn immediately informed the incident pilot of the collision over the radio and recommended the pilot check the aircraft’s tail before take-off. The pilot contacted their team member at the track via radio, but reported at interview that the team member could not observe the collision. The pilot also reported that they did not feel the contact with the barrier, and that after the trophy was delivered, a full control check was conducted on the ground as well as a visual check of the tail from their cockpit seated position, with no control problems or visible damage identified.

The landing and impact with the barrier were captured live by a media helicopter crew, who immediately reported the collision to the incident pilot with a recommendation to inspect the tailplane before take-off. However, the pilot elected not to shutdown the aircraft and exit for an external inspection, or request their team member conduct an inspection, and instead departed overhead the crowd with a damaged tailplane. The pilot had nominated an experienced aerobatic pilot as the display coordinator with authority to stop the display. However, this person was not at the event and was not aware they had been nominated. Therefore, they were unable to challenge the planning or exercise their authority to stop the display after the media helicopter pilot alerted the incident pilot to the collision over the radio.

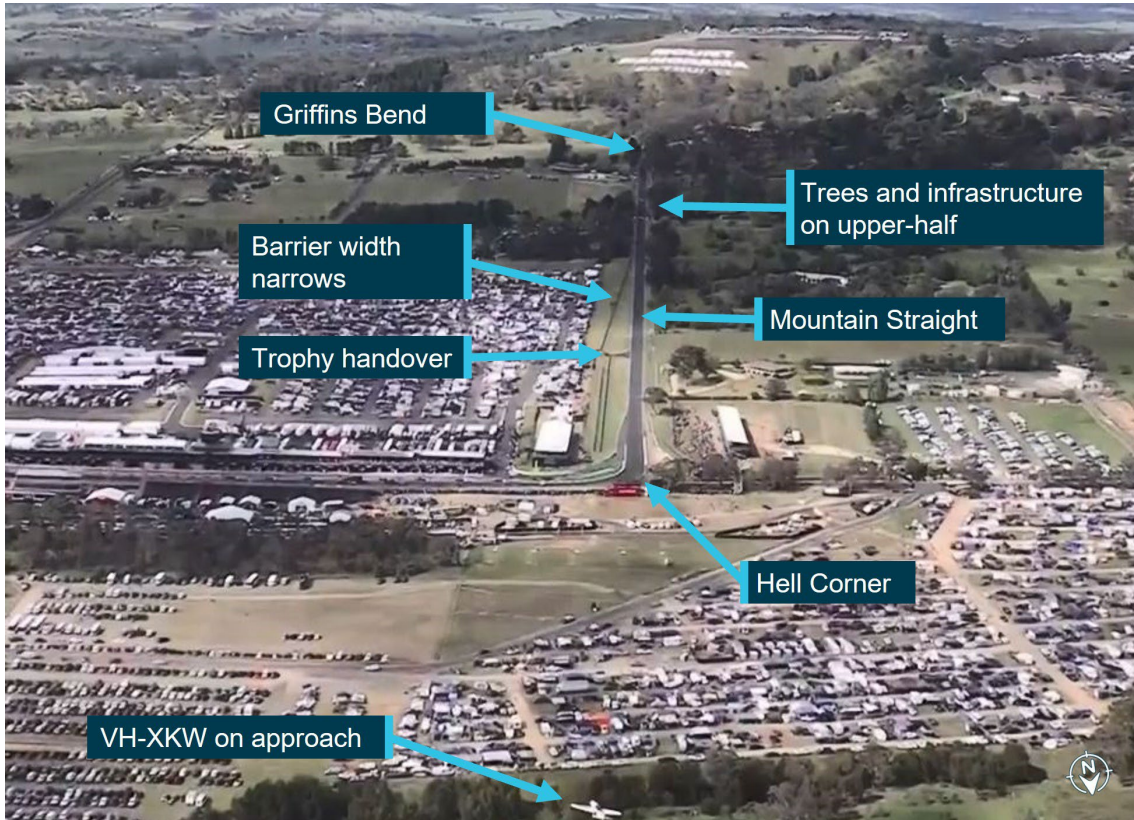
Figure 3: View of Mountain Straight looking to the south with VH-XKW on approach

Mountain Straight is oriented 190° T / 010° T and is about 1,111 m in length from the northern end at Hell Corner, just after Pit Straight, to the first turn at Griffins Bend.⁴ It climbs in a southerly direction towards Griffins Bend, with an average gradient of about 5.4% (Figure 3). The northern (lower) half of the straight is about 20 m wide between the western edge of the bitumen track and the barriers on the eastern side of the track. The width reduces to about 8–10 m for the southern (upper) half of the straight, starting about 585 m from the northern end, where there is trackside tree coverage and co-located infrastructure leading to Griffins Bend.

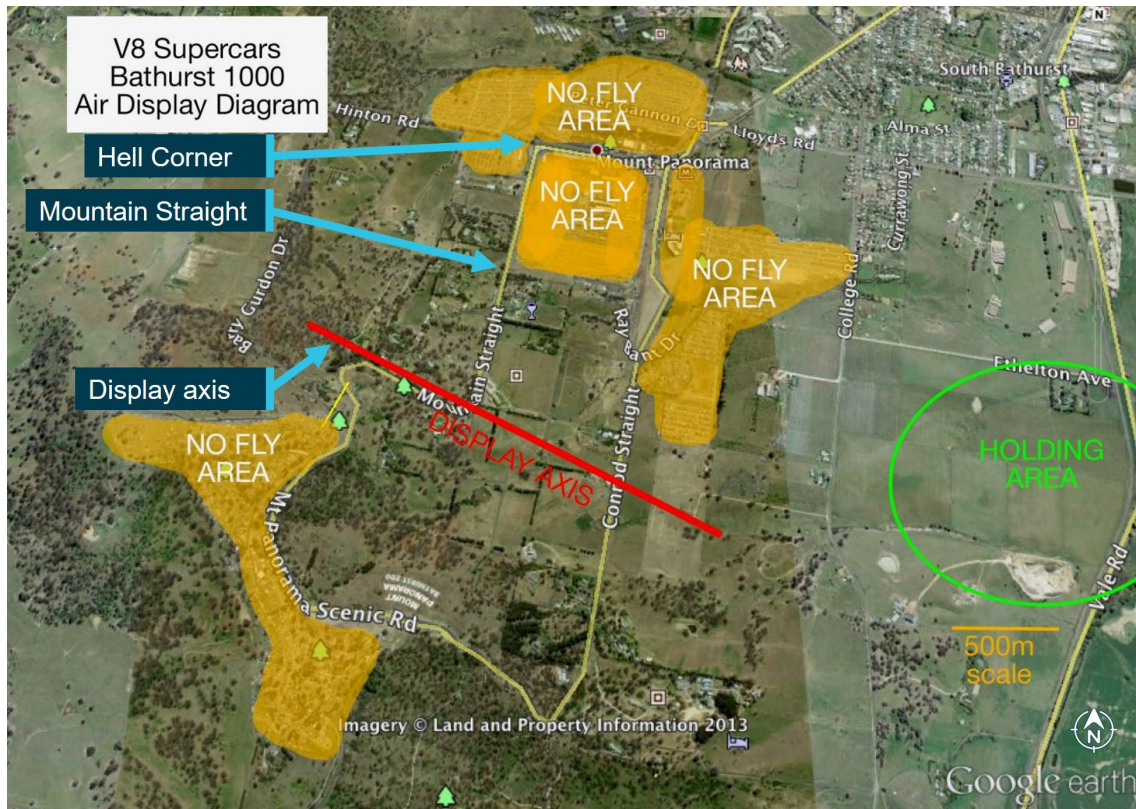
Figure 4: Pilot’s display diagram

The display diagram in the application included the pilot’s aerobatic display axis and the spectator NO FLY AREAs, located inside and outside of the track (Figure 4). The northern end of Mountain Straight was surrounded by NO FLY AREAs but the display diagram did not include the planned approach and departure paths over those areas. Similar to the Sandown risk assessment, the only risk associated with the trophy handover was ‘Landing with people on track’.

There was no information about the dimensions and suitability of the proposed landing area, spectator safety distances or weather limits. The pilot advised the ATSB that the race organisers had a spare trophy at the track if the landing had to be aborted and an off-track parking location if the aircraft became unserviceable after landing. These measures were in place to mitigate the pressure to land and take-off in unfavourable circumstances but were not included in the risk assessment.

The pilot's Bathurst display application did not include how the landing and take-off would be conducted without breaching the NO FLY AREAs. While the FOI was reportedly unaware of the topography of Mountain Straight, they assumed the pilot would comply with the NO FLY AREAs and that the nominated display coordinator would be in attendance. Consequently, the FOI did not question the pilot's planning or check the topography, either one of which would have revealed that the spectator safety distance could not be met while landing on the proposed section of the racetrack. In addition, a check of the pilot's previous air display applications would have revealed they had a history of difficulty applying the requirements of AC 91-21 to their display planning.
